[Docket No. **FAA-2006-24446**; Directorate Identifier **2005-SW-15-AD**; Amendment **39-14561**; AD **2006-08-06**]

Airworthiness Directives; Eurocopter France Model SA-360C, SA-365C, SA-365C1, and SA-365C2 Helicopters

2006-08-06 Eurocopter France:

Amendment 39-14561. Docket No. FAA-2006-24446; Directorate Identifier 2005-SW-15-AD.

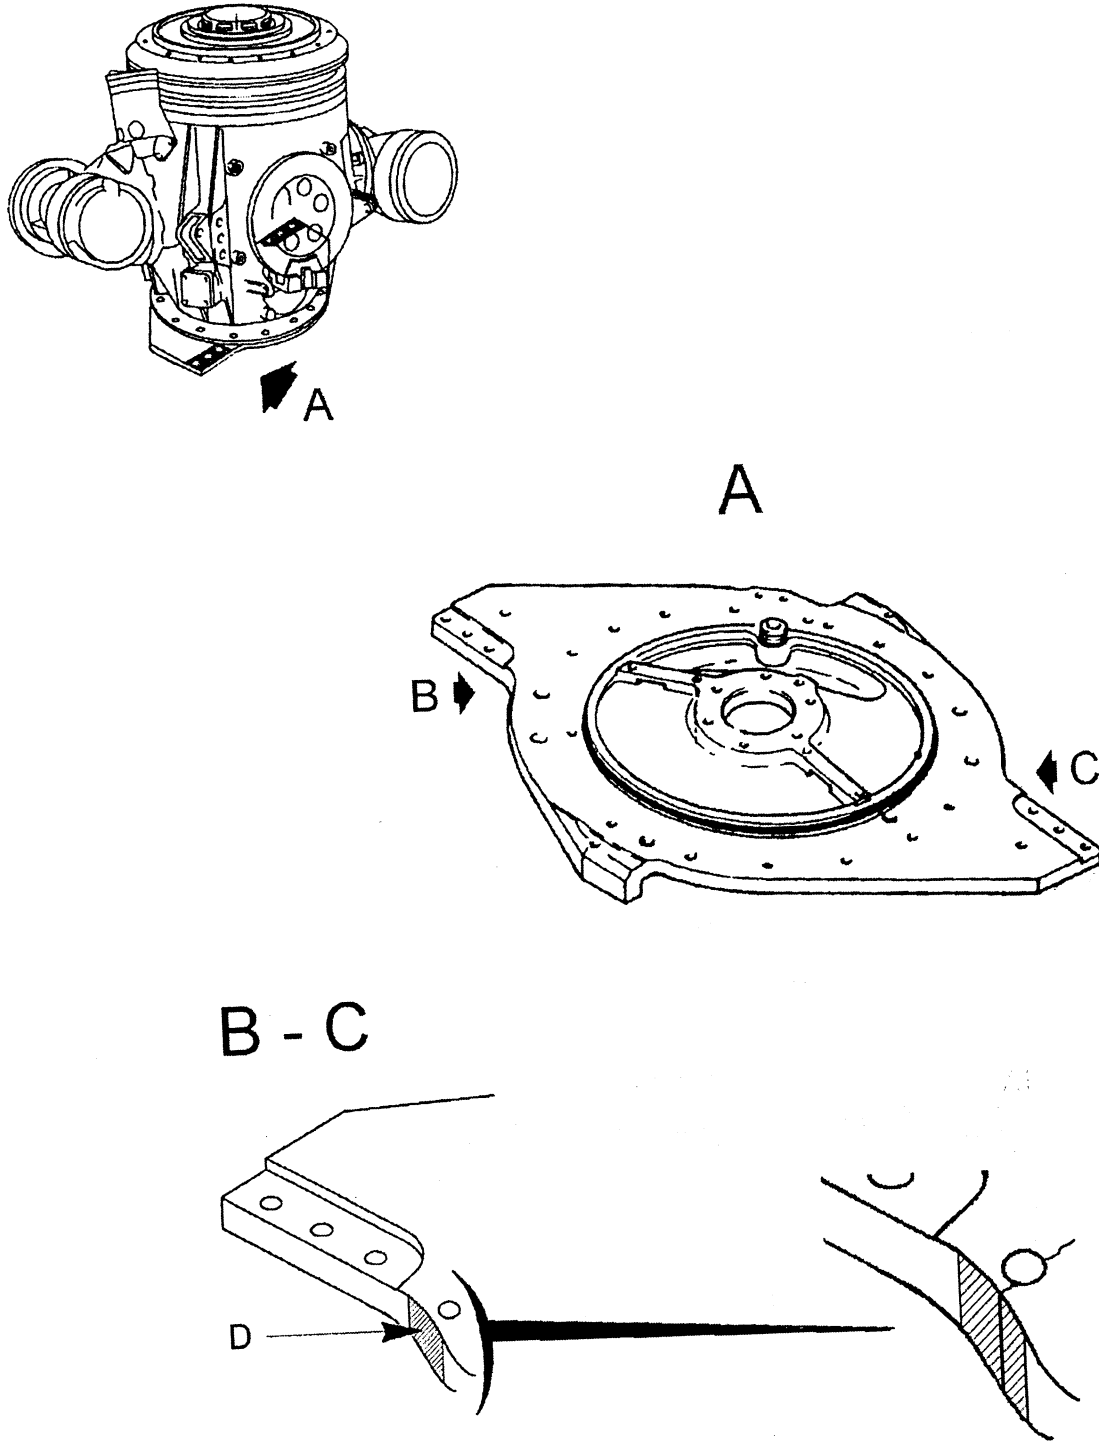
paint from area "D" on both sides ("B" and "C") of the MGB base plate as depicted in Figure 1 of this AD.

(b) At the times indicated in the compliance table, inspect area “D” of the MGB base plate for a crack using a 10x or higher magnifying glass. Area “D” to be inspected is depicted in Figure 1 of this AD.

(c) If a crack is found in a MGB base plate, remove and replace the MGB with an airworthy MGB before further flight.
