[Docket No. FAA-2006-24446; Directorate Identifier 2005-SW-15-AD; Amendment 39-14561; AD 2006-08-06]

**Airworthiness Directives; Eurocopter France Model SA-360C, SA-365C, SA-365C1, and SA-365C2 Helicopters**

**2006-08-06 Eurocopter France:**

Amendment 39-14561. Docket No. FAA-2006-24446; Directorate Identifier 2005-SW-15-AD.

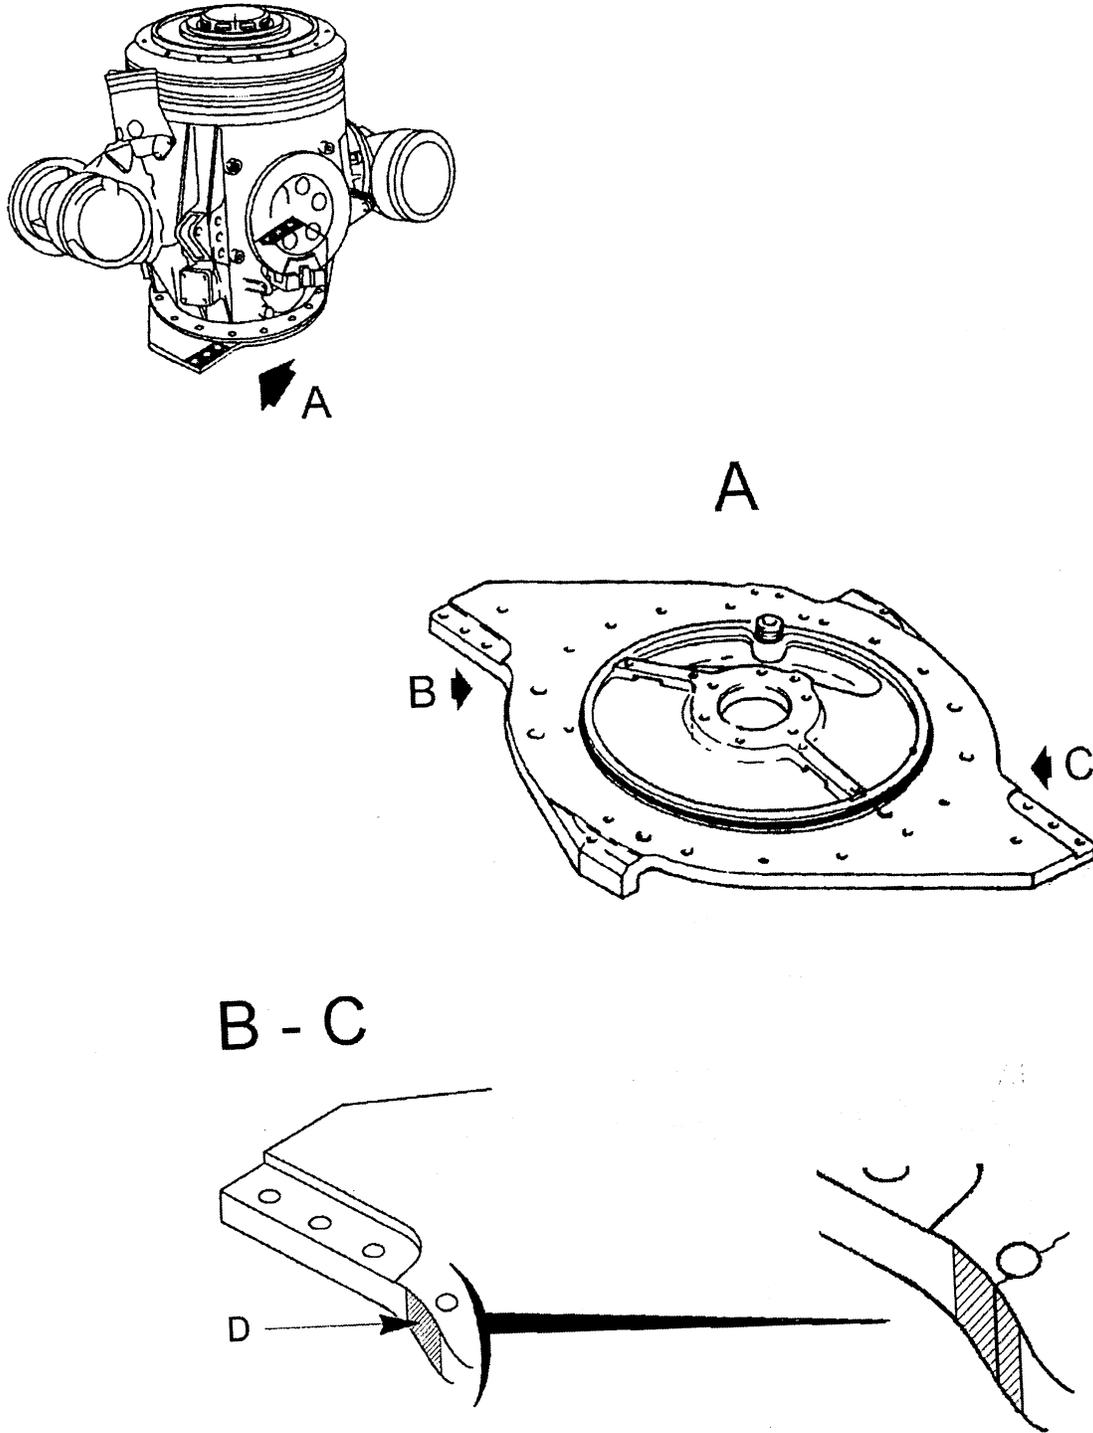
To detect a crack in a MGB base plate and prevent failure of one of the MGB attachment points to the frame, which could result in severe vibration and subsequent loss of

paint from area "D" on both sides ("B" and "C") of the MGB base plate as depicted in Figure 1 of this AD.

(b) At the times indicated in the compliance table, inspect area "D" of the MGB base plate for a crack using a 10x or higher magnifying glass. Area "D" to be inspected is depicted in Figure 1 of this AD.

(c) If a crack is found in a MGB base plate, remove and replace the MGB with an airworthy MGB before further flight.
