Airworthiness Directives; Eurocopter France Model AS-365N2, AS 365 N3, EC 155B, EC155B1, SA-365N, N1, and SA-366G1 Helicopters

ACTION: Notice of proposed rulemaking (NPRM).

Eurocopter France: Docket No. FAA–2004–18850; Directorate Identifier 2004–SW–19–AD. Revises AD 2004–16–15, Amendment 39–13771.

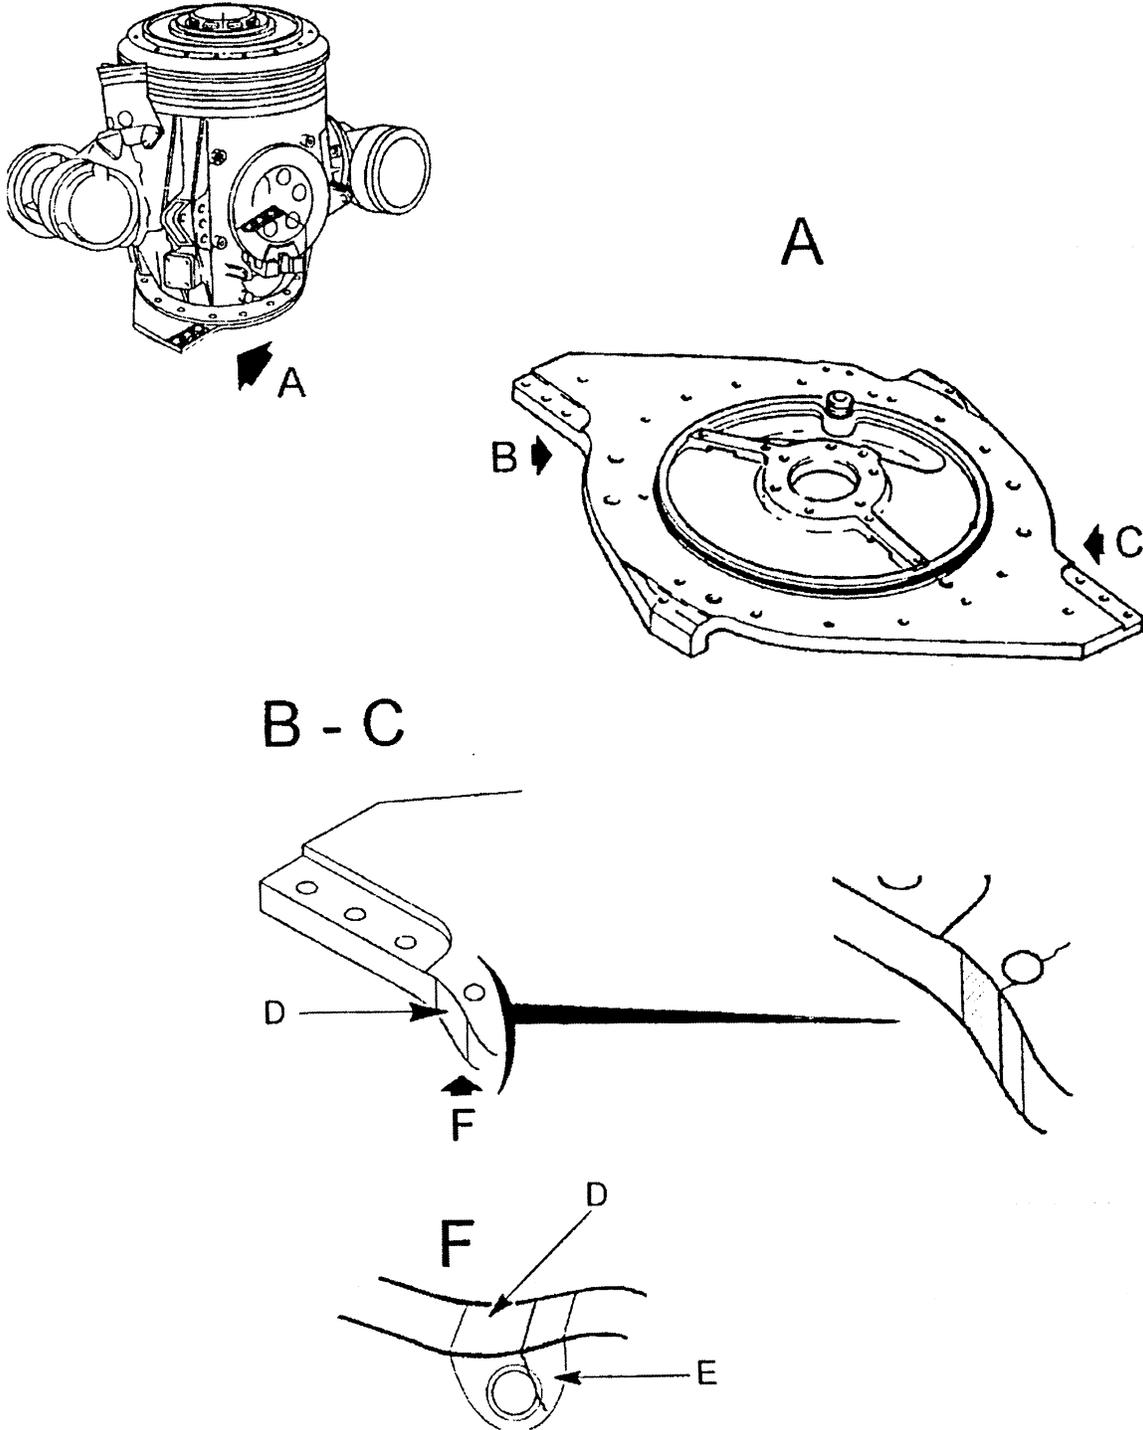
strip the paint from area "D" on both sides ("B" and "C") of the MGB base plate as depicted in Figure 1 of this AD.

(b) At the times indicated in the compliance table, inspect area "D" of the MGB base plate for a crack using a 10x or higher magnifying glass. Area "D" to be inspected is depicted in Figure 1 of this AD.

(c) If a crack is found in a MGB base plate, remove and replace the MGB with an airworthy MGB before further flight.
