[Docket No. FAA-2006-25097; Directorate Identifier 2005-SW-19-AD]

Airworthiness Directives; Arrow Falcon Exporters, Inc. (Previously Utah State University); Firefly Aviation Helicopter Services (Previously Erickson Air-Crane Co.); California Department of Forestry; Garlick Helicopters, Inc.; Global Helicopter Technology, Inc.; Hagglund Helicopters, LLC (Previously Western International Aviation, Inc.); International Helicopters, Inc.; Precision Helicopters, LLC; Robinson Air Crane, Inc.; San Joaquin Helicopters (Previously Hawkins and Powers Aviation, Inc.); S.M.&T. Aircraft (Previously US Helicopters, Inc., UNC Helicopter, Inc., Southern Aero Corporation, and Wilco Aviation); Smith Helicopters; Southern Helicopter, Inc.; Southwest Florida Aviation International, Inc. (Previously Jamie R. Hill and Southwest Florida Aviation); Tamarack Helicopters, Inc. (Previously Ranger Helicopter Services, Inc.); US Helicopter, Inc. (Previously UNC Helicopter, Inc.); West Coast Fabrication; and Williams Helicopter Corporation (Previously Scott Paper Co.) Model HH-1K, TH-1F, TH-1L, UH-1A, UH-1B, UH-1E, UH-1F, UH-1H, UH-1L, and UH-1P Helicopters; and Southwest Florida Aviation Model SW204, SW204HP

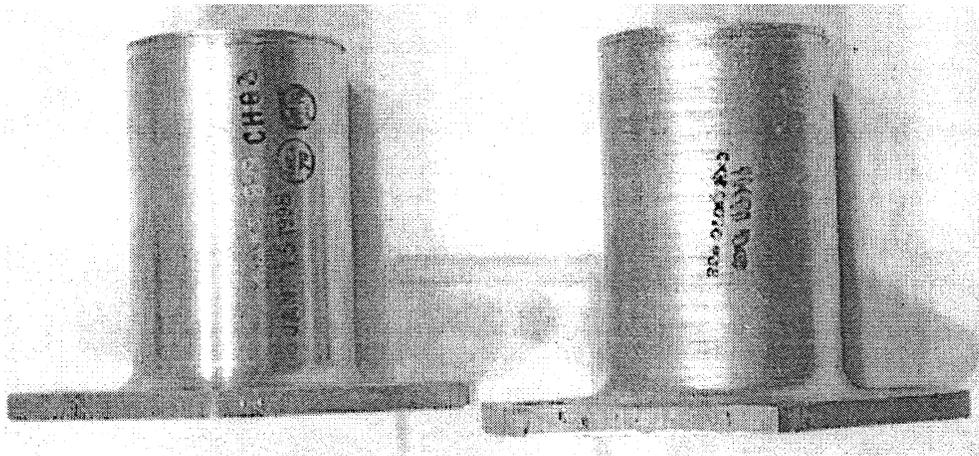
FIGURE 1

excess surface roughness. This proposal is prompted by two accidents attributed to sub-standard T/R sliders that failed during flight. This condition, if not corrected, could result in cracking in the T/R slider, loss of T/R control, and subsequent loss of control of the helicopter.

Note 1: T/R sliders manufactured by Forest Scientific, Inc., were produced under a military contract and do not meet the OEM specifications. The machining process resulted in excess surface roughness. See Figure 1 of this AD.

Tail rotor sliders manufactured by Bell Helicopter Textron, Inc. (left) and Forest Scientific, Inc. (right). Note the rough finish of the Forest Scientific, Inc.-manufactured T/R slider compared to the one shown on the left.

(iii) On or before accumulating 1000 hours TIS or on or before 12 months, whichever occurs first, replace each T/R slider that

has an illegible CAGE code or Code 15716 or 26098 with an FAA approved airworthy slider without a CAGE code or with a legible CAGE code other than 15716 or 26098. Any T/R slider removed from service based on the requirements of this paragraph is not eligible for installation on any helicopter.
