[Docket No. FAA-2006-25105; Directorate Identifier 2006-CE-33-AD]

#### Airworthiness Directives; Raytheon Aircraft Company Beech Models 45 (YT-34), A45 (T-34A, B-45), and D45 (T-34B) Airplanes

**ACTION:** Notice of proposed rulemaking (NPRM).

**SUMMARY:** We propose to supersede Airworthiness Directive (AD) 62-24-01, which applies to all Raytheon Aircraft Company (Raytheon) Beech Models 45 (YT-34), A45 (T-34A, B45), and D45 (T-34B) airplanes. AD 62-24-01 currently requires you to repetitively inspect, using the dye penetrant method, the front and rear horizontal stabilizer spars for cracks and replace any cracked stabilizer. Since we issued AD 62-24-01, we determined that using dye penetrant inspection method may not detect cracks before failure of the horizontal stabilizer spars. Therefore, we are proposing to require the surface eddy current inspection method to detect cracks in the horizontal stabilizer spars. Consequently, this proposed AD would retain the actions required in AD 62-24-01 and change the required inspection method from dye penetrant to surface eddy current. We are proposing this AD to prevent failure of the front and rear horizontal stabilizer spars caused by

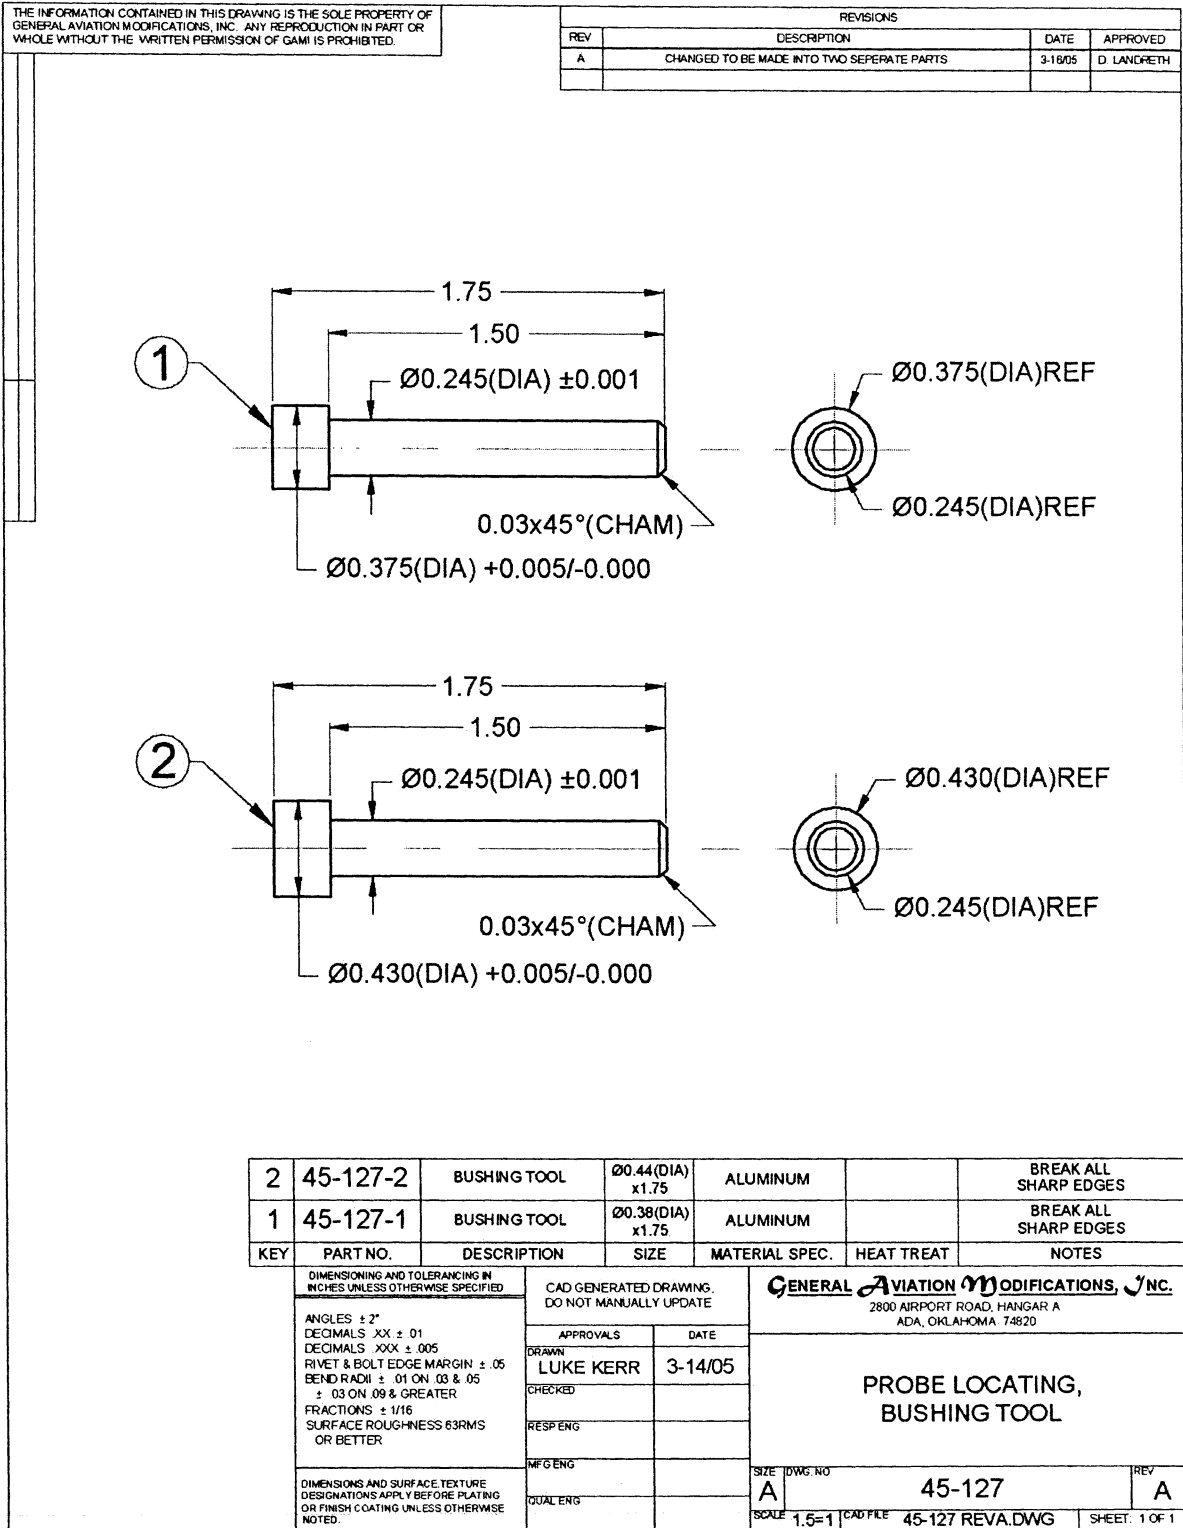
Figure 1

**Typical Set-up Parameters:**  
Frequency – 350 KHz, Gain Vertical – 75 dB, Horizontal – 69 dB, Drive-Mid, Filters-Lo Pass-30, Hi Pass-0, Lift off-Horizontal to the left, adjust as required. The most reliable indication (minimum of 1½ to 2 graticules) of the smallest observable flaw in the coupon (see attach Figures) occurs from the notch extending 0.025" past the edge of the nominal fastener head (total notch length of 0.100" from the edge of the nominal hole). Install appropriate aluminum guide pin into bushing such that the edge of the guide pin is flush with the edge of the bushing. Using the pin (see the attached Figures) as a guide, circle the area surrounding the steel bushing with the probe and adjacent area (approximately ¼") to inspect for cracks. Inspect forward and aft surfaces surrounding bushings of each spar.
