[Docket No. FAA-2006-25703; Directorate Identifier 2006-SW-20-AD; Amendment 39-14747; AD 2006-17-51]

Airworthiness Directives; Agusta S.p.A. Model AB139 Helicopters

2006-17-51 Agusta S.p.A.: Amendment 39-14747. Docket No. FAA-2006-25703; Directorate Identifier 2006-SW-20-AD.

Applicability: Model AB139 helicopters, with tailpipe assembly left hand, part number (P/N) 3G7800L00131 and right hand, P/N 3G7800L00231, installed, certificated in any category.

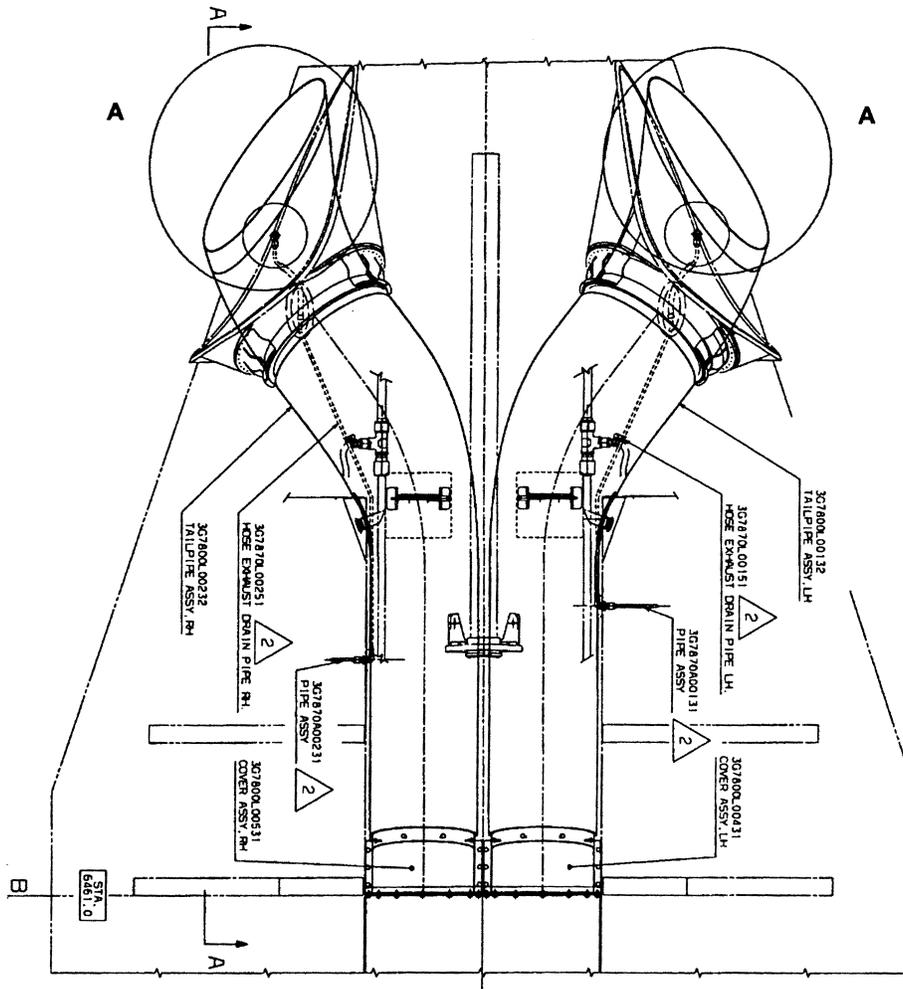
Figure 1

- Inspect for overheating in the area of each tailpipe assembly outside the cowling. Inspect the internal part of each tailpipe assembly in the areas depicted in Areas A, Figure 1, of this AD for a crack:

(2) Inspect the structure surrounding each tailpipe assembly for overheating. If you find areas of overheating, inspect for heat damage to the surrounding structure. Inspect for overheating in the area of each tailpipe assembly outside the cowl. Inspect the internal part of each tailpipe assembly in the areas depicted in Areas A, Figure 1, of this AD.

(i) Clean the end of each tailpipe assembly with a cloth. While applying slight pressure on it, inspect for a crack using a flashlight.

(ii) Inspect each tailpipe assembly toward the centerline of the helicopter for a crack using a flashlight.

(iii) Inspect each tailpipe assembly toward the outboard side of the helicopter for a crack using a mirror and a flashlight.

(3) If you find a crack, before further flight, replace the tailpipe assembly with an airworthy tailpipe assembly.
