14 CFR Part 39

[Docket No. FAA-2006-25724; Directorate Identifier 2006-NM-197-AD; Amendment 39-14742; AD 2006-18-04]

Airworthiness Directives; Bombardier Model CL-600-2B16 (CL-604) Airplanes and Model CL-600-2B19 (Regional Jet Series 100 & 440) Airplanes

2006-18-04 Bombardier, Inc. (Formerly Canadair): Amendment 39-14742.

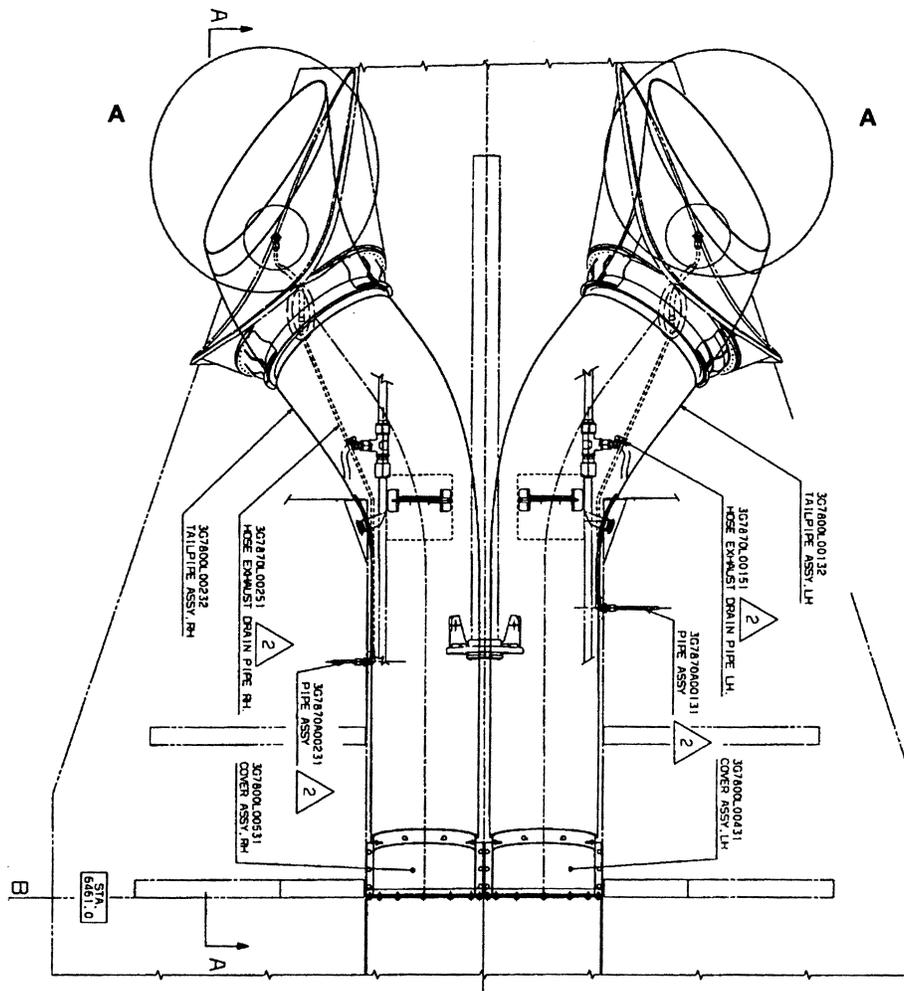
Figure 1

(i) Clean the end of each tailpipe assembly with a cloth. While applying slight pressure on it, inspect for a crack using a flashlight.

(ii) Inspect each tailpipe assembly toward the centerline of the helicopter for a crack using a flashlight.

(iii) Inspect each tailpipe assembly toward the outboard side of the helicopter for a crack using a mirror and a flashlight.

(3) If you find a crack, before further flight, replace the tailpipe assembly with an airworthy tailpipe assembly.
