DEPARTMENT OF TRANSPORTATION**Federal Aviation Administration****14 CFR Part 39**

[Docket No. FAA–2006–25760; Directorate Identifier 2006–CE–48–AD; Amendment 39–14757; AD 2006–18–51]

Airworthiness Directives; Raytheon Aircraft Company Models 1900, 1900C, and 1900D Airplanes**AGENCY:** Federal Aviation Administration (FAA), DOT.**ACTION:** Final rule; request for comments.

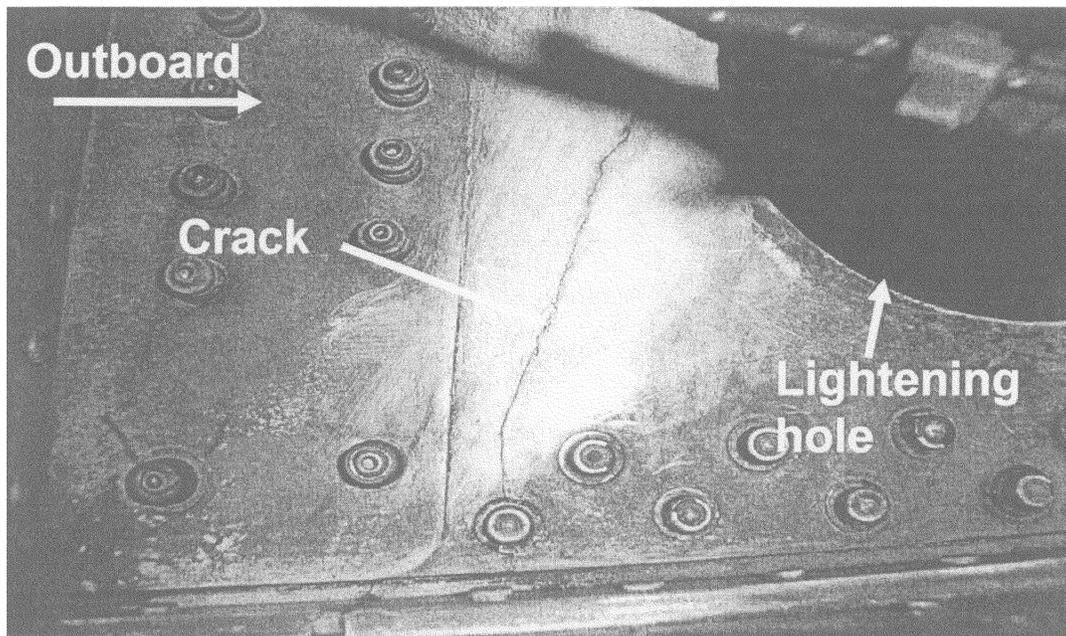
One airplane had 19,126 hours TIS when cracks were found. The cracks were in the lower aft spar cap flange, but the cracks extended upward into the web and terminated at the lightening hole in the spar web. Fasteners were also found missing in the spar cap and wing cove splice plate. There were no discrepancies recorded from the initial inspection at 17,500 hours TIS on this airplane.

Figure 2: Closeup view of R/H wing rear spar web crack at BL 114 area looking forward (The inboard flap is removed in this figure, but removal of the flap is not required to do the inspection).

(3) Repair any cracks or other damage such as loose or missing fasteners found during the inspection required in paragraph (e)(1) of this AD. Do this by obtaining and incorporating an FAA-approved repair scheme from RAC.	Before further flight after the inspection required by paragraph (e)(1) of this AD.	Contact RAC at Post Office Box 85, Wichita, Kansas 67201-0085; phone: 316-676-8366; fax: (316) 676-8745; e-mail: <i>tom_peay@rac.ray.com</i> .

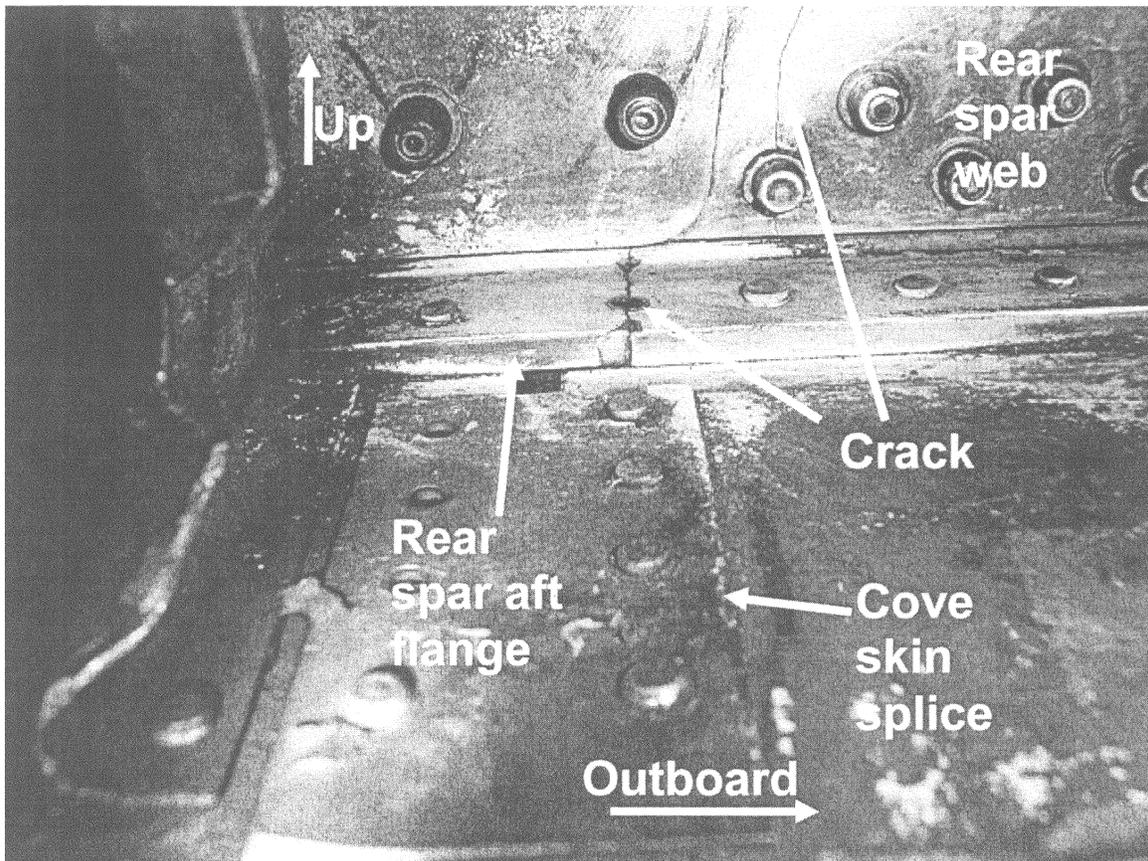
Figure 3: Closeup view of R/H wing rear spar cracks at BL 114 area looking forward (The inboard flap is removed in this figure, but removal of the flap is not required to do the inspection).
