[Docket No. FAA-2006-25097; Directorate Identifier 2005-SW-19-AD; Amendment 39-14762; AD 2006-19-05]

Airworthiness Directives; Arrow Falcon Exporters, Inc. (Previously Utah State University); Firefly Aviation Helicopter Services (Previously Erickson Air-Crane Co.); California Department of Forestry; Garlick Helicopters, Inc.; Global Helicopter Technology, Inc.; Hagglund Helicopters, LLC (Previously Western International Aviation, Inc.); International Helicopters, Inc.; Precision Helicopters, LLC; Robinson Air Crane, Inc.; San Joaquin Helicopters (Previously Hawkins and Powers Aviation, Inc.) S.M.&T. Aircraft (Previously U.S. Helicopters, Inc., UNC Helicopter, Inc., Southern Aero Corporation, and Wilco Aviation); Smith Helicopters; Southern Helicopter, Inc.; Southwest Florida Aviation International, Inc. (Previously Jamie R. Hill and Southwest Florida Aviation); Tamarack Helicopters, Inc. (Previously Ranger Helicopter Services, Inc.); U.S. Helicopter, Inc. (Previously UNC Helicopter, Inc.); West Coast Fabrication; and Williams Helicopter Corporation (Previously Scott Paper Co.) Model HH-1K, TH-1F, TH-1L, UH-1A, UH-1B, UH-1E, UH-1F, UH-1H, UH-1L, and UH-1P Helicopters; and Southwest

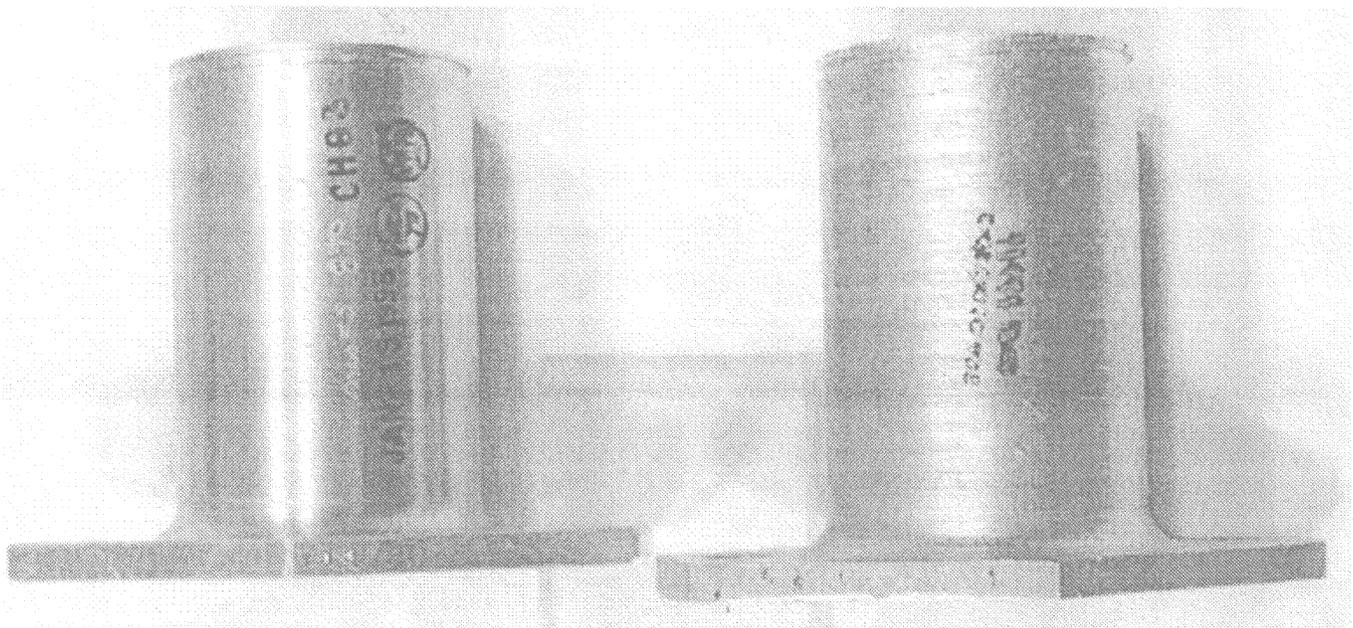
FIGURE 1

Note 1: T/R sliders manufactured by Forest Scientific, Inc., were produced under a military contract and do not meet the OEM specifications. The machining process resulted in excess surface roughness. See Figure 1 of this AD.

Tail rotor sliders manufactured by Bell Helicopter Textron, Inc. (left) and Forest Scientific, Inc. (right). Note the rough finish of the Forest Scientific, Inc.-manufactured T/R slider compared to the one shown on the left.

(iii) On or before accumulating 1000 hours TIS or on or before 12 months, whichever occurs first, replace each T/R slider that has an illegible CAGE code or Code 15716 or 26098 with an FAA approved airworthy slider without a CAGE code or with a legible CAGE code other than 15716 or 26098. Any T/R slider removed from service based on the requirements of this paragraph is not eligible for installation on any helicopter.
