Airworthiness Directives; Bell Helicopter Textron Model 204B, 205A, 205A-1, 205B, 210, 212, 412, 412CF, and 412EP Helicopters

ACTION: Notice of proposed rulemaking (NPRM).

Bell Helicopter Textron: Docket No. FAA-2006-26219; Directorate Identifier 2004-SW-49-AD.

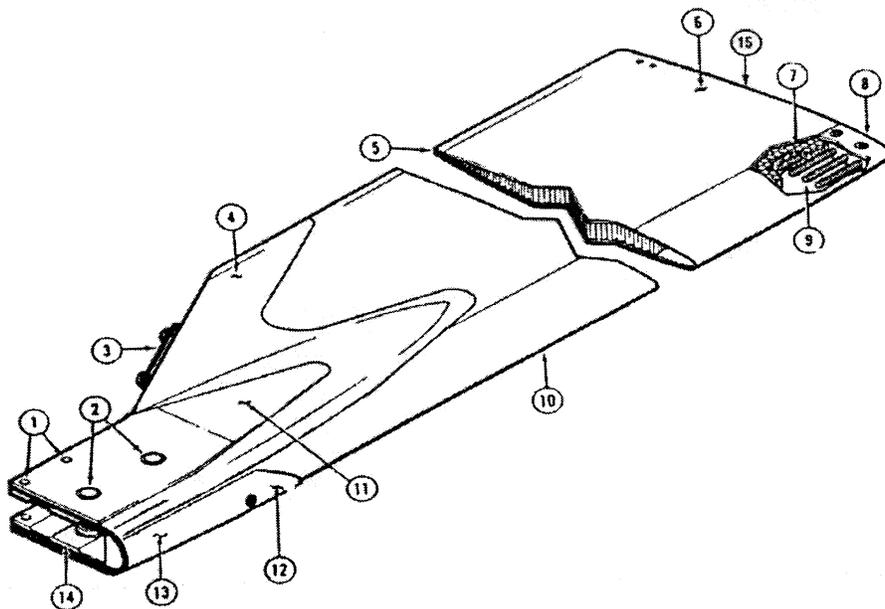
T/R Blade Assembly
Figure 1

(2) Using a 3-power or higher magnifying glass and a bright light, visually inspect the T/R blade skins, leading edge spar, doublers, grip plates, and trailing edge for a crack, corrosion (may be indicated by blistering, peeling, flaking, bubbling, or cracked paint) and any other damage (including a nick, scratch, or dent). See Figure 1 of this AD. Pay particular attention to both sides of the T/R

blade in the area located 10 to 25 inches from the T/R blade tip (blade station 26 to 41—the T/R blade tip is located at blade station 51). Also pay particular attention to any blade surface that was snagged by the cloth, as that may be an indication of a crack or paint chip that could lead to corrosion.

(1) Replace any T/R blade that has a crack with an airworthy blade.

(2) Replace any T/R blade that has any corrosion, nick, scratch, dent, or other damage that exceeds any maximum repair limit with an airworthy blade.

(3) Repair or replace with an airworthy blade any T/R blade that has any corrosion, nick, scratch, dent or other damage that is within the maximum repair limits.
