[Docket No. FAA-2006-23871; Directorate
Identifier 2006-NE-01-AD]

Airworthiness Directives; General Electric Company (GE) CF6-80C2 Turbofan Engines

ACTION: Notice of proposed rulemaking
(NPRM).

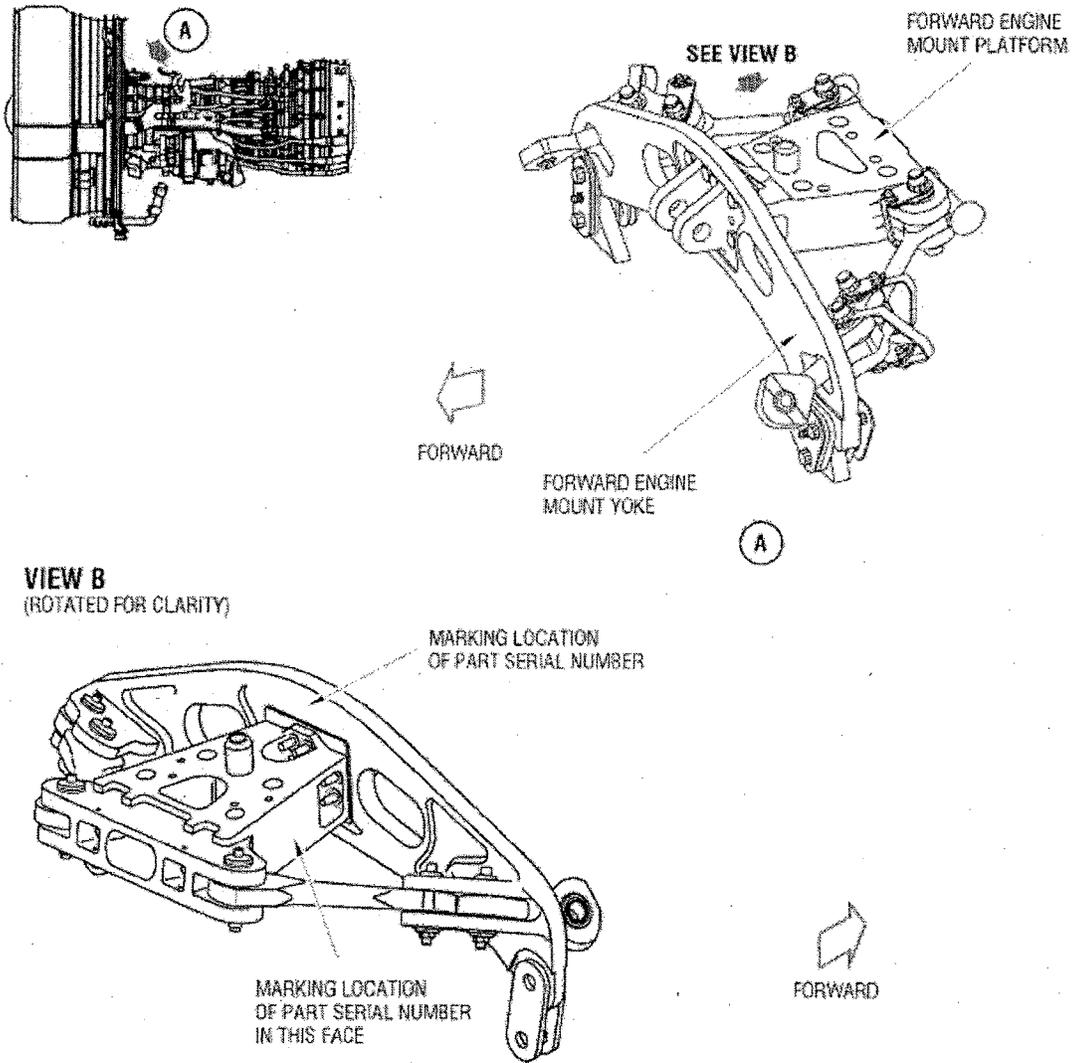
Location of Forward Engine Mount Platform and Forward Engine Mount Yoke
Figure 1

(d) This AD results from the discovery of cracks in a forward engine mount platform and a forward engine mount yoke found during fluorescent penetrant inspection (FPI). We are issuing this AD to prevent cracks in the forward engine mount platform and forward engine mount yoke that could result in possible separation of the engine from the airplane.

(p) Location of the forward engine mount platform and forward engine mount yoke and SN are illustrated in the following Figure 1.

(n) Replace the affected forward engine mount platform and or the affected forward engine mount yoke with a non-weld-repaired cast titanium forward engine mount platform and or the forward engine mount yoke or a forged titanium forward engine mount platform or a forged titanium forward engine mount yoke.
