[Docket No. FAA-2006-23871; Directorate Identifier 2006-NE-01-AD; Amendment 39-14975; AD 2007-05-14]

#### Airworthiness Directives; General Electric Company (GE) CF6-80C2 Turbofan Engines

#### 2007-05-14 General Electric Company:

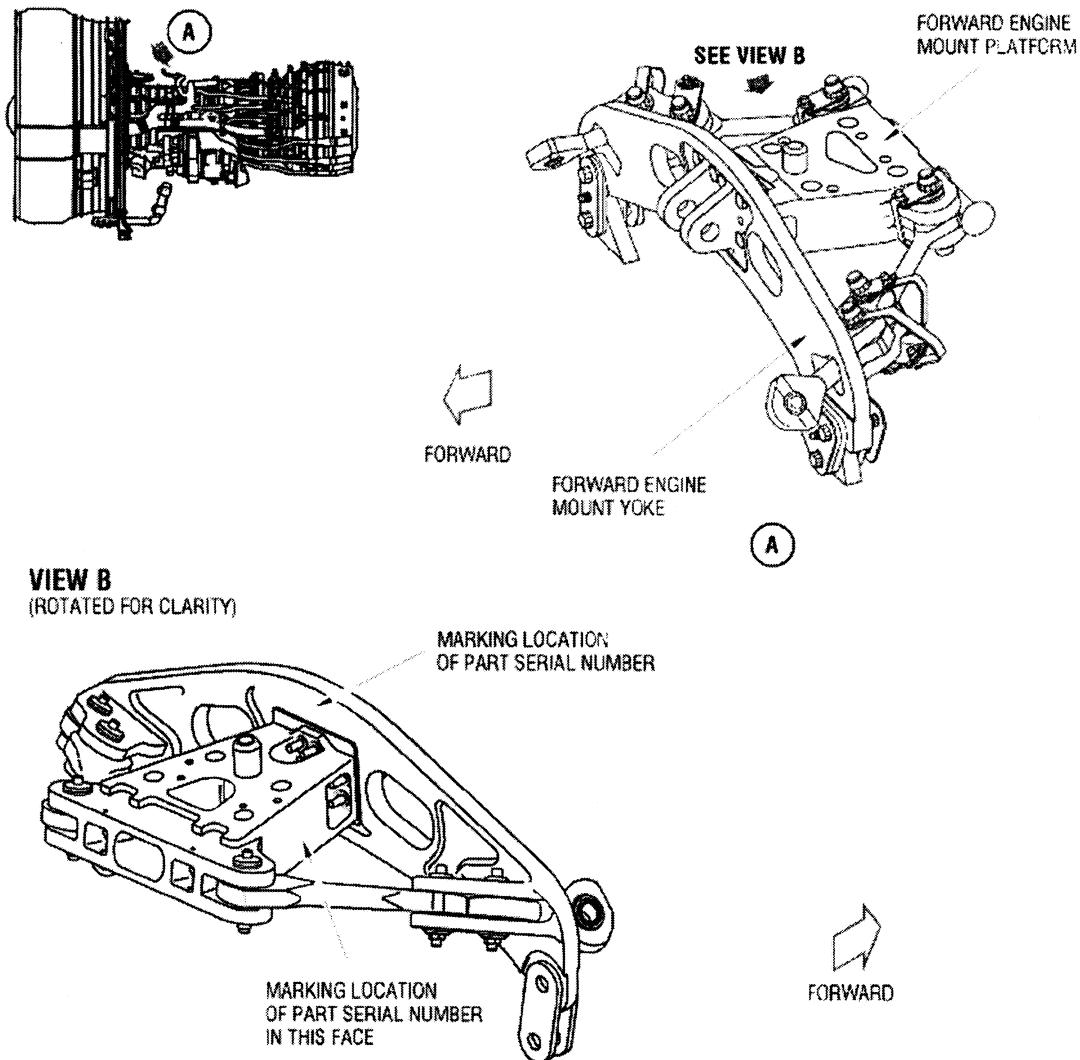
Location of Forward Engine Mount Platform and Forward Engine Mount Yoke  
Figure 1

(d) This AD results from the discovery of cracks in a forward engine mount platform and a forward engine mount yoke found during fluorescent penetrant inspection (FPI). We are issuing this AD to prevent cracks in the forward engine mount platform and forward engine mount yoke that could result in possible separation of the engine from the airplane.

(p) Location of the forward engine mount platform and forward engine mount yoke and SN are illustrated in the following Figure 1.

(n) Replace the affected forward engine mount platform and or the affected forward engine mount yoke with a non-weld-repaired

cast titanium forward engine mount platform and or the forward engine mount yoke or a forged titanium forward engine mount platform or a forged titanium forward engine mount yoke.
