[Docket No. FAA-2006-23871; Directorate Identifier 2006-NE-01-AD; Amendment 39-14975; AD 2007-05-14]

Airworthiness Directives; General Electric Company (GE) CF6-80C2 Turbofan Engines

2007-05-14 General Electric Company:

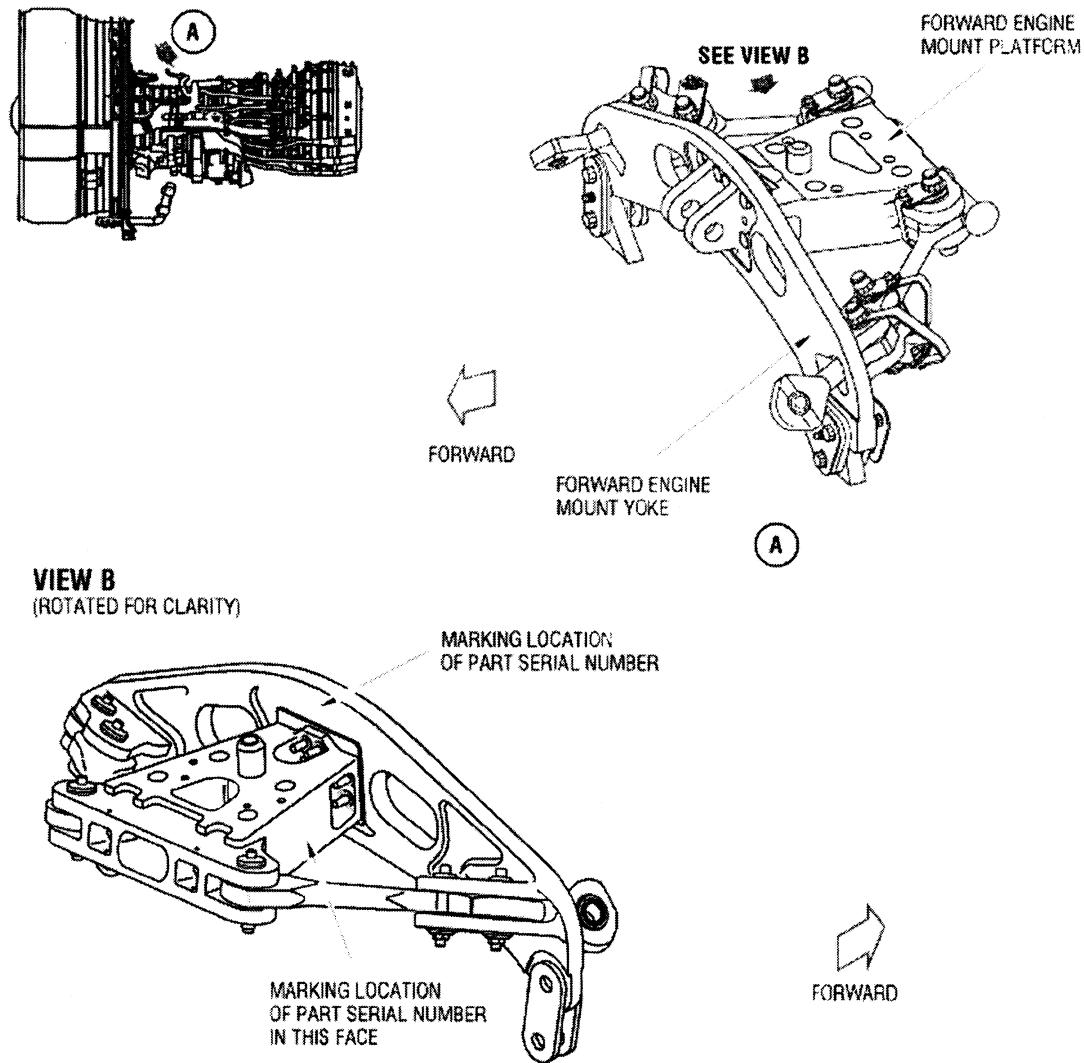
Location of Forward Engine Mount Platform and Forward Engine Mount Yoke
Figure 1

(d) This AD results from the discovery of cracks in a forward engine mount platform and a forward engine mount yoke found during fluorescent penetrant inspection (FPI). We are issuing this AD to prevent cracks in the forward engine mount platform and forward engine mount yoke that could result in possible separation of the engine from the airplane.

(p) Location of the forward engine mount platform and forward engine mount yoke and SN are illustrated in the following Figure 1.

(n) Replace the affected forward engine mount platform and or the affected forward engine mount yoke with a non-weld-repaired

cast titanium forward engine mount platform and or the forward engine mount yoke or a forged titanium forward engine mount platform or a forged titanium forward engine mount yoke.
