Airworthiness Directives; MD Helicopters Inc. (MDHI) Model MD600N Helicopters

2007-05-51 MD Helicopters Inc. (MDHI):
Amendment 39-15030. Docket No. FAA-2007-27343; Directorate Identifier 2007-SW-05-AD.

Applicability: Model MD600N helicopters, with a lateral mixer output link assembly (mixer link), part number (P/N) 600N7636-1, -3, -9, or -11 installed, certificated in any category.

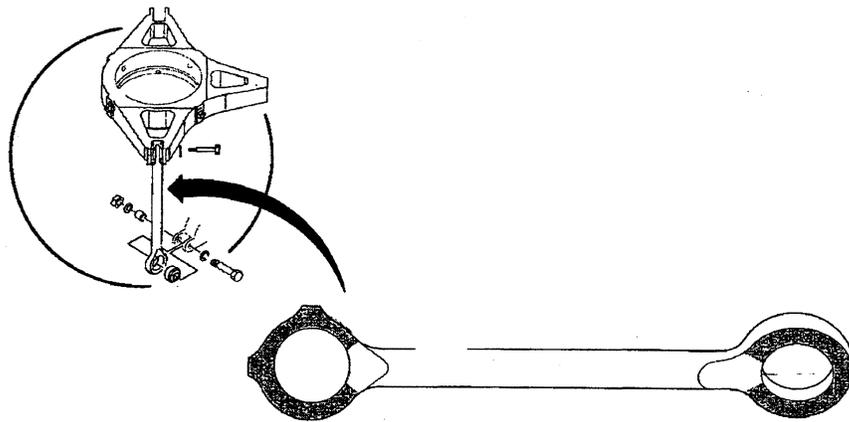
Figure 1

(1) Remove each mixer link and visually inspect, with a bright light and a 10x or higher magnifying glass, the shaded areas around the bearing bore for any crack as depicted in the following Figure 1:

Bearings have been removed for clarity.

(2) Perform an eddy current inspection of each mixer link in the bearing end areas.

(3) Replace any cracked mixer link with an airworthy mixer link on which an eddy current inspection has been performed.
