2007-05-51 MD Helicopters Inc. (MDHI):
Amendment 39-15030. Docket No. FAA-2007-27343; Directorate Identifier 2007-SW-05-AD.

Applicability: Model MD600N helicopters, with a lateral mixer output link assembly (mixer link), part number (P/N) 600N7636-1, -3, -9, or -11 installed, certificated in any category.

To detect a crack in the mixer link, which could result in failure of the mixer link and subsequent loss of control of the helicopter, accomplish the following:

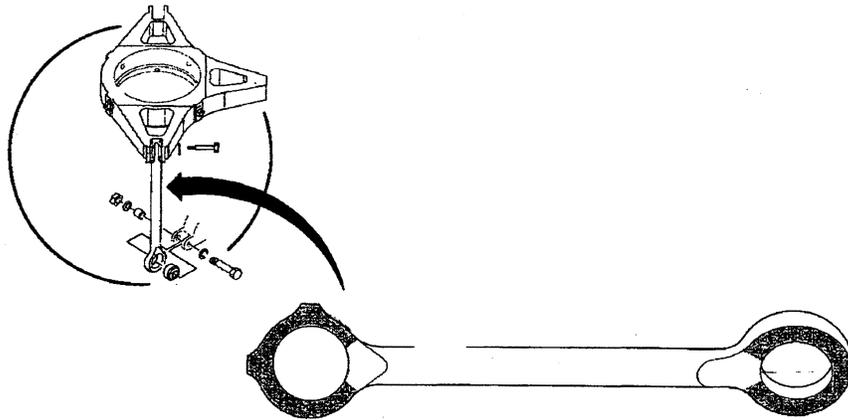
Figure 1

(1) Remove each mixer link and visually inspect, with a bright light and a 10x or higher magnifying glass, the shaded areas around the bearing bore for any crack as depicted in the following Figure 1:

Bearings have been removed for clarity.

(2) Perform an eddy current inspection of each mixer link in the bearing end areas.

(3) Replace any cracked mixer link with an airworthy mixer link on which an eddy current inspection has been performed.
