DEPARTMENT OF TRANSPORTATION**Federal Aviation Administration****14 CFR Part 39**

[Docket No. FAA-2007-27229; Directorate Identifier 2007-NE-03-AD]

Airworthiness Directives; CFM International, S.A. CFM56-7B Series Turbofan Engines

ACTION: Notice of proposed rulemaking (NPRM).

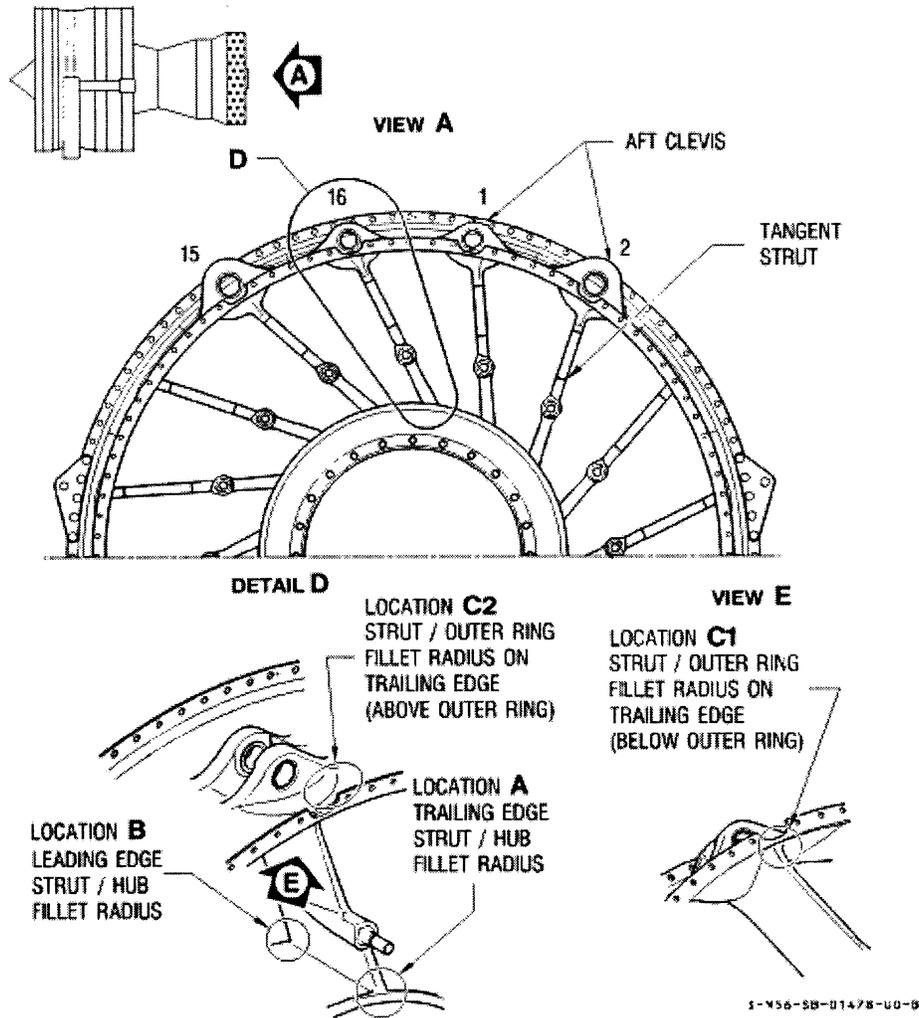
Figure 805,

manufacturer that shows the need to identify an initial threshold for inspecting certain TRFs. We are proposing this AD to prevent failure of the TRF from low-cycle fatigue cracks. Failure of the TRF could result in engine separation from the airplane, which could lead to loss of control of the airplane.

Figure index No.	Inspection location	Inspection threshold (cycles since new)	Inspection intervals (cycles)	Inspection reference
805	Strut/outer ring fillet radius on trailing edge (A).	25,000* for -7B SAC (except business jet) engine models.	Refer to Figure 806* for -7B SAC commercial applications.	Refer to SB 72-0579*.
	Strut/outer ring fillet radius on leading edge (B).	19,000* for -7B SAC business jet engine models.	Refer to Figure 807* for -7B SAC business jet applications.	
	Strut/outer ring fillet radius on trailing edge (C1 below outer ring).			
	Strut/outer ring fillet radius on trailing edge (C2 above outer ring).

Turbine Rear Frame with Tangential struts P/ N 340-166-205-0, 340-166-206-0, 340-166-207-0, 340-166-208-0, 340-166-209-0, 340-166-210-0—Areas to Be Inspected

TURBINE REAR FRAME IS SERVICEABLE AND MUST BE RE-INSPECTED AT 4,700 CYCLE REPETITIVE INTERVALS. IF CRACKS ARE FOUND ON THE MOUNT STRUTS, THE TRF MUST BE RE-INSPECTED ACCORDING TO THE FOLLOWING REPETITIVE INTERVALS

Total cumulated crack length at each location	Re-inspect within
$L < 0.20$ (5)	4,700.
$0.20 (5) \leq L < 0.28$ (7)	3,300.
$0.28 (7) \leq L < 0.39$ (10)	1,300.
$0.39 (10) \leq L < 0.59$ (15)	700.
$0.59 (15) \leq L < 0.79$ (20)	120.
$L \geq 0.79$ (20)	IMMEDIATELY REMOVE THE TURBINE FRAME.

DURING EACH INSPECTION, ALL THE LOCATIONS MUST BE INSPECTED. IF CRACKS ARE FOUND AT DIFFERENT LOCATIONS, THE REPETITIVE INSPECTION INTERVAL IS THE MINIMUM INTERVAL CORRESPONDING TO THE MAX. CUMULATED CRACK LENGTHS.
