[Docket No. FAA-2007-28691; Directorate Identifier 2006-SW-22-AD]

#### Airworthiness Directives; Eurocopter France Model AS355E, F, F1, F2, and N Helicopters

**ACTION:** Notice of proposed rulemaking (NPRM).

**Eurocopter France:** Docket No. FAA–2007–28691; Directorate Identifier 2006–SW–22–AD. Supersedes AD 2003–21–09 R1, Amendment 39–14621, Docket No. 2003–SW–10–AD.

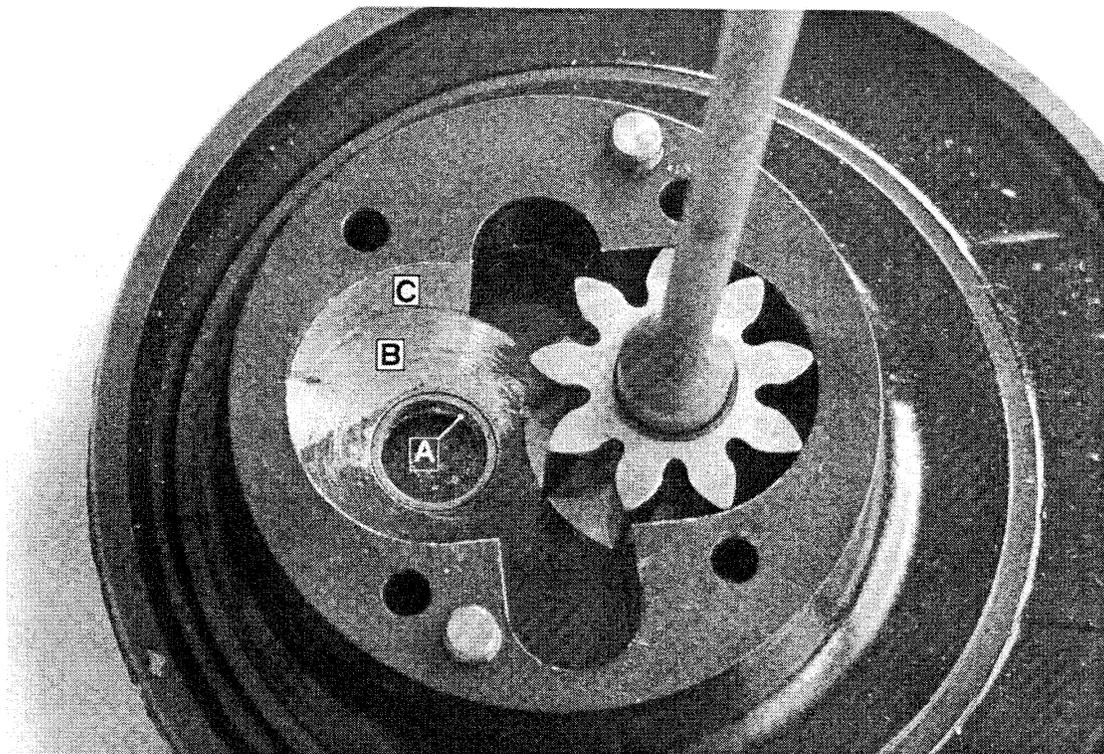
- (1) Crank pin play,
- (2) Out of round bronze bushing in area "A" of Figure 1 of this AD,
- (3) Offset of the driven gear pinion,
- (4) Metal chips, or
- (5) Wear in area "C" of Figure 1 of this AD.

**Note 2:** If wear is present in the B area only, as depicted in Figure 1, replacing the MGB and the pump is not required.

(d) While inspecting the pump, if you find any of the following, replace the MGB and the pump with an airworthy MGB and pump before further flight:
