Federal Register

Monday, July 16, 2007

Airworthiness Directives; Bell Helicopter Textron Canada Model 430 Helicopters

ACTION: Notice of proposed rulemaking (NPRM).

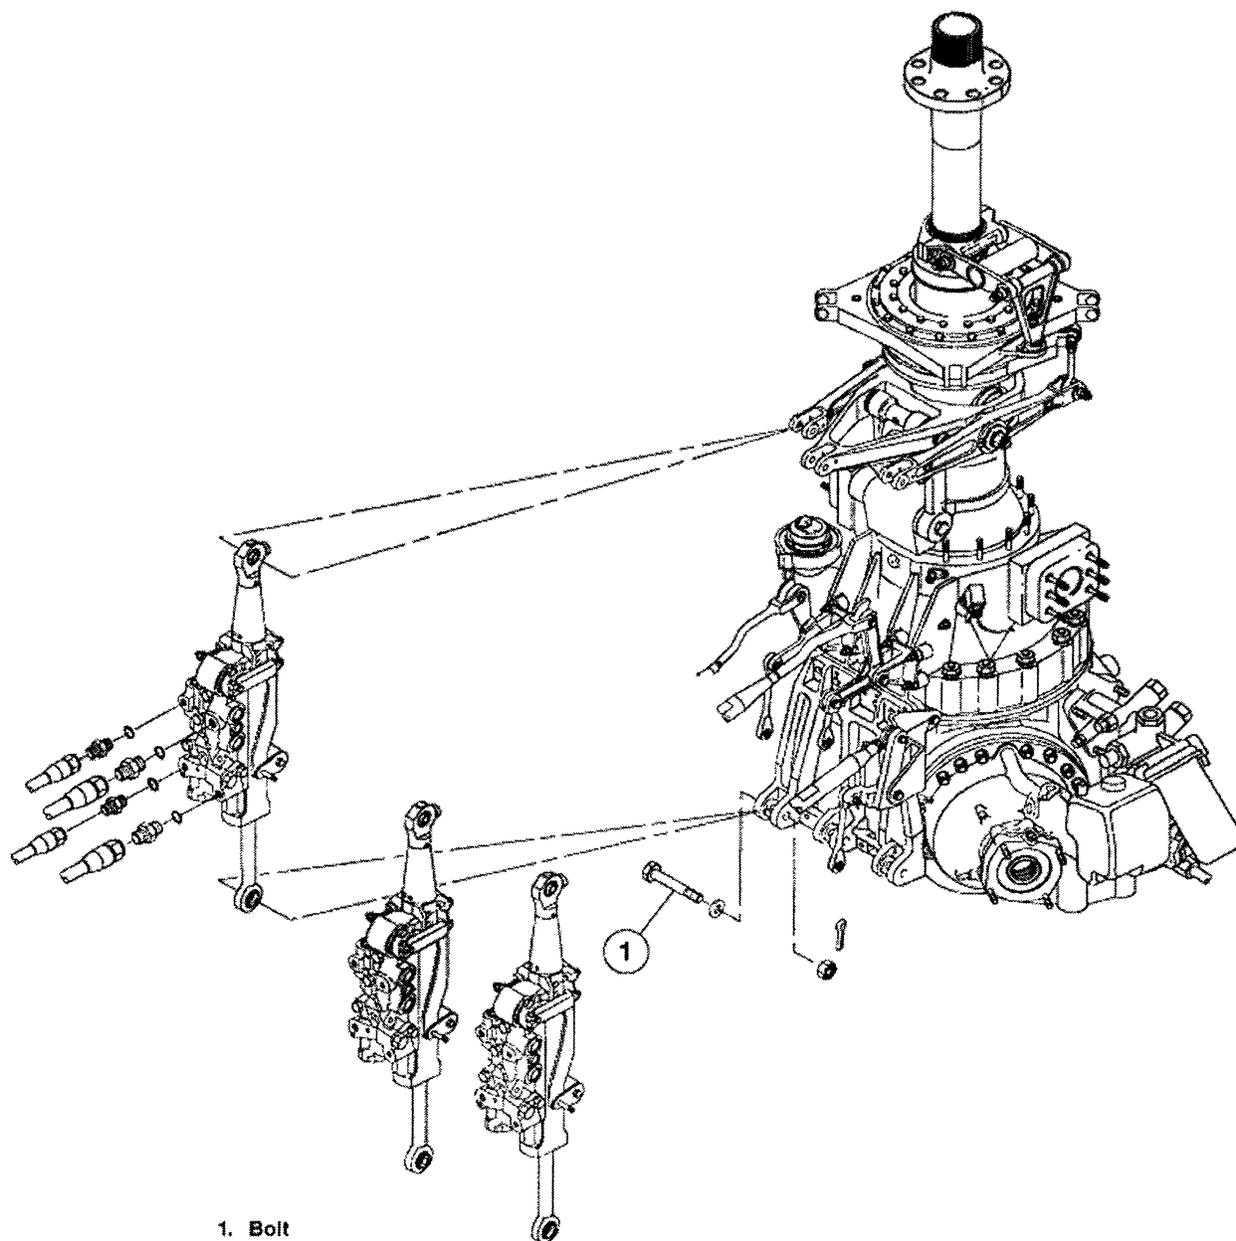
This previously described unsafe condition is likely to exist or develop on other helicopters of the same type design registered in the United States. Further evaluation of certain fatigue-critical parts resulted in establishing a life limit of 5000 hours for the affected bolts which is intended to prevent fatigue failure of the bolt and subsequent loss of control of the helicopter. Therefore, the proposed AD would require the following:

Note: Only the right servo lower attach bolt (1) is shown. The collective and left cyclic servo lower attach bolts are also to be replaced. (This AD does not apply to the same part-numbered bolts at the upper end of each servo.)

- (a) Within 150 hours time-in-service (TIS), replace all three affected bolts, as depicted for one of these bolts in Figure 1 of this AD, with airworthy, zero-time bolts, P/N 50-047C8-31.
