[Docket No. FAA–2008–0101; Directorate Identifier 2007–SW–76–AD; Amendment 39–15357; AD 2007–26–51]

#### **Airworthiness Directives; Eurocopter Deutschland GmbH Model EC135 Helicopters**

#### 2007-26-51 Eurocopter Deutschland

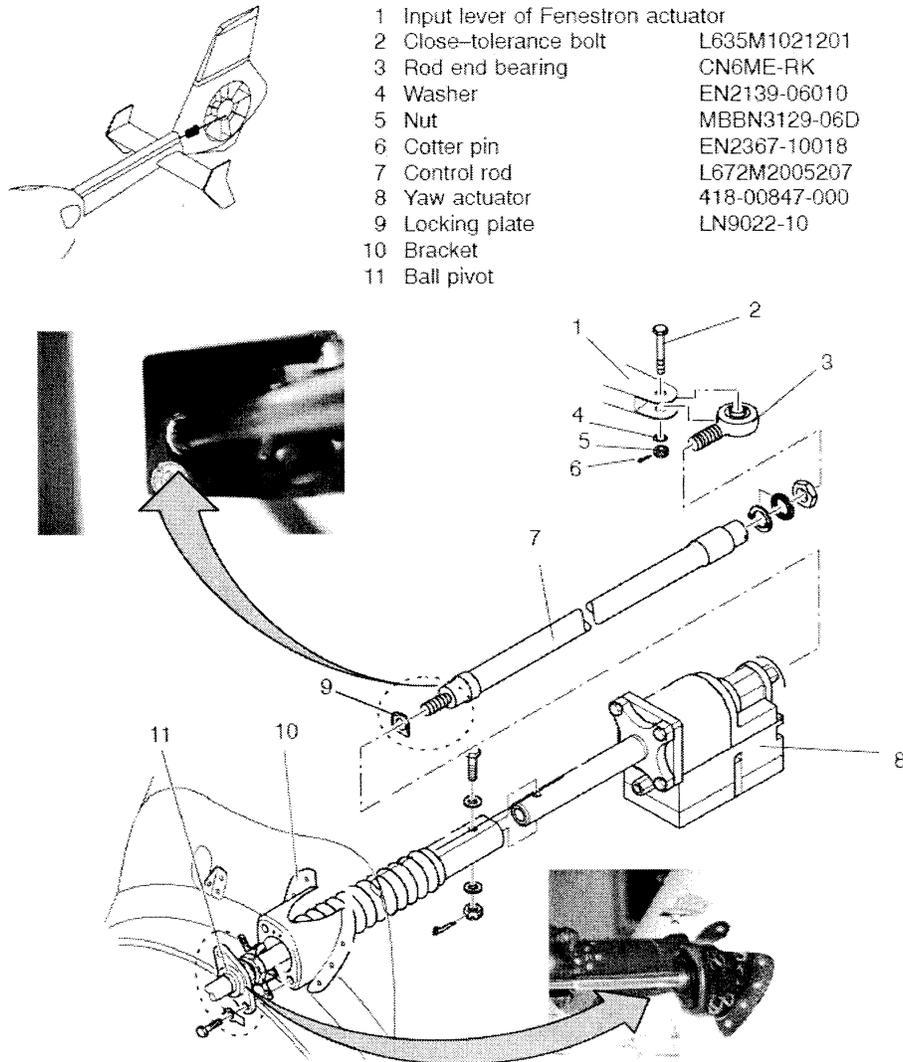
Ball Pivot and Control Rod  
Figure 1

**SUPPLEMENTARY INFORMATION:** On December 14, 2007, the FAA issued Emergency AD 2007–26–51 for Eurocopter Model EC135 helicopters, which requires, within 5 hours TIS, inspecting the control rod and adjoining ball pivot and replacing any unairworthy parts before further flight. That action was prompted by a report of a fatal accident involving the failure of a control rod. This condition, if not corrected, could result in the failure of

The European Aviation Safety Agency (EASA), which is the Technical Agent for the Member States of the European Community, notified us that an unsafe condition may exist on Eurocopter EC135 and EC635 helicopters. EASA advises that an accident recently occurred with an EC135 helicopter in Japan. Preliminary investigation results indicate that the helicopter loss of control was due to the failure of the control rod.

(a) Within 5 hours time-in-service (TIS), inspect the control rod, shown in item 7, Figure 1, of this AD, with the parts identified in parenthesis as follows:

(1) Pull the control rod (7) until it reaches its stop position. Inspect attachment hardware of control rod (7) for a tight fit. Manually inspect for possible relative motion between control rod (7) and yaw actuator (8).

(2) Inspect the locking plate (9) for a tight fit.

(3) Visually inspect the attachment hardware between control rod (7) and yaw actuator (8) for play or thread exposure. If play or thread exposure is found, before further flight, replace the control rod with an airworthy control rod.

(b) Inspect the ball pivot as shown in item 11, Figure 1, of this AD by removing the tail rotor drive shaft fairing and inspecting for a loose bearing or play. If a loose bearing or play is found, before further flight, replace the ball pivot with an airworthy ball pivot.
