[Docket No. FAA-2007-27229; Directorate Identifier 2007-NE-03-AD; Amendment 39-15359; AD 2008-03-09]

Airworthiness Directives; CFM International, S.A. CFM56-7B Series Turbofan Engines

2008-03-09 CFM International, S.A.:
Amendment 39-15359, Docket No. FAA-2007-27229; Directorate Identifier 2007-NE-03-AD.

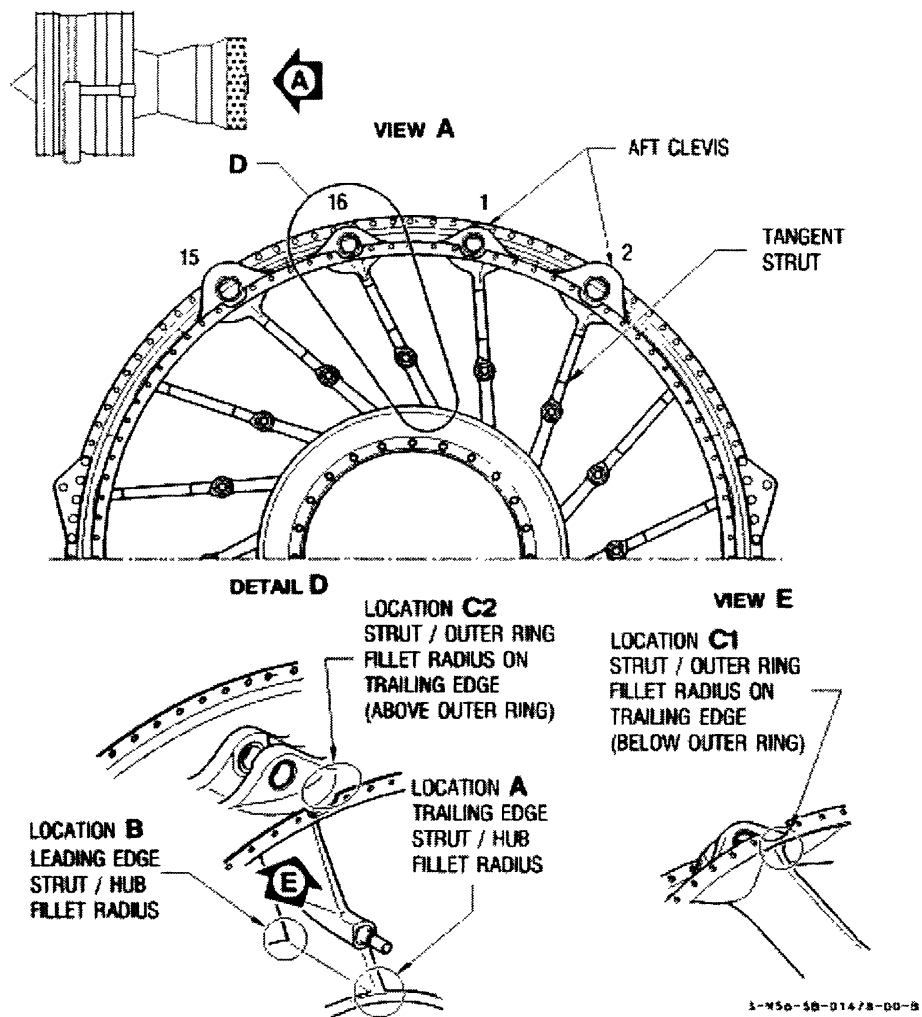
Figure 805

threshold for inspecting certain TRFs. We are issuing this AD to prevent failure of the TRF from low-cycle fatigue cracks. Failure of the TRF could result in engine separation from the airplane, which could lead to loss of control of the airplane.

Figure index No.	Inspection location	Inspection threshold (cycles since new)	Inspection intervals (cycles)	Inspection reference
805	Strut/outer ring fillet radius on trailing edge (A). Strut/hub fillet radius on leading edge (B). Strut/outer ring fillet radius on trailing edge (C1 below outer ring). Strut/outer ring fillet radius on trailing edge (C2 above outer ring).	25,000* for -7B SAC (except business jet) engine models. 19,000* for -7B SAC business jet engine models.	Refer to Figure 806* for -7B SAC (except business jet) engine models. Refer to Figure 807* for -7B SAC business jet engine models.	Refer to SB 72-0579.*

Turbine Rear Frame with Tangential Struts P/N 340-166-205-0,
 340-166-206-0, 340-166-207-0, 340-166-208-0, 340-166-209-0, 340-166-210-0 –
 Areas to Be Inspected

C. Turbine Rear Frame Part Numbers 340-166-205-0, 340-166-206-0, 340-166-207-0, 340-166-208-0, 340-166-209-0, 340-166-210-0, for all CFM56-7B SAC engine models (except -7B27A engine models). Refer to figure 805.

Note: * Applicable to all inspection locations. If inspection is not performed, part must be removed.
