[Docket No. FAA–2008–0490; Directorate Identifier 2008–SW–26–AD; Amendment 39–15509; AD 2008–10–03]

#### Airworthiness Directives; Bell Helicopter Textron Model 204B, 205A, 205A–1, 205B, 210, 212, 412, 412CF, and 412EP Helicopters

**2008-10-03 Bell Helicopter Textron:**

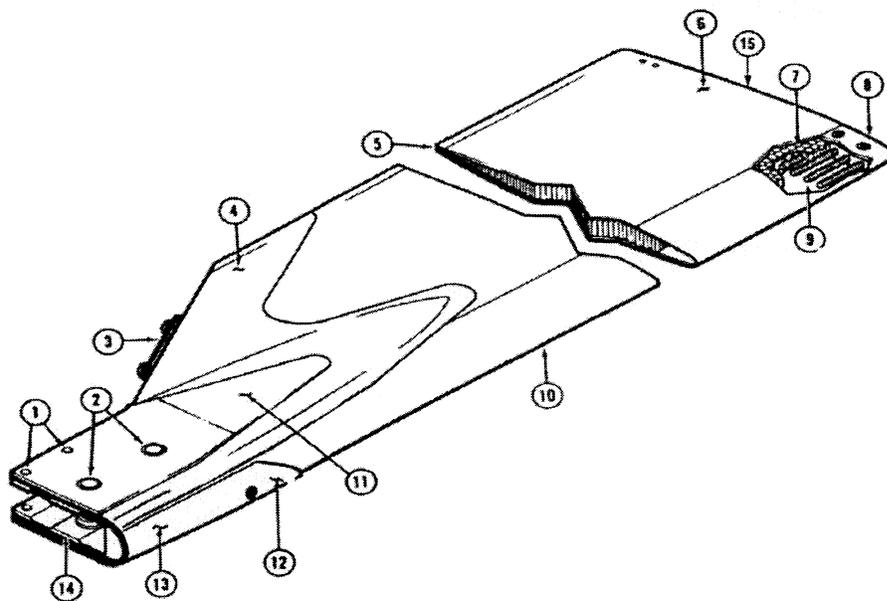
T/R Blade Assembly  
Figure 1

(2) Using a 3-power or higher magnifying glass and a bright light, visually inspect the T/R blade skins, leading edge spar, doublers, grip plates, and trailing edge for a crack, corrosion (may be indicated by blistering, peeling, flaking, bubbling, or cracked paint) and any other damage (including a nick, scratch, or dent). See Figure 1 of this AD. Pay particular attention to both sides of the T/R blade in the area located 16 to 26 inches from the T/R blade tip (blade station 25 to 35—the T/R blade tip is located at blade station 51) and to the inboard blade butt area near the attachment of the external balance weights

and screws. Also pay particular attention to any blade surface that was snagged by the

cloth, as that may be an indication of a crack or paint chip that could lead to corrosion.

(1) Replace any T/R blade that has a crack with an airworthy blade.

(2) Replace any T/R blade that has any corrosion, nick, scratch, dent, or other damage that exceeds any maximum repair limit with an airworthy blade.

(3) Repair or replace with an airworthy blade any T/R blade that has any corrosion, nick, scratch, dent or other damage that is within the maximum repair limits.
