[Docket No. FAA-2008-0071; Directorate Identifier 2006-SW-27-AD]

Airworthiness Directives; Bell Helicopter Textron Canada Model 222, 222B, 222U, 230, and 430 Helicopters

ACTION: Notice of proposed rulemaking (NPRM).

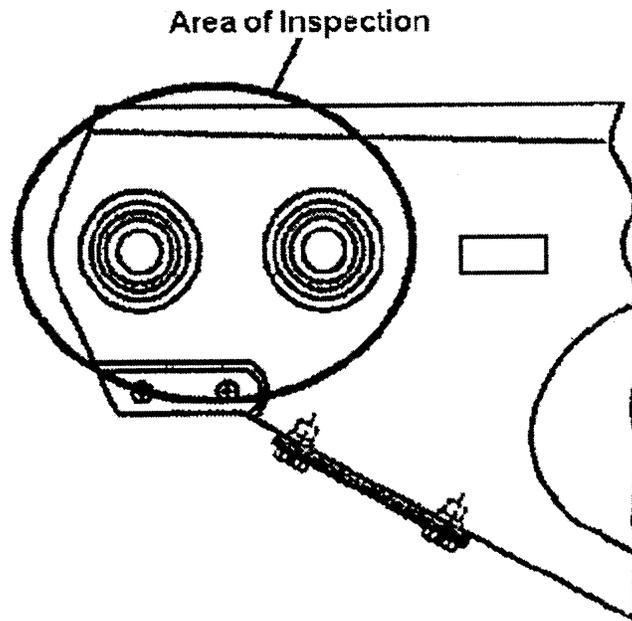
P/N 222-016-001 – all dash numbers

Blade Inspection Area

(c) Within the next 50 hours TIS, unless accomplished previously, and thereafter at intervals not to exceed 50 hours TIS, clean the blade by wiping down both surfaces of each blade in the inspection area depicted in Figure 1 of this AD using aliphatic naphtha (C-305) or detergent (C-318) or an equivalent. Using a 10X or higher power magnifying glass, visually inspect both sides of the blade in the areas depicted in Figure 1 of this AD.

(1) If a crack is found, even if only in the paint, before further flight, remove the blade from the helicopter and proceed with the following:

(2) Remove the paint on the blade down to the bare metal in the area of the suspected crack by using plastic media blasting (PMB) or a nylon web abrasive

(3) Using a 10X or higher power magnifying glass, inspect the blade for a crack.

(i) If a crack is found, replace the blade with an airworthy blade before further flight.

(ii) If no crack is found in the blade surface, refinish the blade by applying one coat of epoxy polyamide primer, MIL-P-23377 or MIL-P-85582, so that the primer overlaps the existing coats just beyond the abraded area. Let the area dry for 30 minutes to 1 hour. Then, apply one sealer coat of polyurethane, MILC85285 TYI CL2, color number 27925 (semi-gloss white), per Fed. Std. 595. Reinstall the blade.

(d) On or before 90 days after the effective date of this AD, replace any affected serial-numbered blade with an airworthy blade that has a S/N that is not subject to, or has been excepted from, the requirements of this AD. Installing an airworthy blade that is not subject to the requirements of this AD,
