[Docket No. FAA-2008-1311; Directorate Identifier 2007-NE-48-AD]

Airworthiness Directives; Honeywell International Inc., T5313 and T5317 Series Turboshift Engines

ACTION: Notice of proposed rulemaking (NPRM).

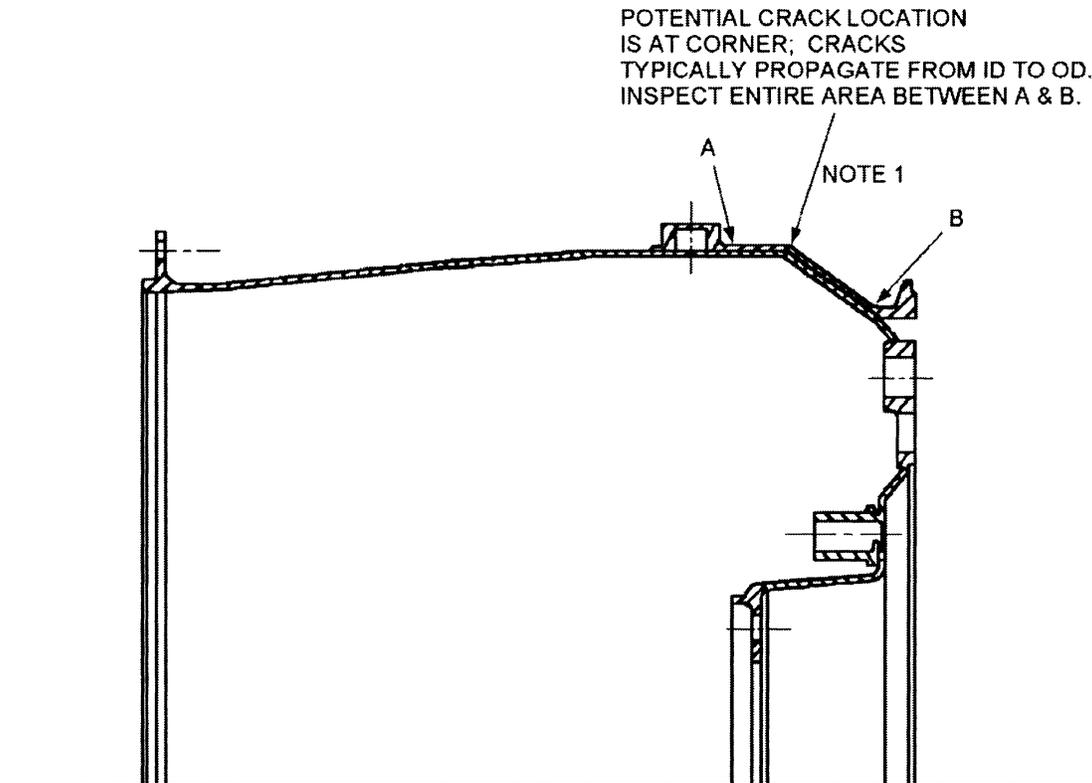
Figure 1. Visual Inspection of CCH

We have received reports of eight instances of cracks developing in CCHs, part numbers (P/Ns) 1-130-610-05 and 1-130-610-12. Two of the instances resulted in an engine shutdown during flight. The cracks developed between the seam welds on the rear outer flange, in the angled bend area, forward of the fuel manifold mounting flange. Fatigue cracking in the "doubler detail" develops from the inside of the CCH, typically starting from corrosion pitting. There have been several instances in which a crack was found during maintenance activities or preflight inspection of the engine. In one instance, with a previously weld-repaired CCH (assumed to be a repair of a crack), additional fatigue cracks grew sufficiently to result in a loss of CCH integrity, subsequent in-flight engine shutdown, and significant airframe damage. A previously weld-repaired CCH has a high potential for additional cracks that might or might not be visible. This condition, if not corrected, could result in rupture of the CCH

NOTE 1. NO WELD REPAIRS ALLOWED IN THIS AREA.

(f) For CCH, P/N 1-130-610-05 and 1-130-610-12, within 50 hours time-in-service (TIS) after the effective date of this AD, inspect the area between points A and B around the entire housing circumference in Figure 1 of this AD for weld repairs and cracks.

(1) If you find any cracks, replace the CCH before further flight. Honeywell International Inc. Alert Service Bulletin (ASB) T53-A0142, Revision 1, dated September 14, 2006, contains additional information on replacing the CCH.

(2) If you find any weld repairs, replace the CCH within 100 hours TIS after the visual inspection. Honeywell International Inc. ASB T53-A0142, Revision 1, dated September 14, 2006, contains additional information on replacing the CCH.

(g) For CCH, P/N 1-130-610-05 and 1-130-610-12, inspect the area between points A and B around the entire housing circumference in Figure 1 of this AD for cracks within 50 hours time-since-last inspection. Honeywell International Inc. Standard Practices Manual 70-20-02, SP 1302, contains additional information on visual inspection.

(h) If you find any cracks, replace the CCH before further flight. Honeywell International Inc. ASB T53-A0142, Revision 1, dated September 14, 2006, contains additional information on replacing the CCH.
