**2009–08–06 General Electric Company:**  
Amendment 39–15879. Docket No. FAA–2008–0827; Directorate Identifier 2008–NE–26–AD.

### Airworthiness Directives; Honeywell International Inc. ALF502L–2 and ALF502L–2C Turbofan Engines

**SUMMARY:** The FAA is adopting a new airworthiness directive (AD) for Honeywell International Inc. ALF502L–2 and ALF502L–2C turbofan engines with certain high-pressure compressor (HPC) first stage discs installed. This AD requires performing a dimensional inspection to determine if excessive disc balance material was removed and a magnetic particle inspection if the disc

**2009-08-07 Honeywell International Inc. (Formerly AlliedSignal and Lycoming):** Amendment 39-15880. Docket No. FAA-2008-1207; Directorate Identifier 2007-NE-47-AD.

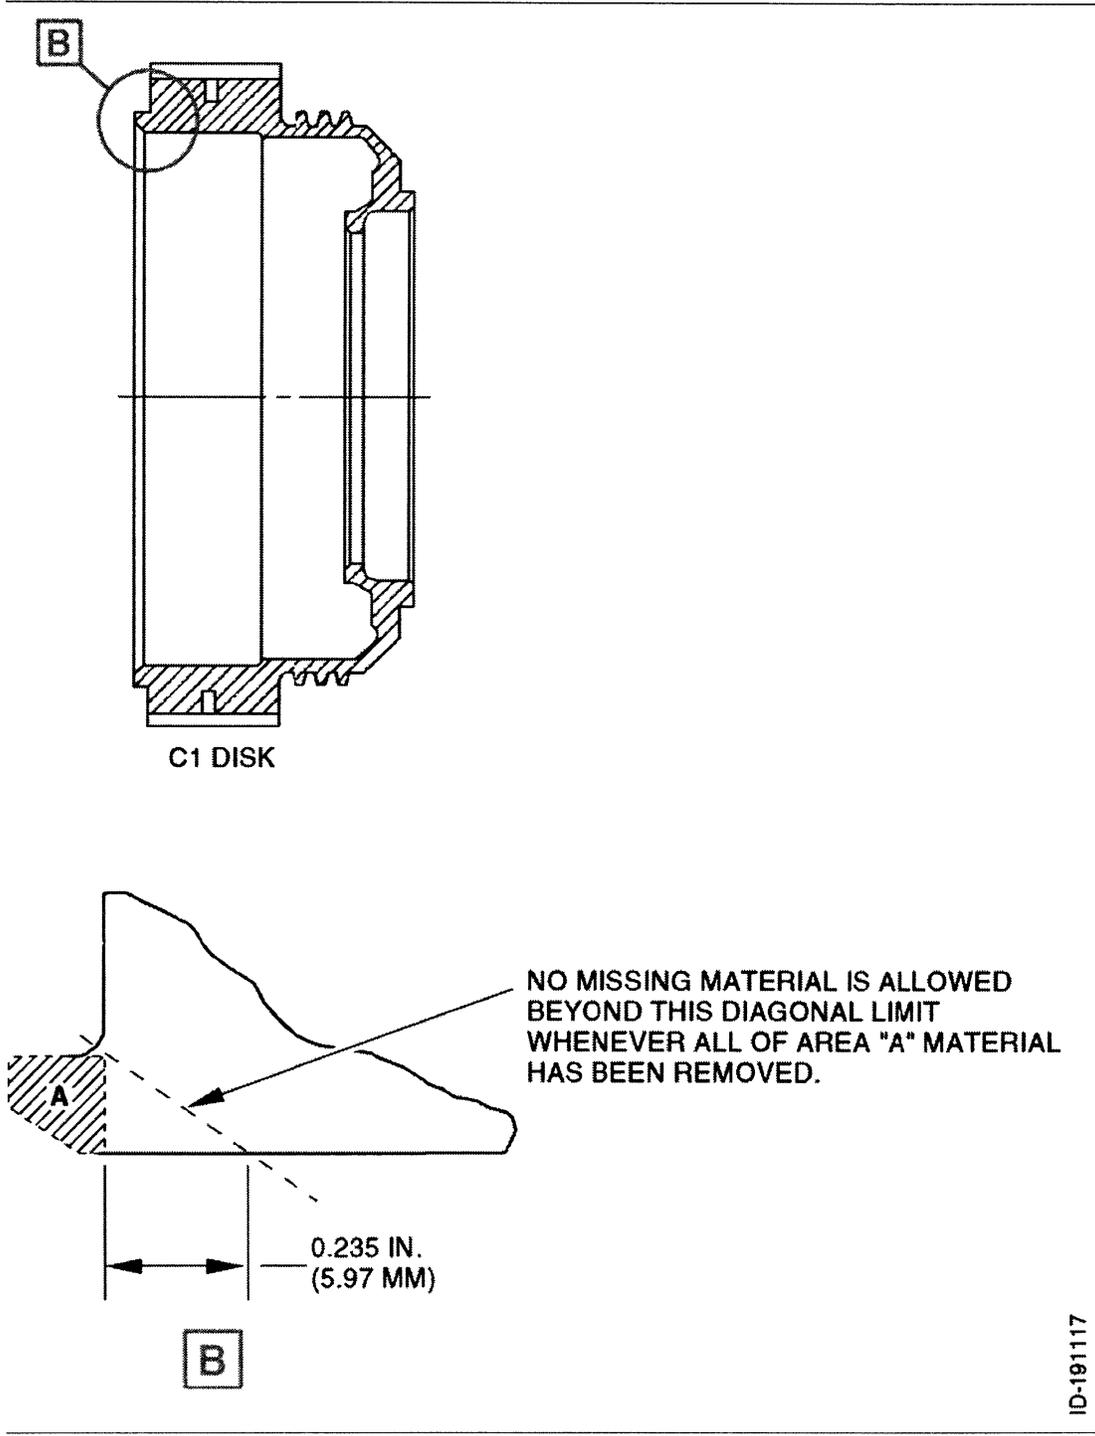
Limits for Removed Balance Material, Disc Forward Flange  
Figure 1 (Sheet 1 of 2)

(f) For discs with 5,000 or more cycles-since-new on the effective date of this AD, perform a dimensional inspection of the HPC first stage disc to determine if excessive disc

balance material was removed. See the following Figure 1 for limits.

(g) Replace the disc if excessive disc balance material was removed. See limits in Figure 1 of this AD.

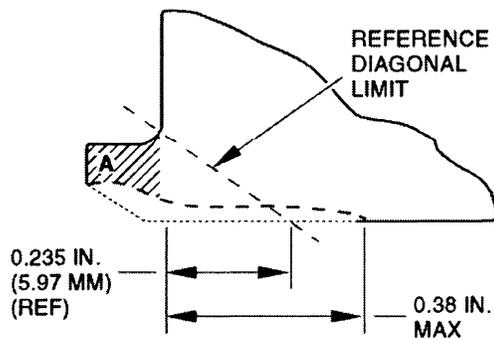
Any remaining Area 'A' lip material is sufficient to permit axial material removal up to 0.38 inch (0.97 mm) limit. Surface shall have a smooth contour and 0.020 inch (0.51 mm) minimum blend radius.

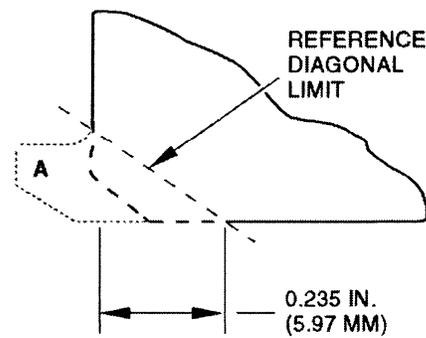
Removal of all Area 'A' material is permitted when axial material removal is less than 0.235 inch (5.97 mm) diagonal limit. Surface shall have a smooth contour and 0.020 inch (0.51 mm) minimum blend radius.

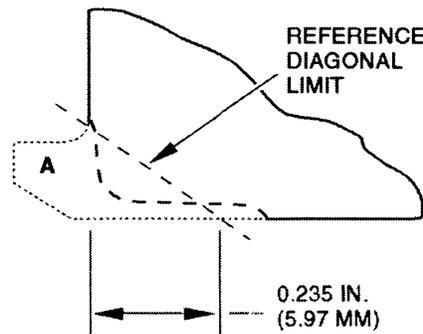
No Area 'A' material remaining and 0.235 inch (5.97 mm) diagonal limit is exceeded.
