[Docket No. FAA-2007-0096; Directorate Identifier 2007-NE-39-AD]

Airworthiness Directives; Honeywell International Inc. ALF502 Series and LF507 Series Turbofan Engines

ACTION: Notice of proposed rulemaking (NPRM).

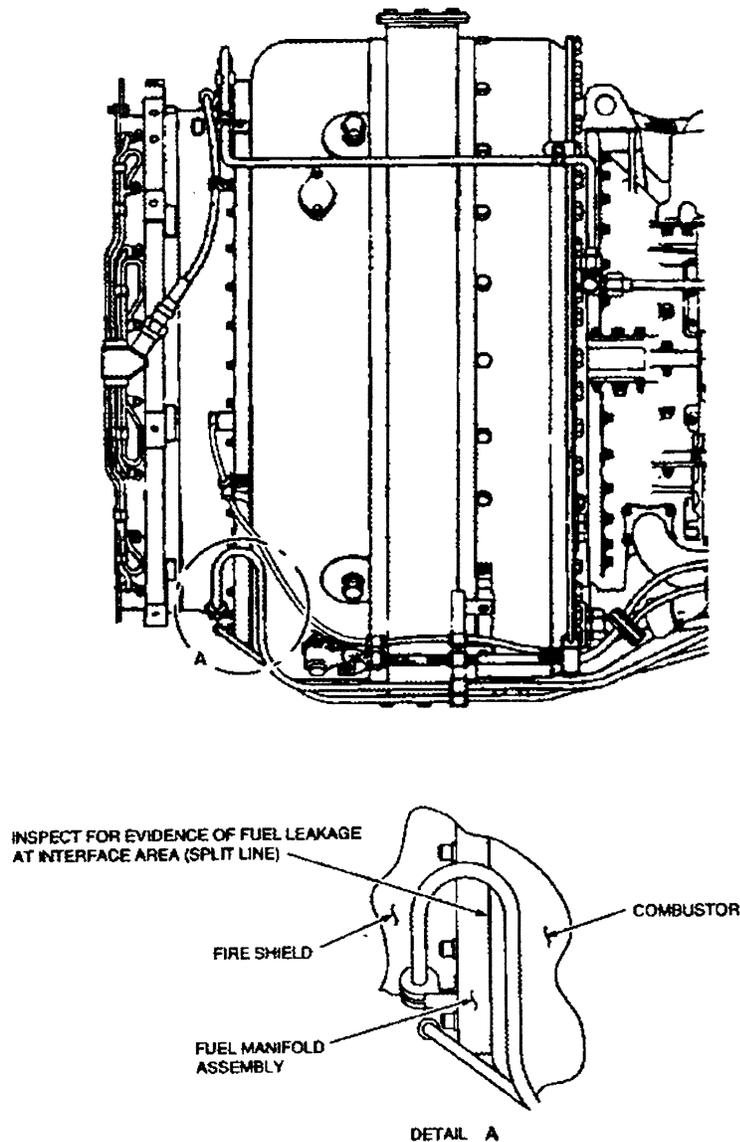
Figure 1 - Fuel Manifold Assembly-to-Fire Shield Interface Area

Since we issued that AD, we have received reports of about 36 events of fuel leaking at the fuel nozzles on fuel manifold assemblies, P/Ns 2-163-620-37 and 2-163-620-38, due to loosening of the fuel nozzles. Failure to detect and remove a leaking manifold assembly is likely to result in a fire in the engine nacelle and create a hazard to the aircraft.

(2) With the engine operating, look for fuel leaking from the fuel manifold assembly to the fire shield interface area (see Figure 1). No leaks allowed.

(5) Look for fuel leaking from the fuel manifold assembly to the fire shield interface area (see Figure 1.) No leaks allowed.

(3) If you find any leaks, shut down the engine and replace the fuel manifold assembly with an FAA approved serviceable assembly.

(6) If you find any leaks, replace the fuel manifold assembly with an FAA approved serviceable assembly.
