[Docket No. FAA-2009-0484; Directorate Identifier 2008-SW-44-AD; Amendment 39-15924; AD 2009-12-01]

**Airworthiness Directives; Bell Helicopter Textron, Inc. Model 47, 47B, 47B3, 47D, 47D1, 47E, 47G, 47G-2, 47G-2A, 47G-2A-1, 47G-3, 47G-3B, 47G-3B-1, 47G-3B-2, 47G-3B-2A, 47G-4, 47G-4A, 47G-5, 47G-5A, 47H-1, 47J, 47J-2, 47J-2A, and 47K Helicopters**

**ACTION:** Final rule; request for comments.

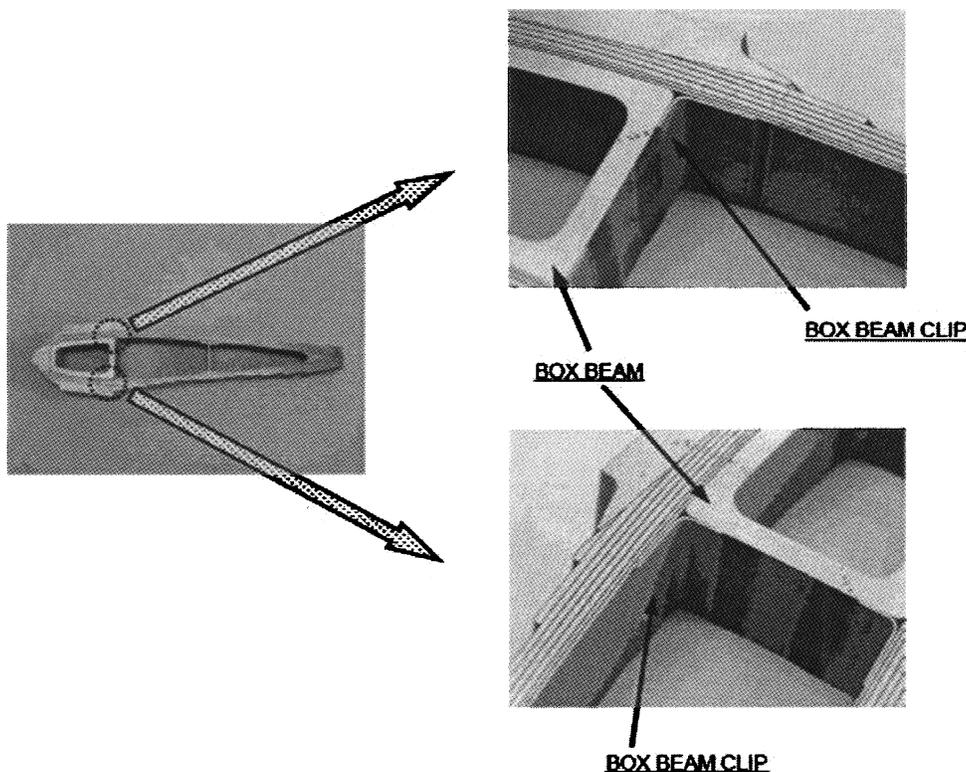
Figure 1 - Correct Installation of Clip for Box Beam

To prevent a main rotor blade spar crack as a result of an incorrectly installed main rotor blade box beam clip (clip), loss of a main rotor blade, and subsequent loss of control of the helicopter, do the following:

- (a) Within 10 hours time-in-service (TIS), visually inspect the entire length of each upper and lower clip of each main rotor blade from the main rotor blade tip to the root by following Part II of the Accomplishment Instructions, paragraphs 1. through 8., of Bell Helicopter Textron, Inc. Alert Service Bulletin No. 47-08-25, dated May 26, 2008 (ASB) and referring to the depictions in Figures 1 and 2 of the ASB and Figure 1 of this AD for correct installation.

(b) Before further flight, if you find a main rotor blade with an incorrectly installed clip, replace that unairworthy main rotor blade with an airworthy main rotor blade that has a clip that is installed correctly.
