**[Docket No. FAA-2008-1311; Directorate Identifier 2007-NE-48-AD; Amendment 39-15976; AD 2009-15-13]**

#### **Airworthiness Directives; Honeywell International Inc., T5313 and T5317 Series Turboshaft Engines**

**2009-15-13 Honeywell International Inc. (Formerly AlliedSignal and Textron-Lycoming):** Amendment 39-15976. Docket No. FAA-2008-1311; Directorate Identifier 2007-NE-48-AD.

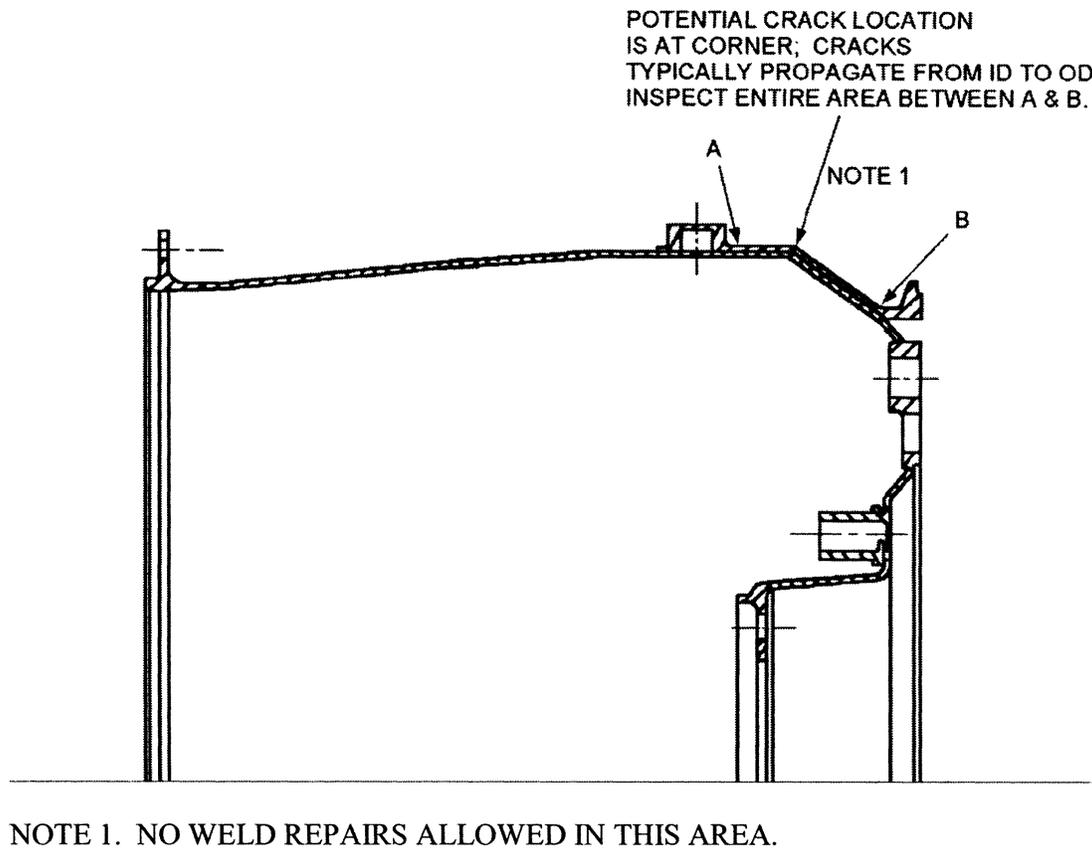
Figure 1. Visual Inspection of CCH

(d) This AD results from eight instances of cracks in CCHs. Two of the instances resulted in an engine shutdown during flight. We are issuing this AD to detect cracks in the CCH, which could result in rupture of the CCH, leading to loss of engine power and damage to the helicopter.

(f) For CCH, P/N 1-130-610-05 and 1-130-610-12, within 50 hours time-in-service (TIS) after the effective date of this AD, inspect the area between points A and B around the entire housing circumference in Figure 1 of this AD for weld repairs and cracks.

(g) For CCH, P/N 1-130-610-05 and 1-130-610-12, inspect the area between points A and B around the entire housing circumference in Figure 1 of this AD for cracks within every 50 hours time-since-last inspection. Honeywell International Inc. Standard Practices Manual 70-20-02, SP 1302, contains additional guidance on visual inspection.

(1) If you find any cracks, replace the CCH before further flight. Honeywell International Inc. Alert Service Bulletin (ASB) T53-A0142, Revision 1, dated September 14, 2006, contains additional guidance on replacing the CCH.

(2) If you find any weld repairs, replace the CCH within 100 hours TIS after the visual inspection. Honeywell International Inc. ASB T53-A0142, Revision 1, dated September 14, 2006, contains additional guidance on replacing the CCH.

(h) If you find any cracks, replace the CCH before further flight. Honeywell International Inc. ASB T53-A0142, Revision 1, dated September 14, 2006, contains additional guidance on replacing the CCH.
