[Docket No. FAA-2007-0096; Directorate Identifier 2007-NE-39-AD; Amendment 39-16141; AD 2009-26-06]

Airworthiness Directives; Honeywell International Inc. ALF502 Series and LF507 Series Turbofan Engines

ACTION: Final rule.

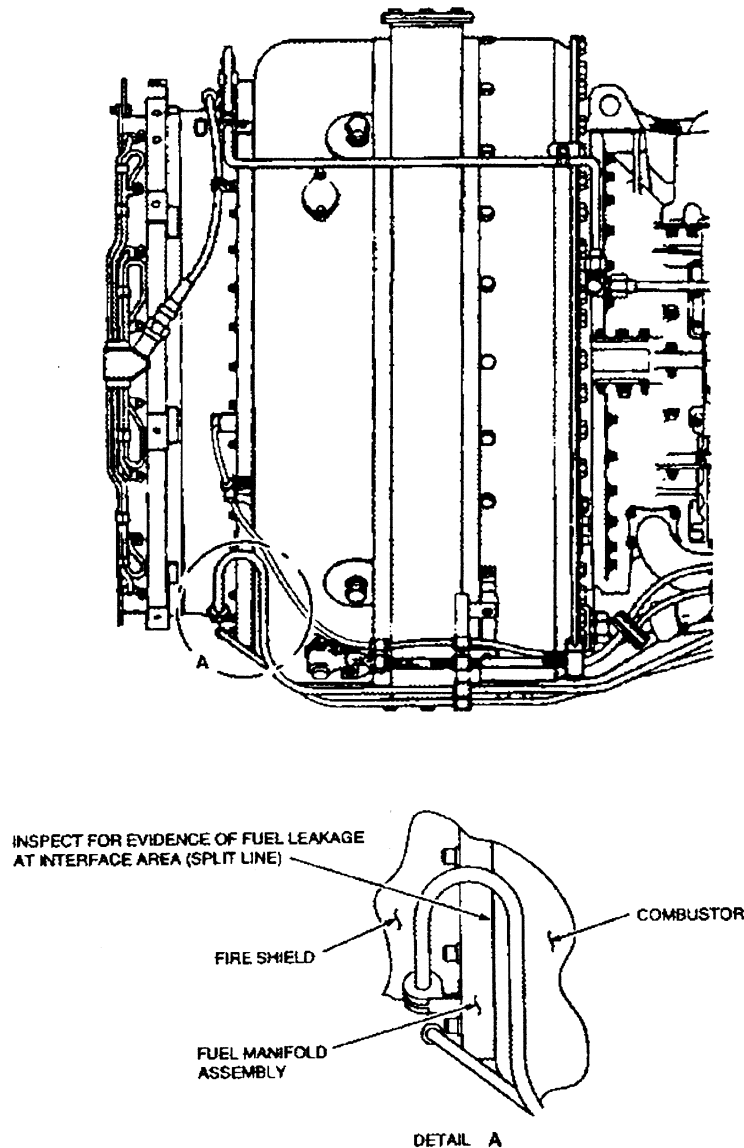
Figure 1 - Fuel Manifold Assembly-to-Fire Shield Interface Area

(d) This AD results from reports of fire in the engine nacelle. We are issuing this AD to detect cracks in certain fuel manifolds and fuel leaks from other fuel manifolds, which could result in a fire in the engine nacelle and a hazard to the aircraft.

(2) With the engine operating, look for fuel leaking from the fuel manifold assembly to the fire shield interface area (see Figure 1 of this AD). No leaks allowed.

(5) Look for fuel leaking from the fuel manifold assembly to the fire shield interface area (see Figure 1 of this AD). No leaks allowed.

(3) If you find any leaks, shutdown the engine and replace the fuel manifold assembly with an FAA-approved serviceable assembly.

(6) If you find any leaks, replace the fuel manifold assembly with an FAA-approved serviceable assembly.
