Federal Register

[Docket No. FAA-2008-0071; Directorate Identifier 2006-SW-27-AD; Amendment 39-16291; AD 2010-10-12]

Airworthiness Directives; Bell Helicopter Textron Canada Model 222, 222B, 222U, 230, and 430 Helicopters

ACTION: Final rule.

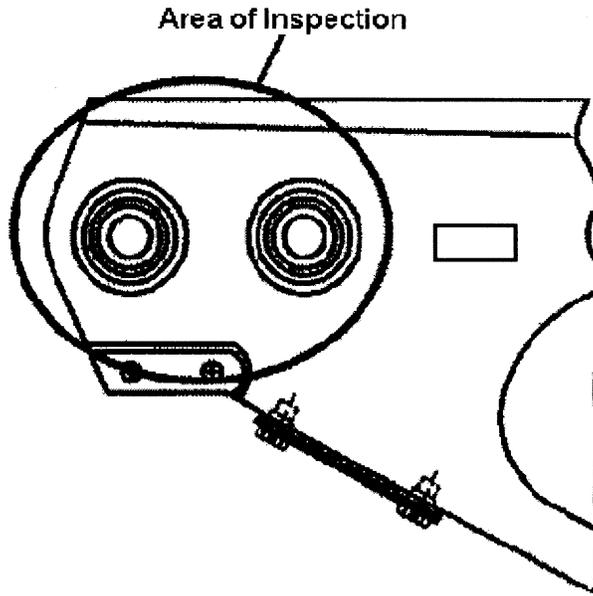
the specified BHTC model helicopters. Transport Canada advises of the discovery of cracked blades during scheduled inspections on three occasions. Two cracks originated from the outboard feathering bearing bore underneath the flanged sleeves. The third crack started from the inboard feathering bearing bore. Investigation found that the cracks originated from either a machining burr or a corrosion site in the bearing bore underneath the flanged sleeves.

(a) Within 3 hours time-in-service (TIS), unless accomplished previously, and thereafter at intervals not to exceed 3 hours TIS, clean and visually check both sides of each blade for a crack in the paint in the areas shown in Figure

Blade Inspection Area

(c) Within the next 50 hours TIS, unless accomplished previously, and thereafter at intervals not to exceed 50 hours TIS, clean the blade by wiping down both surfaces of each blade in the inspection area depicted in Figure 1 of this AD using aliphatic naphtha (C-305) or detergent (C-318) or an equivalent. Using a 10X or higher power magnifying glass, visually inspect both sides of the blade in the areas depicted in Figure 1 of this AD.

(1) If a crack is found, even if only in the paint, before further flight, remove the blade from the helicopter and proceed with the following:

(2) Remove the paint on the blade down to the bare metal in the area of the suspected crack by using plastic media blasting (PMB) or a nylon web abrasive pad. Abrade the blade surface in a span-wise direction only.

(3) Using a 10X or higher power magnifying glass, inspect the blade for a crack.

(i) If a crack is found, replace the blade with an airworthy blade before further flight.

(ii) If no crack is found in the blade surface, refinish the blade by applying one coat of epoxy polyamide primer, MIL-P-23377 or MIL-P-85582, so that the primer overlaps the existing coats just beyond the abraded area. Let the area dry for 30 minutes to 1 hour. Then,
