[Docket No. FAA-2010-0564; Directorate Identifier 2010-SW-13-AD]

Airworthiness Directives; Arrow Falcon Exporters, Inc. (Previously Utah State University), et al., Model HH-1K, TH-1F, TH-1L, UH-1A, UH-1B, UH-1E, UH-1F, UH-1H, UH-1L, and UH-1P Helicopters; and Southwest Florida Aviation Model UH-1B (SW204 and SW204HP) and UH-1H (SW205) Helicopters

ACTION: Notice of proposed rulemaking (NPRM).

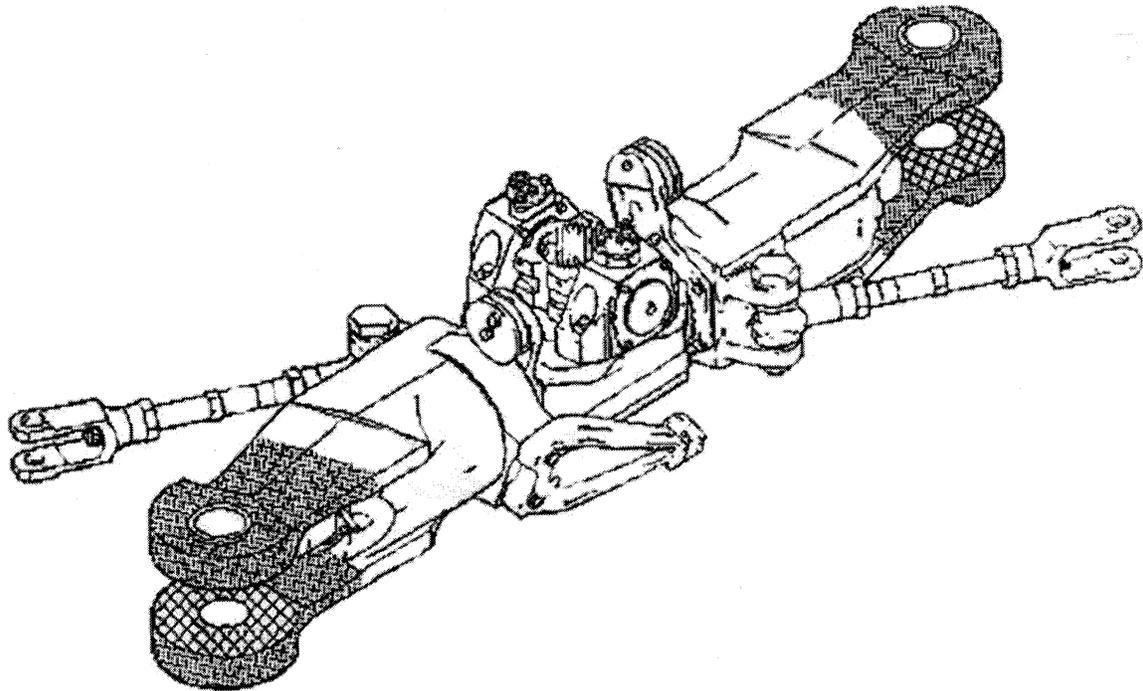
Figure 1. Inspection of Main Rotor Hub Grip Tangs

(2) Using a 10-power or higher magnifying glass, visually inspect the exposed surfaces of the upper and lower tangs of each grip for a crack. Pay particular attention to the lower surface of each lower grip tang from the main rotor blade bolt-bushing flange to the leading and trailing edge of each grip tang. See Figure 1 of this AD.

INSPECT BUFFER PAD FOR DELAMINATION (IF INSTALLED)

AREA TO BE INSPECTED UPPER AND LOWER TANGS ALL EXPOSED SURFACES

- (1) Remove each main rotor blade, and
- (2) Inspect each grip buffer pad on the inner surfaces of each grip tang for delamination (see Figure 1 of this AD). If there is any delamination, remove the buffer pad and inspect the grip surface for corrosion or other damage.
