[Docket No. FAA-2010-1013; Directorate Identifier 2010-CE-048-AD; Amendment 39-16478; AD 2010-21-18]

#### Airworthiness Directives; Cessna Aircraft Company (Cessna) Models 336, 337, 337A (USAF 02B), 337B, M337B (USAF 02A), T337B, 337C, T337C, 337D, T337D, 337E, T337E, 337F, T337F, 337G, T337G, 337H, P337H, T337H, T337H-SP, F337E, FT337E, F337F, FT337F, F337G, FT337GP, F337H, and FT337HP Airplanes

#### Appendix 1 to AD 2010-21-18—General and Focused Inspection Procedures

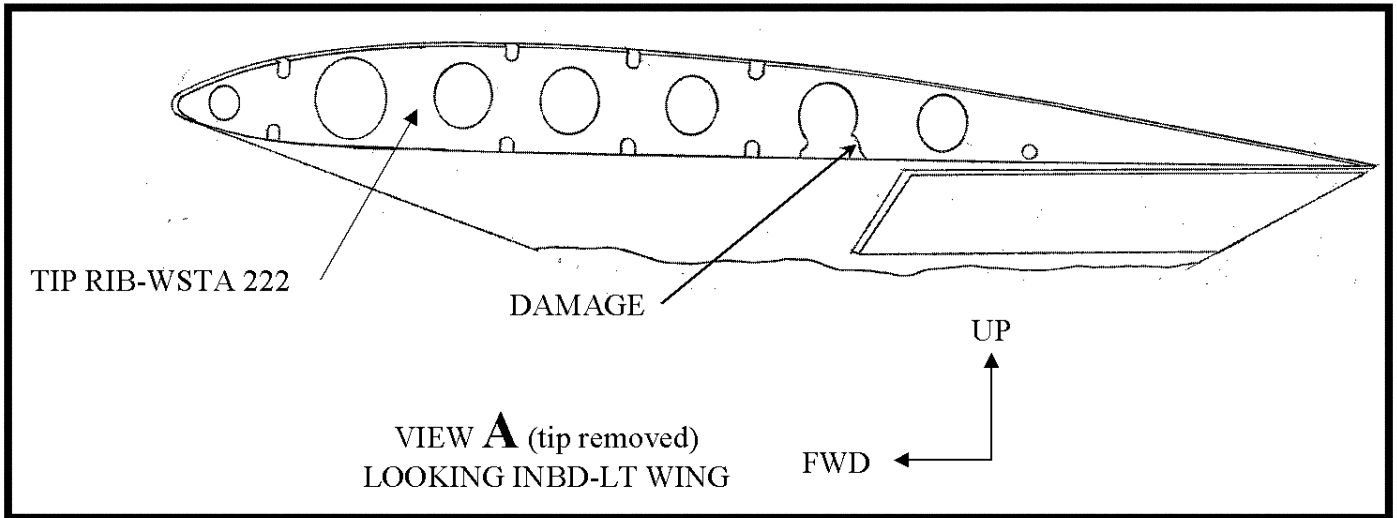
Figure 2

(11) Inspect rib at WSTA 222 for damage. Trimming of the rib may have been done to allow installation of fuel lines (*See View A, Figure 2*). Repair in accordance with AC 43.13-1B, Chapter 4, paragraph 4-58(g) and Figure 4-14, or by using another FAA-approved method that restores equivalent strength of the wing rib.

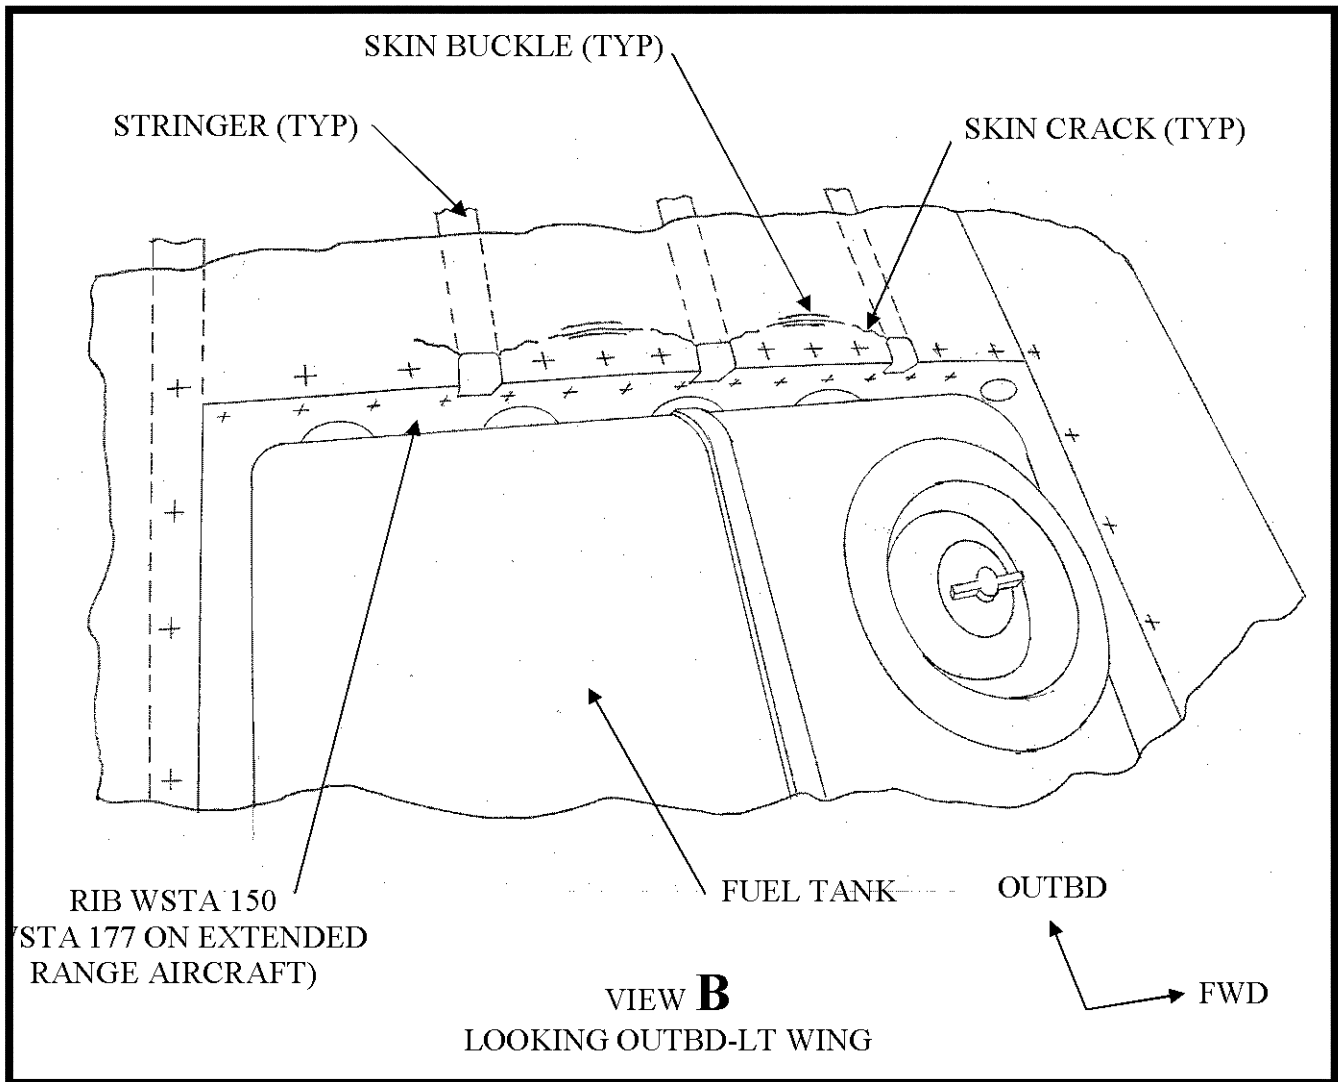
Figure 3

(1) Wrinkles in upper wing skins, from the outboard edge on the fuel tank access covers (WSTA 150 or 177) to the WSTA 222 (*See View B, Figure 3*).

(3) Cracking of the upper wing skins. Pay particular attention to any wrinkles, the radius between stiffeners at WSTA 150 (under fuel tank covers), and unreinforced access holes (*See View B, Figure 3*).

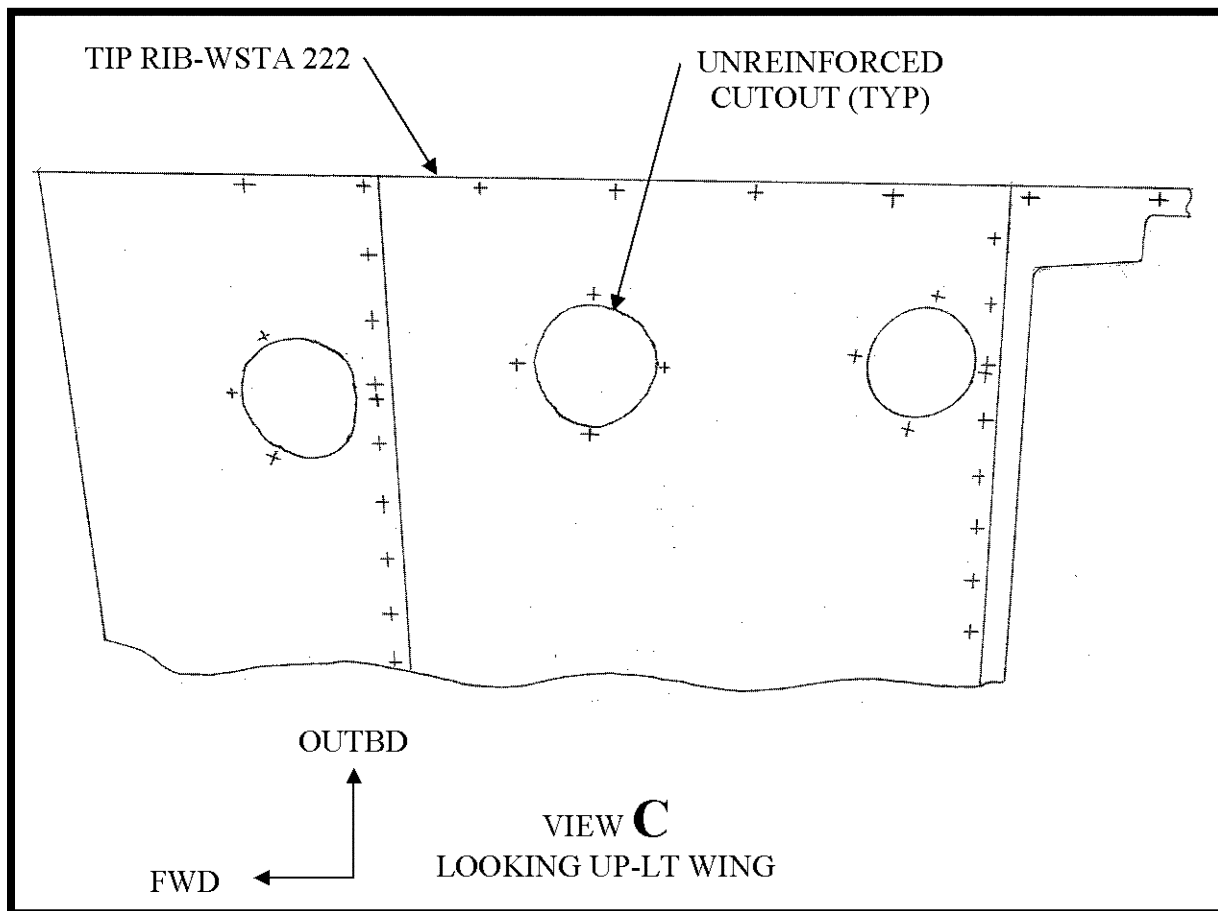
Figure 4

(2) Inspect wing skins for unreinforced cutouts. (*See View C, Figure 4*).

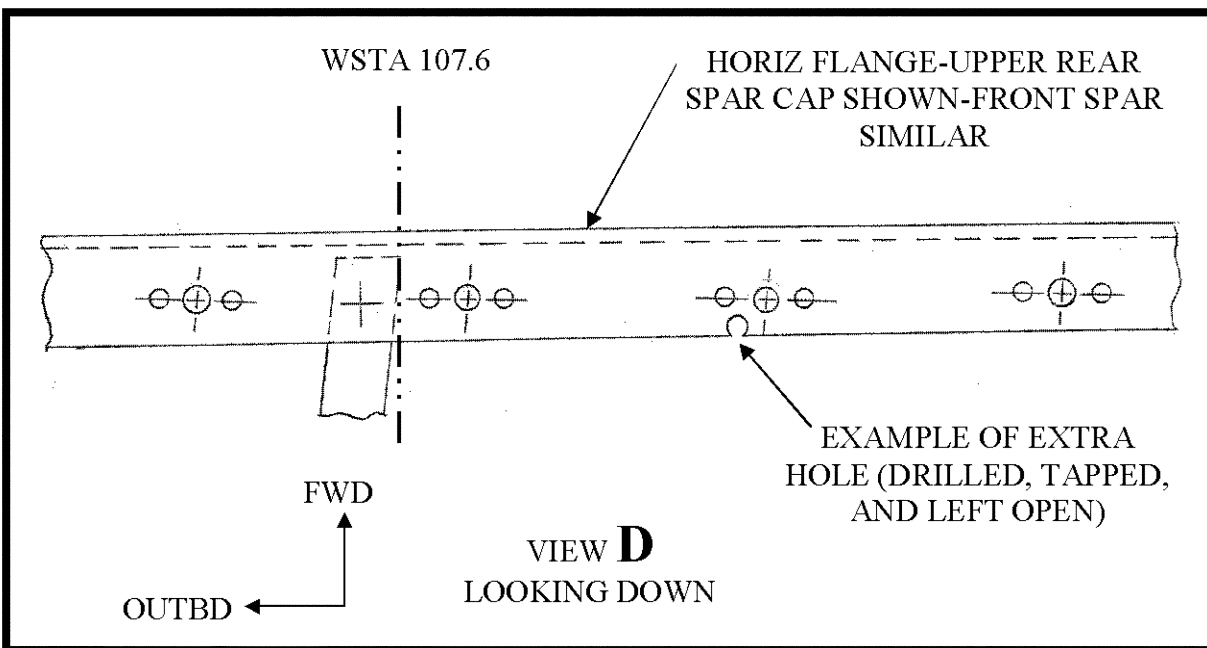
Figure 5

(3) Inspect the upper spar cap horizontal flanges for open holes (*See View D, Figure 5*).

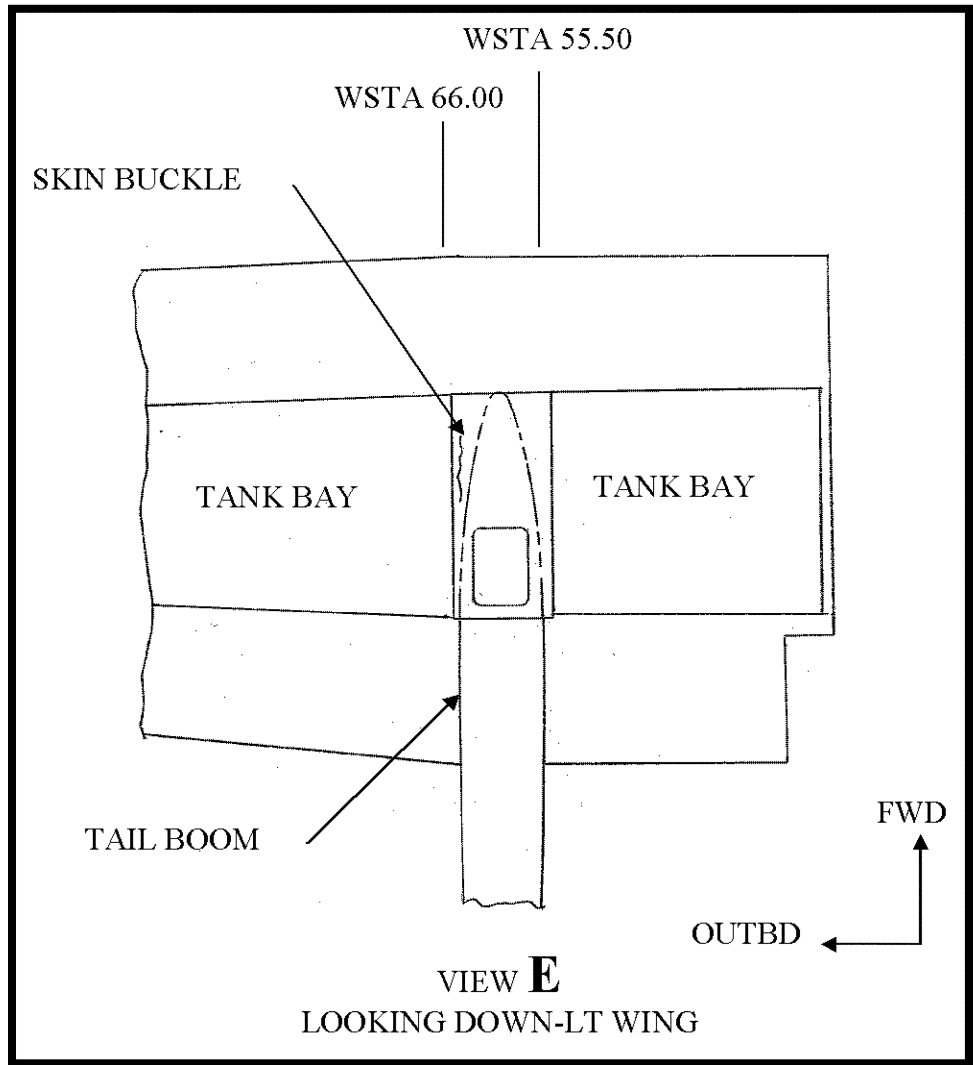
Figure 6

(2) Wrinkles in the upper wing skins from WSTA 55 to 66, adjacent to the booms (*See View E, Figure 6*).

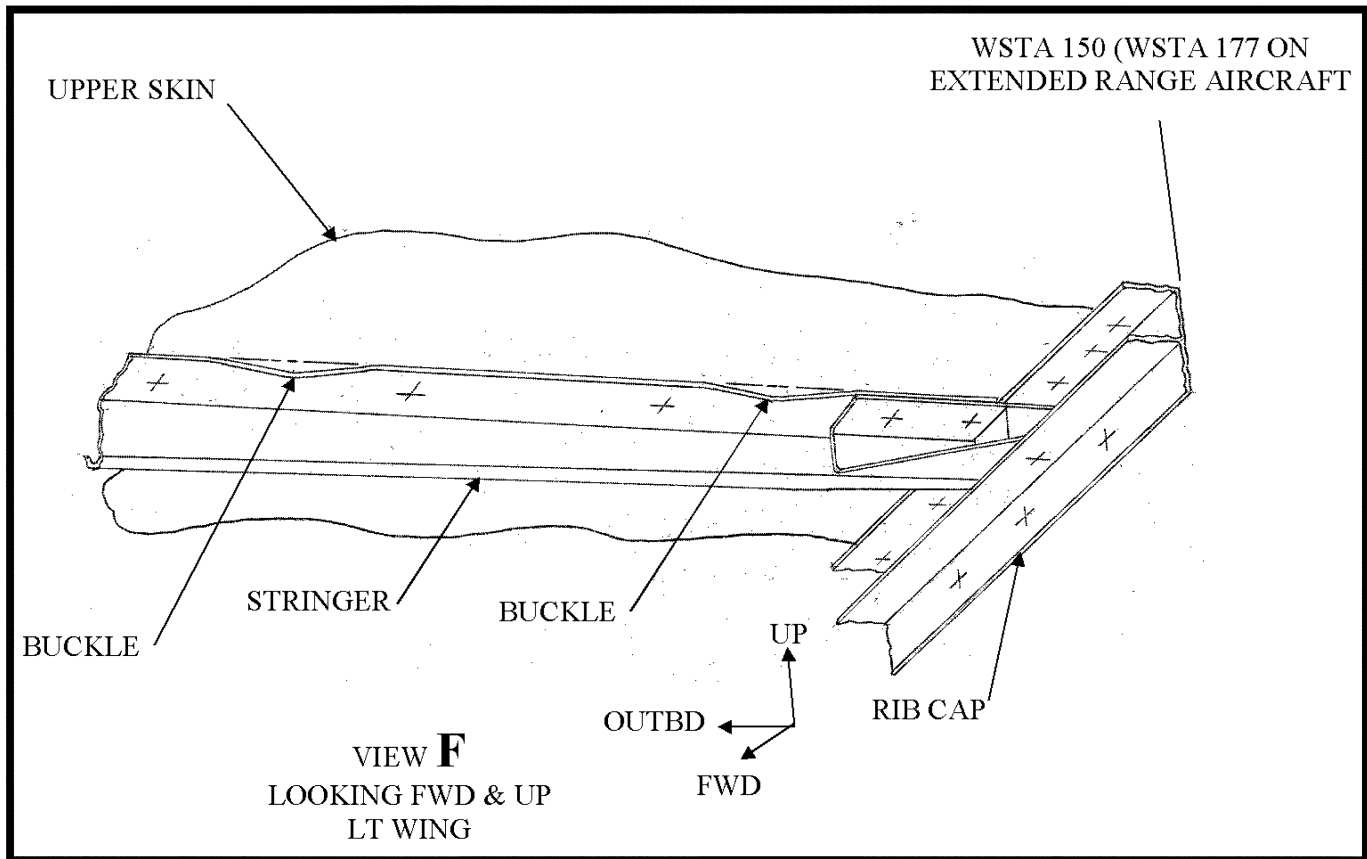
Figure 7

(10) Inter-rivet buckling of the stringers attached to the upper surface skin, outboard of the fuel tank access covers (*See View F, Figure 7*).
