[Docket No. FAA-2010-1013; Directorate Identifier 2010-CE-048-AD; Amendment 39-16478; AD 2010-21-18]

#### Airworthiness Directives; Cessna Aircraft Company (Cessna) Models 336, 337, 337A (USAF 02B), 337B, M337B (USAF 02A), T337B, 337C, T337C, 337D, T337D, 337E, T337E, 337F, T337F, 337G, T337G, 337H, P337H, T337H, T337H-SP, F337E, FT337E, F337F, FT337F, F337G, FT337GP, F337H, and FT337HP Airplanes

#### Appendix 1 to AD 2010-21-18—General and Focused Inspection Procedures

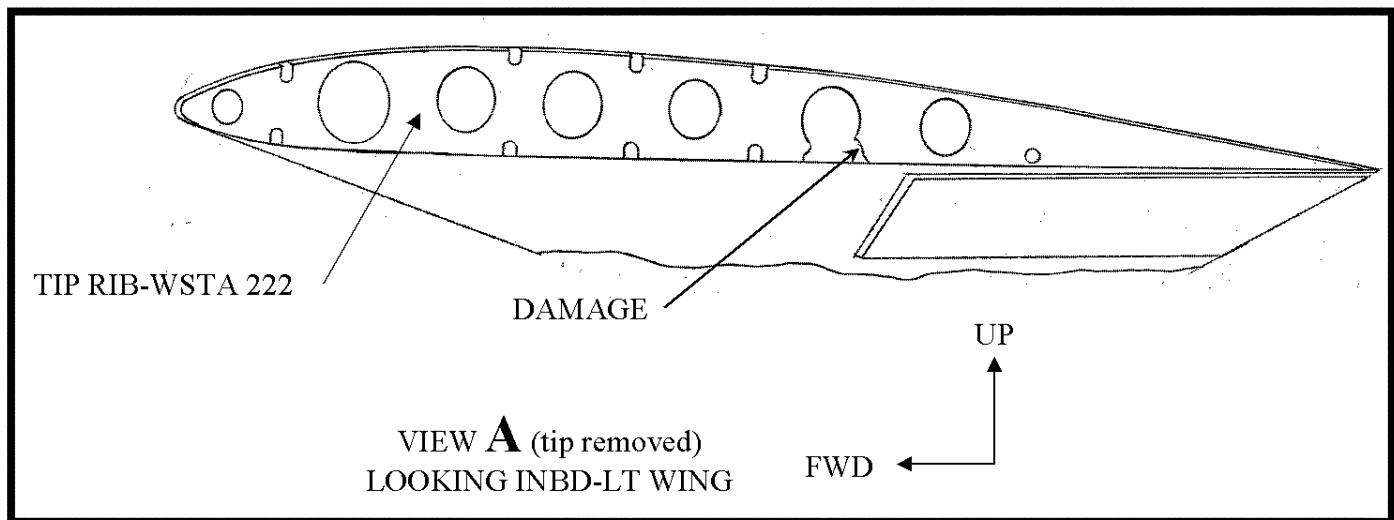
Figure 2

(11) Inspect rib at WSTA 222 for damage. Trimming of the rib may have been done to allow installation of fuel lines (See View A, Figure 2). Repair in accordance with AC 43.13-1B, Chapter 4, paragraph 4-58(g) and Figure 4-14, or by using another FAA-approved method that restores equivalent strength of the wing rib.

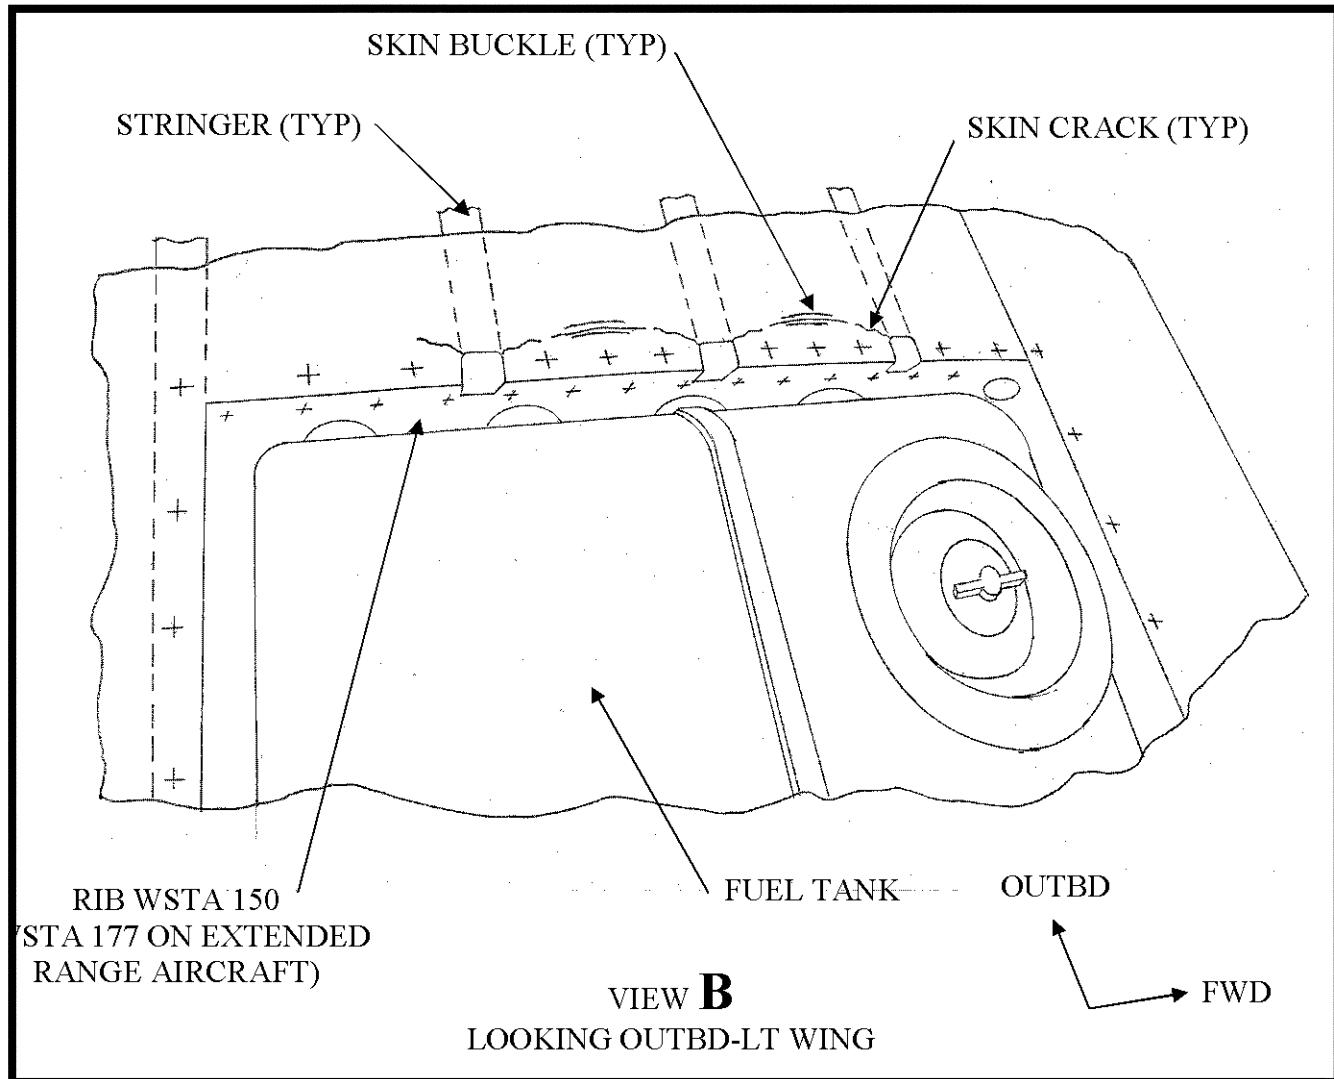
Figure 3

(1) Wrinkles in upper wing skins, from the outboard edge on the fuel tank access covers (WSTA 150 or 177) to the WSTA 222 (See View B, Figure 3).

(3) Cracking of the upper wing skins. Pay particular attention to any wrinkles, the radius between stiffeners at WSTA 150 (under fuel tank covers), and unreinforced access holes (See View B, Figure 3).

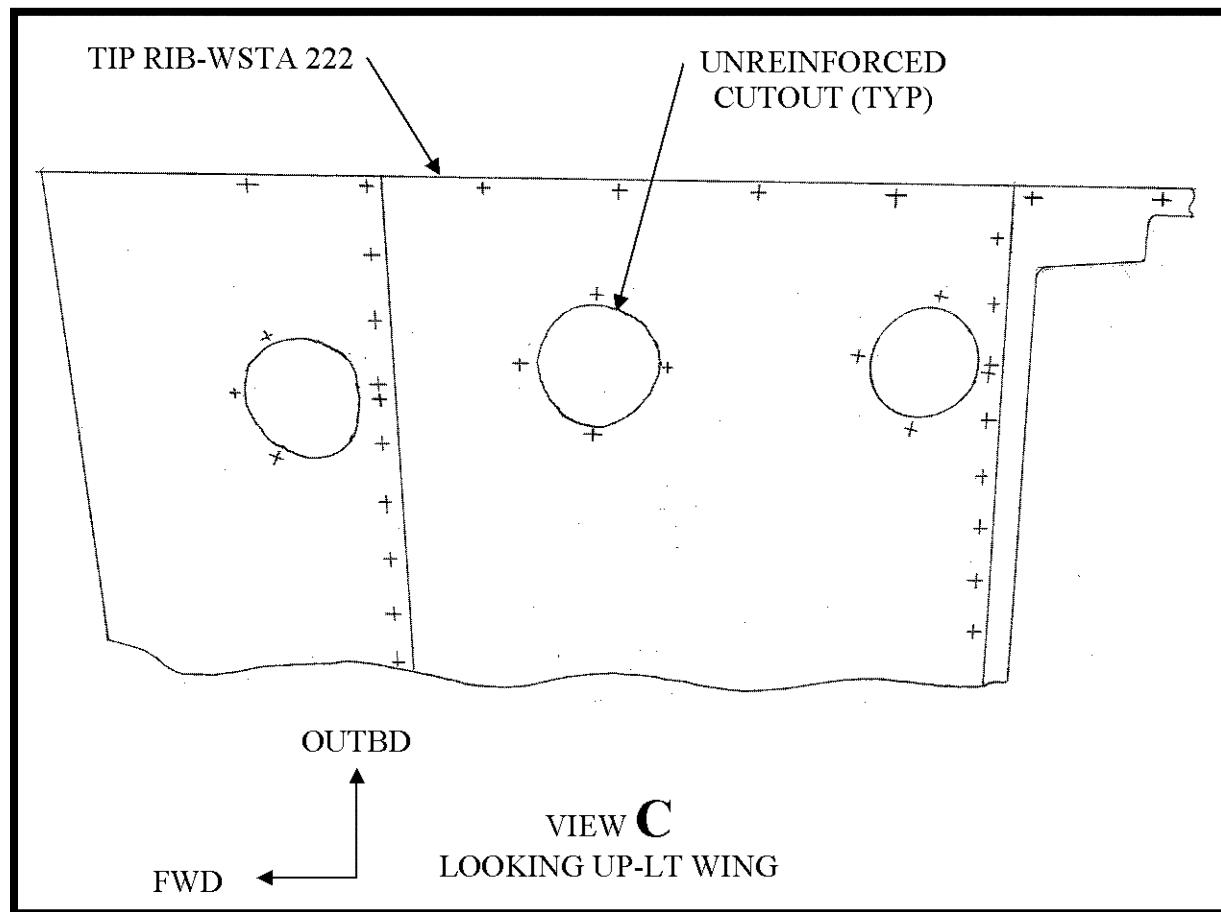
Figure 4

(2) Inspect wing skins for unreinforced cutouts. (See View C, Figure 4).

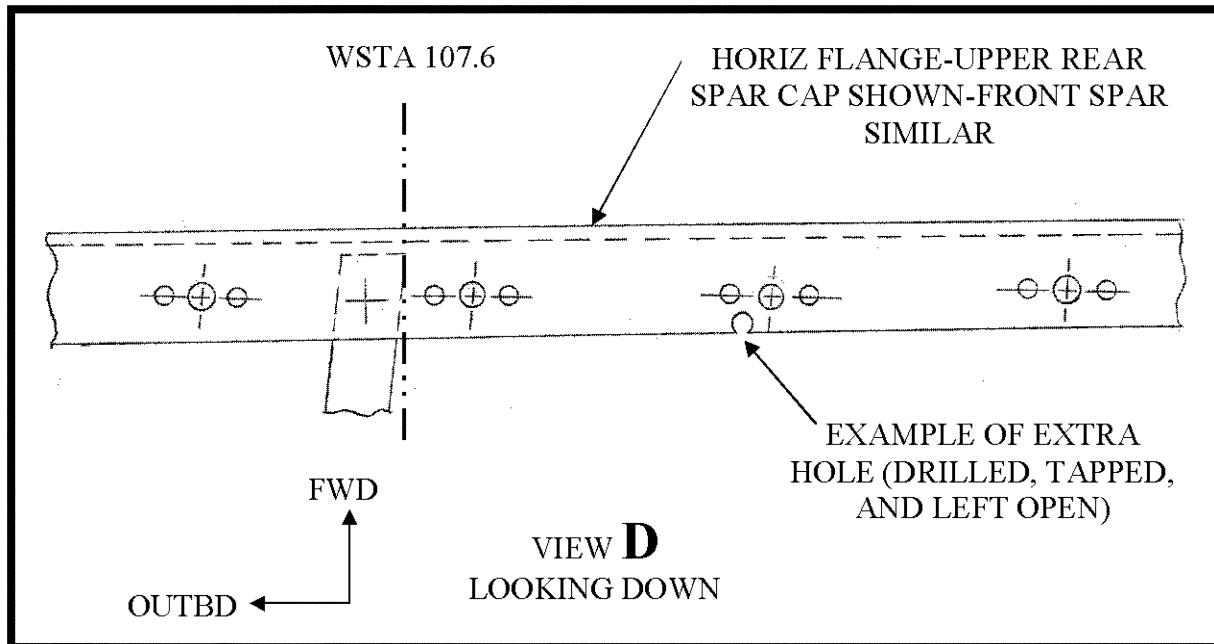
Figure 5

(3) Inspect the upper spar cap horizontal flanges for open holes (See View D, Figure 5).

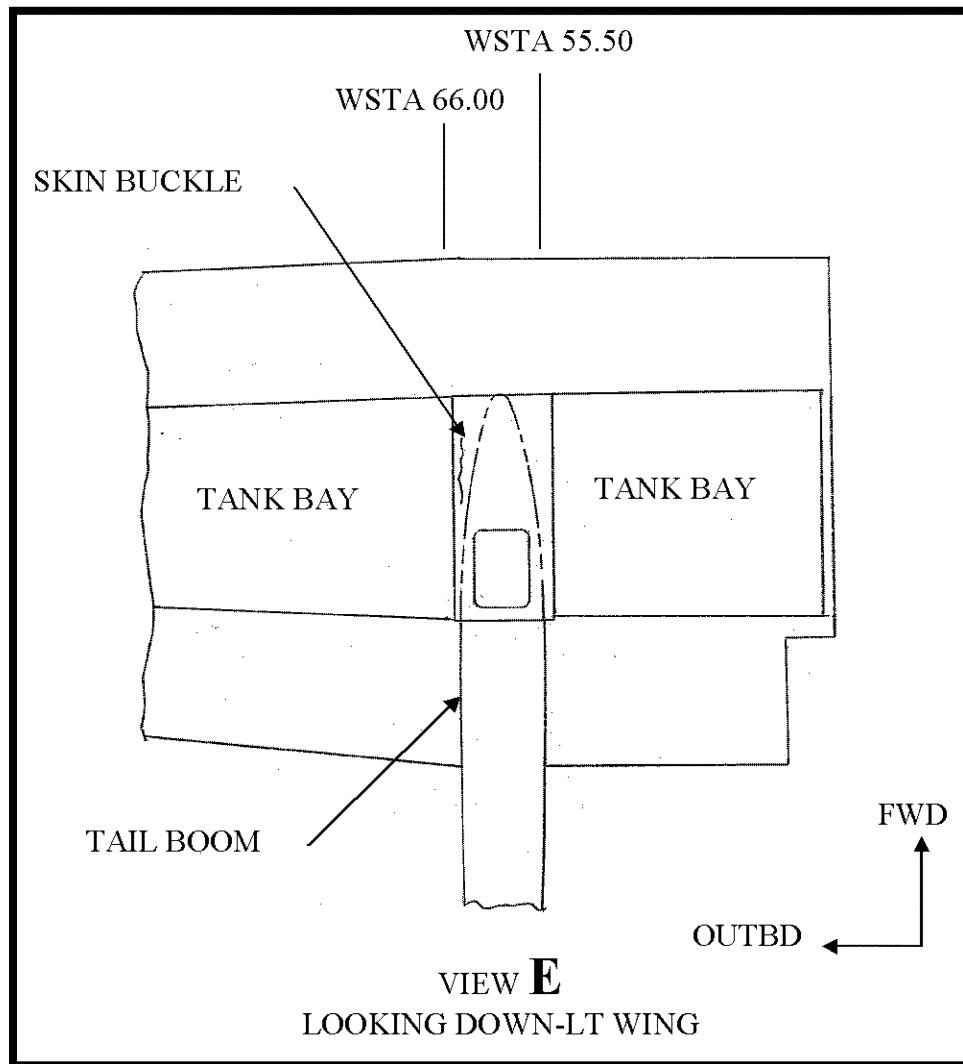
Figure 6

(2) Wrinkles in the upper wing skins from WSTA 55 to 66, adjacent to the booms (See View E, Figure 6).

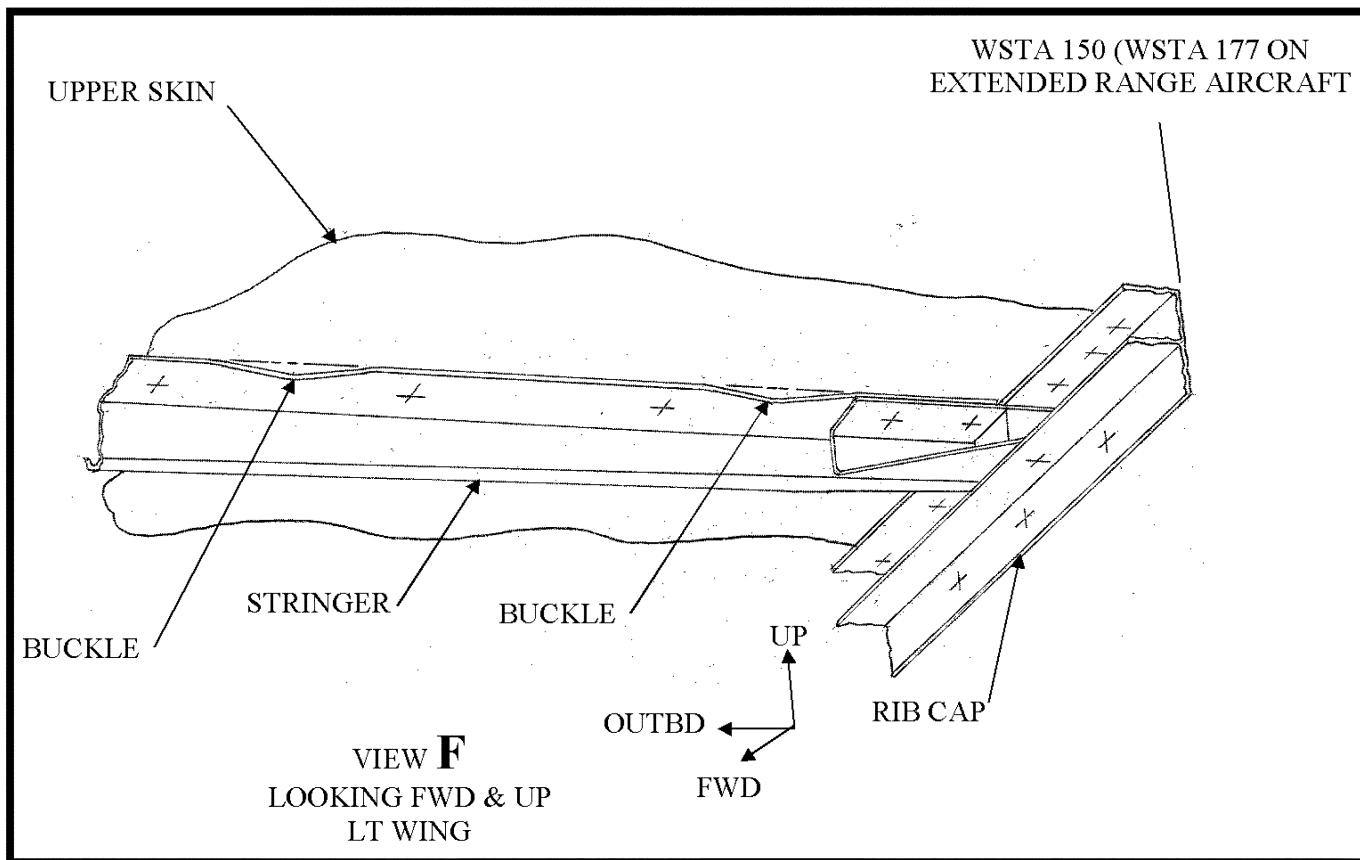
Figure 7

(10) Inter-rivet buckling of the stringers attached to the upper surface skin, outboard of the fuel tank access covers (See View F, Figure 7).
