[Docket No. FAA-2010-1101; Directorate Identifier 2009-CE-013-AD]

Airworthiness Directives; Cessna Aircraft Company Models 150, 152, 170, 172, 175, 177, 180, 182, 185, 188, 190, 195, 206, 207, 210, T303, 336, and 337 Airplanes

ACTION: Notice of proposed rulemaking (NPRM).

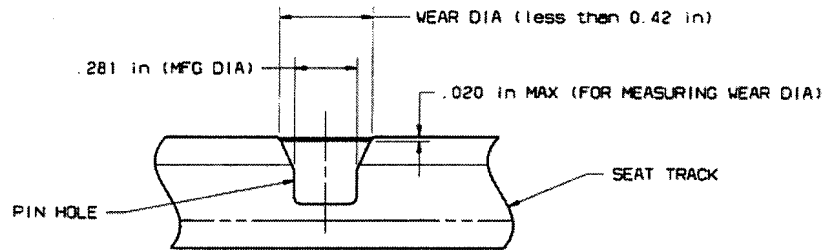
Figure 1. Diameter of seat pin locking engagement hole

(4) Inspect the diameter of each seat locking pin engagement hole in the pilot and copilot seat rails for excessive wear. Due to wear on the rail surface at the hole opening, we allow this measurement 0.020 of an inch

below the surface of the rail. You must take this measurement somewhere between the surface of the rail or no more than 0.020 of an inch below the surface of the rail.

(i) If the diameter of any of the holes is 0.42 of an inch or more (see figure 1), before further flight, replace the rail.

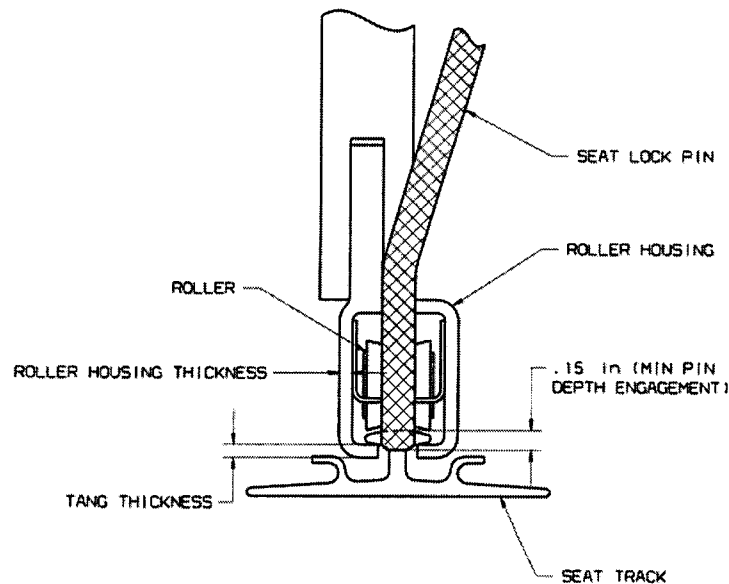
Figure 2. Seat locking pin depth engagement

(2) Lift up the forward edge of each seat to eliminate vertical play of the seat locking pin

in the engagement hole, and from this position, inspect the depth of engagement of each seat locking pin (see figure 2). If the rail is worn, this depth is measured from the worn surface, not the manufactured surface.

(i) If engagement of any of the seat locking pins measures less than 0.15 of an inch, before further flight, replace or repair any seat components necessary to achieve a seat pin engagement of a minimum of 0.15 of an inch.

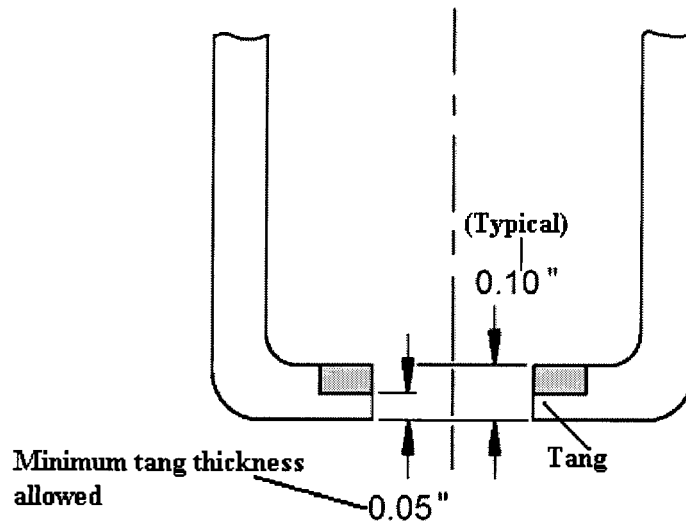
Figure 3. Closeup of seat roller housing and tang thickness

(6) Inspect the thickness of the tang (see figure 2 and figure 3). Due to wear of the tang chafing against the seat rail, measure the tang thickness where the tang inner edges contact the seat rail.

(i) If the tang thickness measures less than 0.05 of an inch, before further flight replace the roller housing.

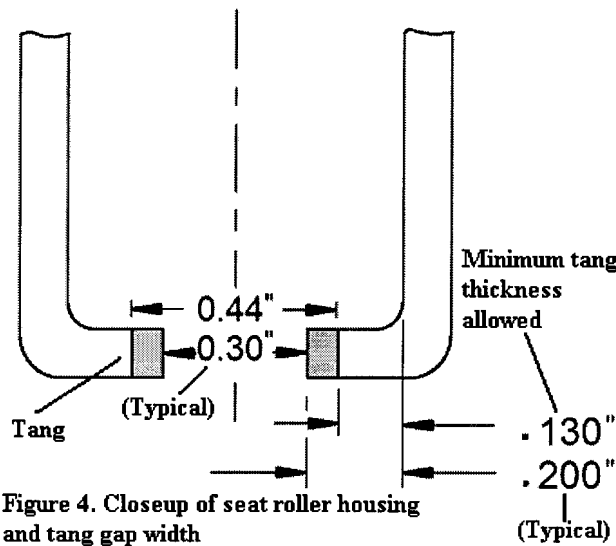
Figure 4. Closeup of seat roller housing and tang gap width

(7) Inspect the inner edges of the tangs. Due to wear or deformation of the tangs, measure the distance from one tang inner

edge to the other tang inner edge (see figure 4).

(i) The maximum distance allowed between tang edges is 0.44 inches. If the

distance between tang inner edges measures 0.44 of an inch or more, before further flight, replace the roller housing.

(ii) The minimum measurement allowed for the remaining tang is 0.130 inches remaining on either of the tangs, from the inner edge of the tang to the bend of the roller housing. If the measurement is less than 0.130 inches on either of the tangs, before further flight, replace the roller housing.

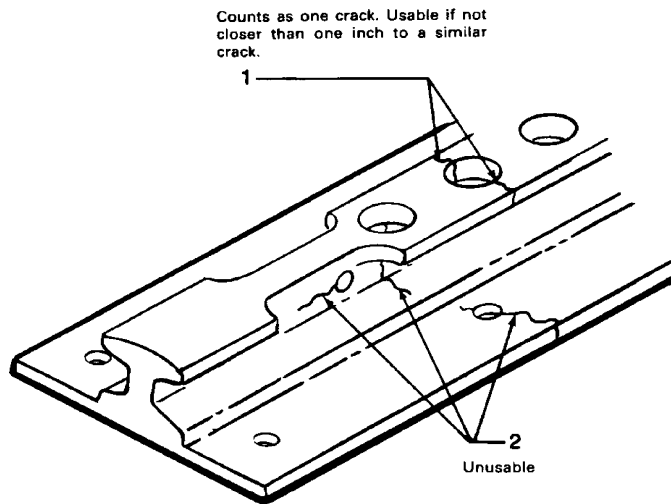
Figure 5. Seat rail

(9) Visually inspect the seat rails for cracks.

- (1) Any portion of web or lower flange is cracked (index 2).
- (2) Any crack in crown of rail is in any direction other than right angle to length of rail.
- (3) Number of cracks on any one rail exceeds four, or any two cracks (index 1) are closer than one inch.

(i) If there are seat rail cracks that exceed the crack criteria in figure 5, before further flight, replace the seat rail.

REPLACE SEAT RAIL WHEN:
