[Docket No. FAA-2010-1303; Directorate Identifier 2010-SW-049-AD]

Airworthiness Directives; Eurocopter France (Eurocopter) Model SA-365N, SA-365N1, AS-365N2, AS 365 N3, and SA-366G1 Helicopters

ACTION: Notice of proposed rulemaking (NPRM).

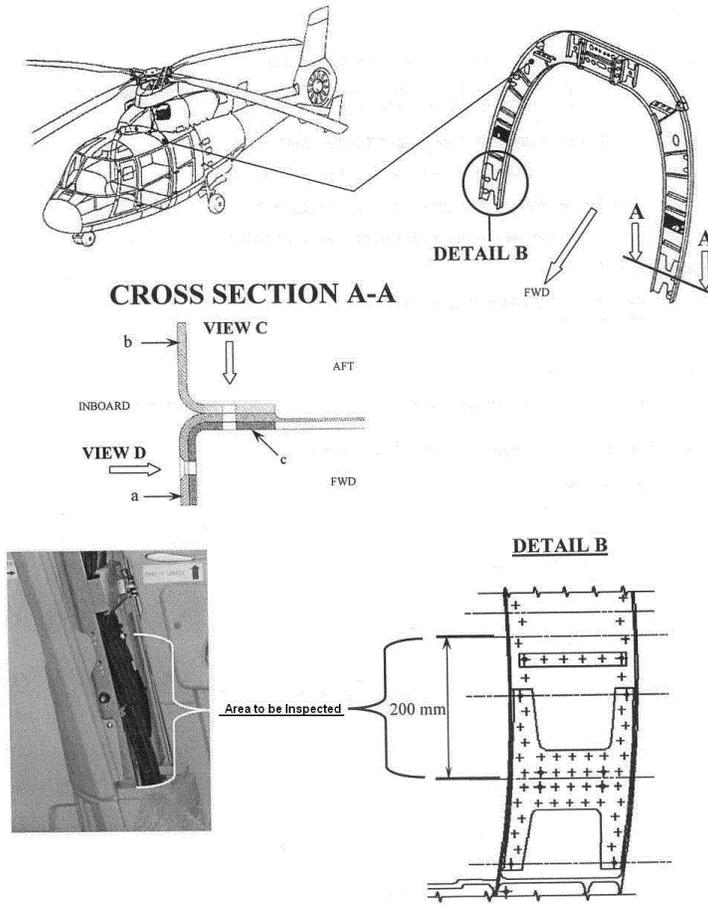
(a) On or before the affected model helicopters reach the hours time-in-service (TIS) listed in Table 1 of this AD or within 10 hours TIS, whichever occurs later, unless accomplished previously, and thereafter at intervals not to exceed 110 hours TIS, using a 10X or higher magnifying glass, inspect the inner angles and flanges of the 9-degree fuselage frame on the right hand and left hand sides for a crack in the area depicted in Figure 1 and as shown in Figure 2 of this AD.

(b) If you find a crack, before further flight, repair the frame. Repairing a frame does not constitute terminating action for the
