[Docket No. FAA-2011-0054; Directorate Identifier 2010-CE-070-AD; Amendment 39-16582; AD 2011-01-53]

Airworthiness Directives; PIAGGIO AERO INDUSTRIES S.p.A Model PIAGGIO P-180 Airplanes

Functional Test of the Fuselage Drain Holes

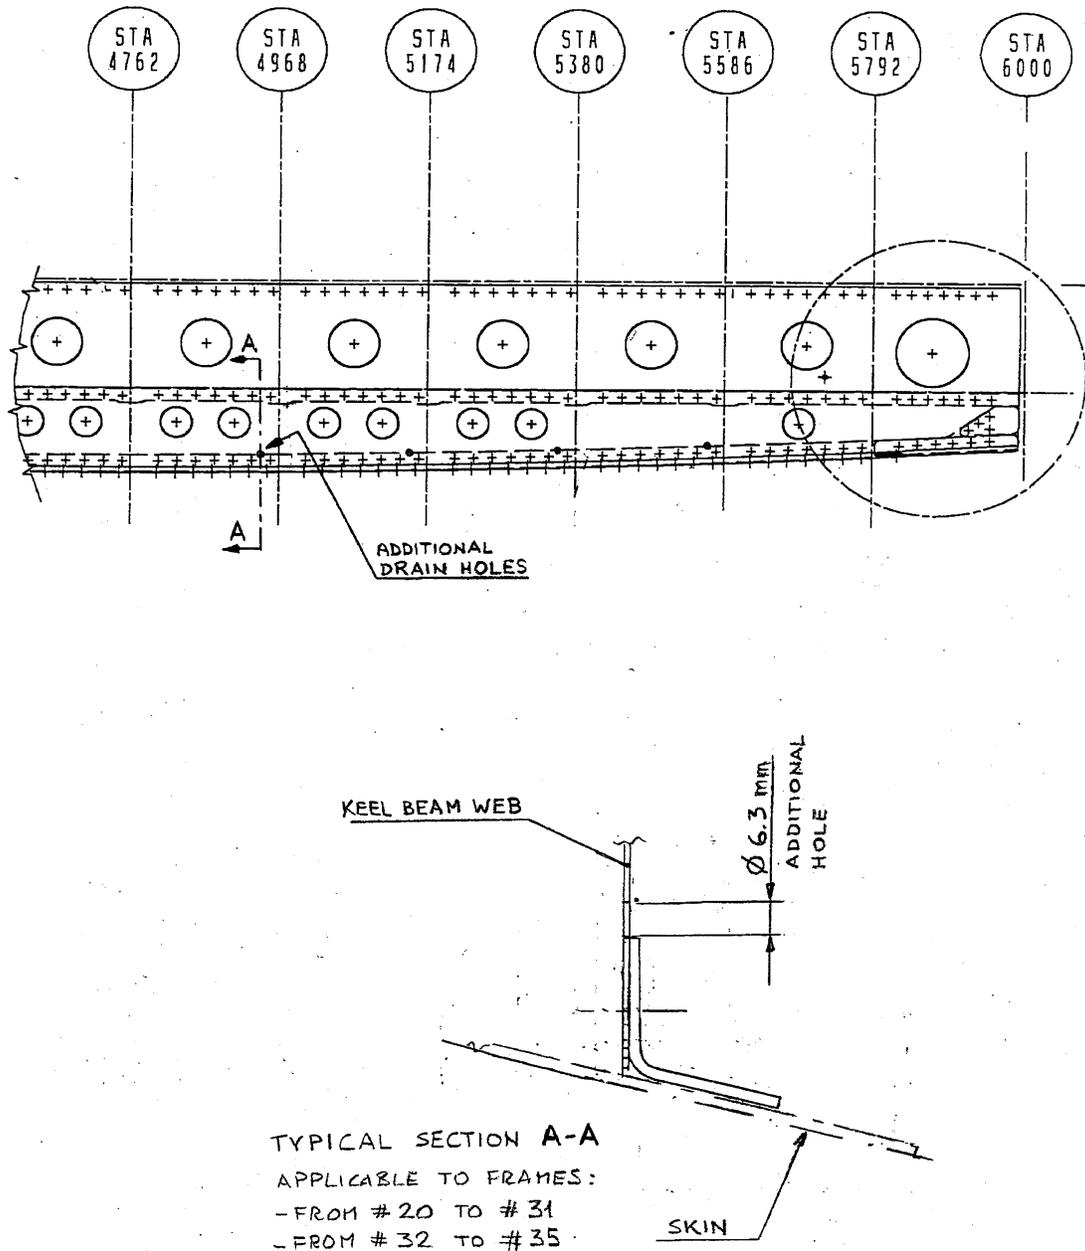
Figure 1. Additional drain holes on keel beam webs

i. If water is found only in the bottom of the belly (*i.e.*, undrainable within the keel

beams), go to step 6. Step 5 does not need to be accomplished at this time.

ii. If water is found in excess of item above (4-c-i), do step 5.

5. Add 6.3 mm draining holes as per attached figure 1 (additional drain holes on keel beam webs) connecting the lateral bays to the center ones or, as alternative, apply Piaggio Aero Industries Service Bulletin 80-0291. Then proceed with step 6.
