[Docket No. FAA-2007-28661; Directorate Identifier 2007-NM-013-AD]

Airworthiness Directives; The Boeing Company Model 737-600, -700, -700C, -800, and -900 Series Airplanes

ACTION: Supplemental notice of proposed rulemaking (NPRM); reopening of comment period.

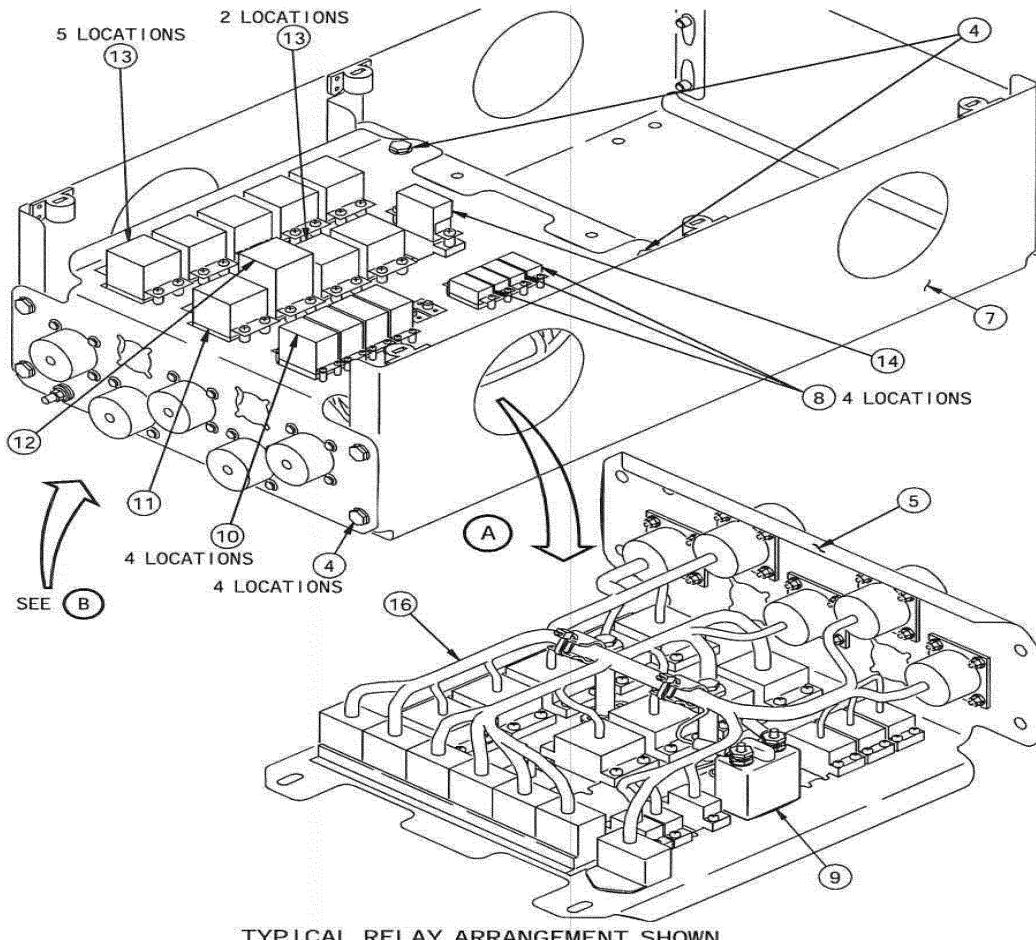
- Sheet 2 of 4 of Figure 11 of Boeing Alert Service Bulletin 737–28A1206, Revision 2, dated May 21, 2009, was inadvertently replaced with Sheet 2 of 4 of Figure 11 from Boeing Alert Service Bulletin 737–28A1206, dated January 11, 2006. That figure was corrected in Boeing Alert Service Bulletin 737–28A1206, Revision 1, dated January 30,

2008, and did not need to be changed in Boeing Alert Service Bulletin 737–28A1206, Revision 2, dated May 21, 2009. We have added Figure 1 in this supplemental NPRM to provide the correct Sheet 2 of 4 of Figure 11.
