**[Docket No. FAA–2009–1253; Directorate Identifier 2009–NM–080–AD; Amendment 39–16629; AD 2011–06–05]**

**Airworthiness Directives; The Boeing Company Model 737–600, –700, –700C, –800, –900, and –900ER Series Airplanes**

#### 2011–06–05 The Boeing Company:

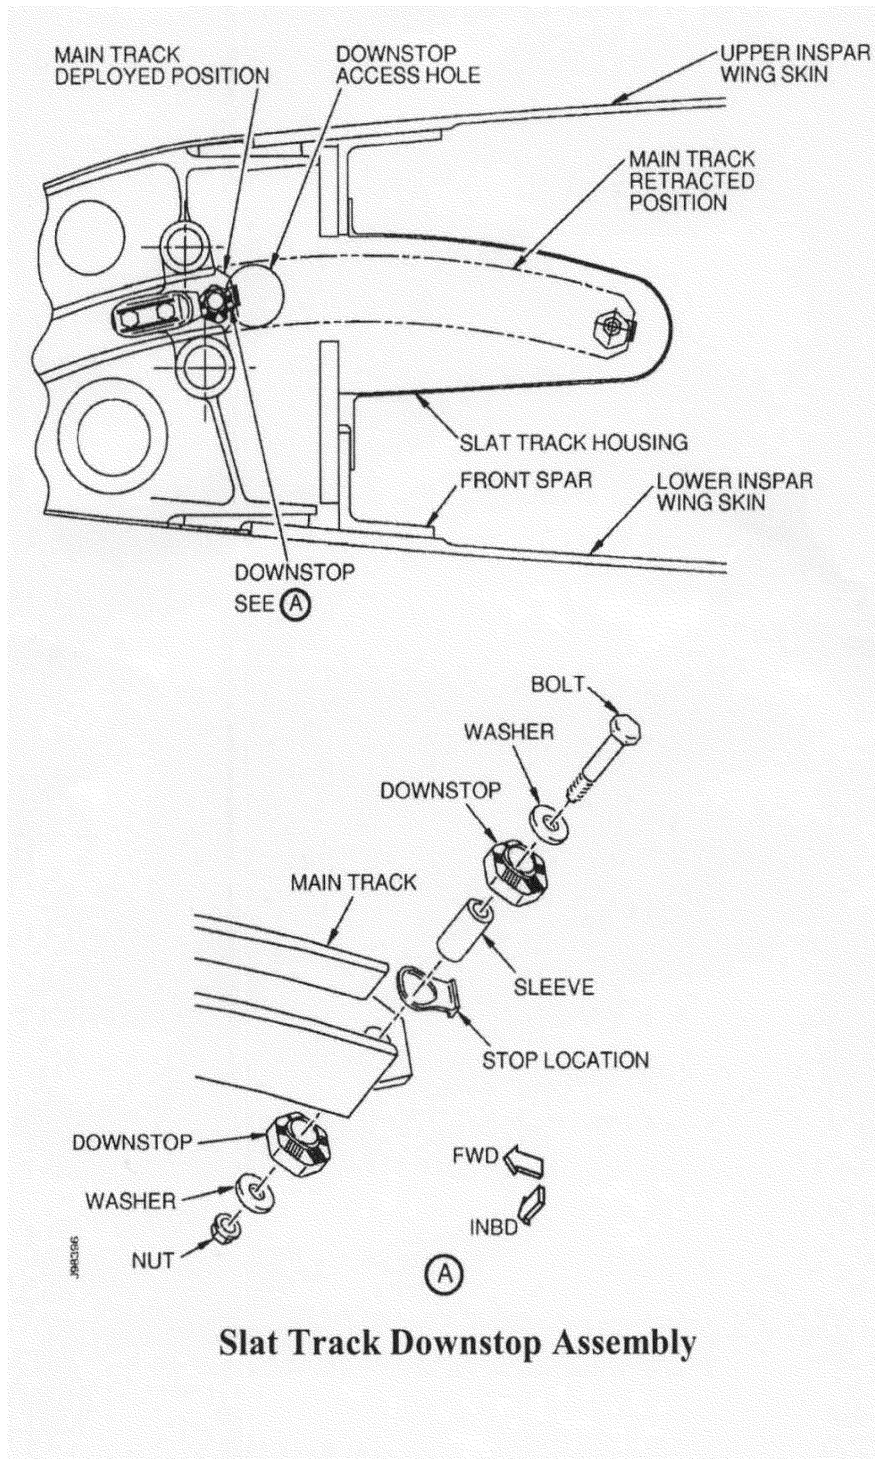
**Figure 1**

- (g) Within 10 days after September 26, 2007 (the effective date of AD 2007–18–52): Do a detailed inspection or a borescope inspection of each main slat track downstop assembly to verify proper installation of the slat track hardware (*i.e.*, the bolt, washers, downstops, stop location, and nut shown in Figure 1 of Boeing Service Letter 737–SL–57–084–B, dated July 10, 2007, and in this AD). Proper installation of the sleeve need not be confirmed, and the stop location part may be installed on either the inboard or the outboard side of the slat track. If any part is missing or is installed improperly, before further flight, install a new or serviceable part using a method approved in accordance with the procedures specified in paragraph (j) of this AD; and do a detailed inspection of the inside of the slat can for foreign object debris (FOD) and damage. Before further flight, remove any FOD found and repair any damage found using a method approved in accordance with the procedures specified in paragraph (j) of this AD. Verify proper installation; install a new or serviceable part; and inspect for damage and FOD, and remove FOD and repair damage; in accordance with a method by approved by the Manager, Seattle Aircraft Certification Office, FAA; or in accordance with Boeing Multi Operator Message Number 1–523812011–1, issued August 25, 2007, or 1–527463441–1, issued August 28, 2007. Repeat the actions required by paragraph (g) of this AD thereafter at intervals not to exceed 3,000 flight cycles.

**Slat Track Downstop Assembly**

- (h) Within 24 days after receipt of emergency AD 2007–18–51: Apply a torque between 50 to 80 inch-pounds to the nut. The bolt head must be held with the torque applied to the nut.
