[Docket No. FAA–2010–1101; Directorate Identifier 2009–CE–013–AD; Amendment 39–16690; AD 2011–10–09]

Airworthiness Directives; Cessna Aircraft Company Models 150, 152, 170, 172, 175, 177, 180, 182, 185, 188, 190, 195, 206, 207, 210, T303, 336, and 337 Airplanes

ACTION: Final rule.

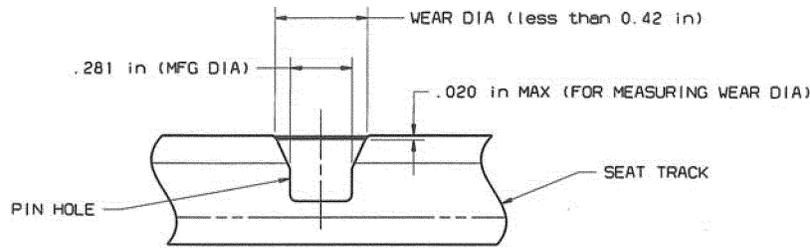
Figure 1. Diameter of seat pin locking engagement hole

(3) Inspect the diameter of each seat locking pin engagement hole in the pilot and copilot seat rails for excessive wear. Due to wear on the rail surface at the hole opening, we allow this measurement 0.020 of an inch below the surface of the rail. You must take this measurement somewhere between the surface of the rail or no more than 0.020 of an inch below the surface of the rail.

(i) If the diameter of any of the holes is 0.42 of an inch or more (see figure 1), before further flight, replace the rail.

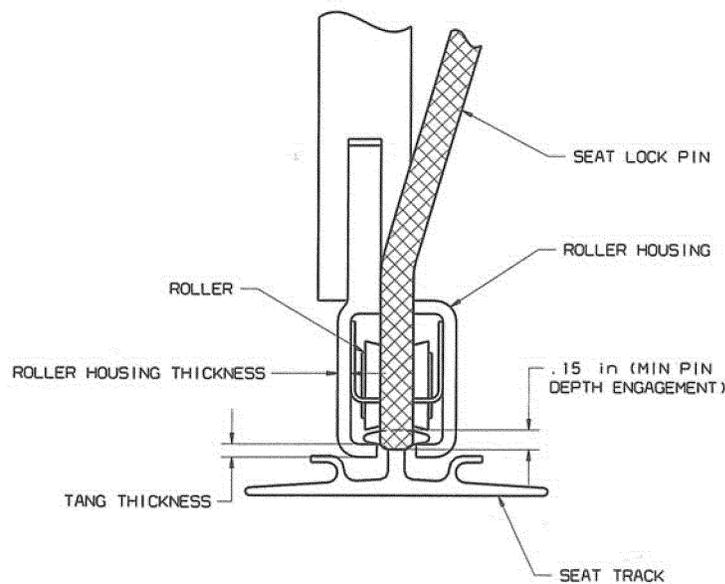
Figure 2. Seat locking pin depth engagement

(10) Lift up the forward edge of each seat to eliminate vertical play of the seat locking pin in the engagement hole, and from this position, inspect the depth of engagement of each seat locking pin (see figure 2). If the rail is worn, this depth is measured from the worn surface, not the manufactured surface.

(i) If engagement of any of the seat locking pins measures less than 0.15 of an inch, before further flight, replace or repair any seat components necessary to achieve a seat pin engagement of a minimum of 0.15 of an inch.

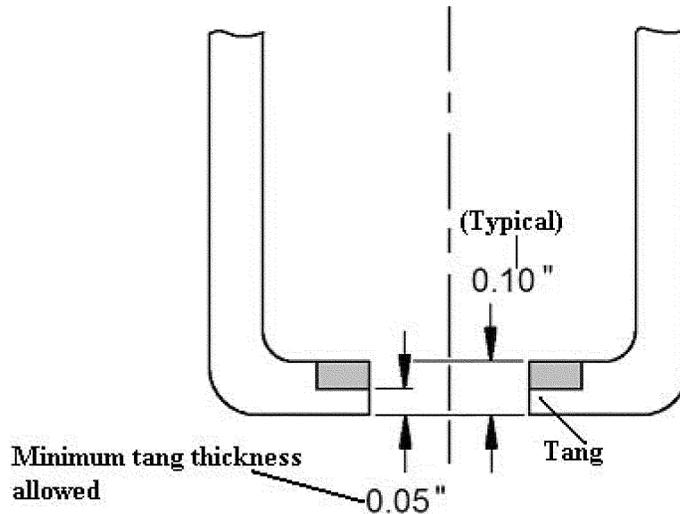
Figure 3. Closeup of seat roller housing and tang thickness

(5) Inspect the thickness of the tang (see figure 2 and figure 3). Due to wear of the tang chafing against the seat rail, measure the tang

(i) If the tang thickness measures less than 0.05 of an inch, before further flight replace the roller housing.

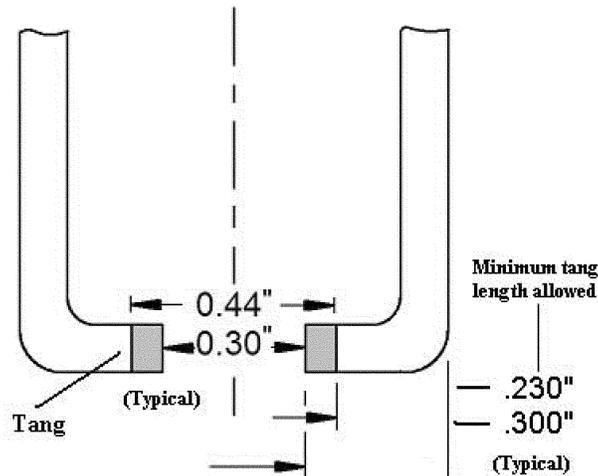
Figure 4. Closeup of seat roller housing and tang gap width

We have changed the callouts in figure 4 to measure the tang length from outside of the roller housing instead of from inside of the roller housing. We have also changed the description of the tang measurement in figure 4 to more accurately describe the measurement.

(6) Due to wear or deformation of the tangs, inspect the tang length from the inner edge of the tang to the outer edge (the bend area) of the roller housing (see figure 4).

(i) The minimum measurement allowed for the remaining tang length is 0.230 inches remaining on either of the tangs, from the inner edge of the tang to the outer edge (the bend area) of the roller housing. If the measurement is less than 0.230 inches on either of the tangs, before further flight, replace the roller housing.

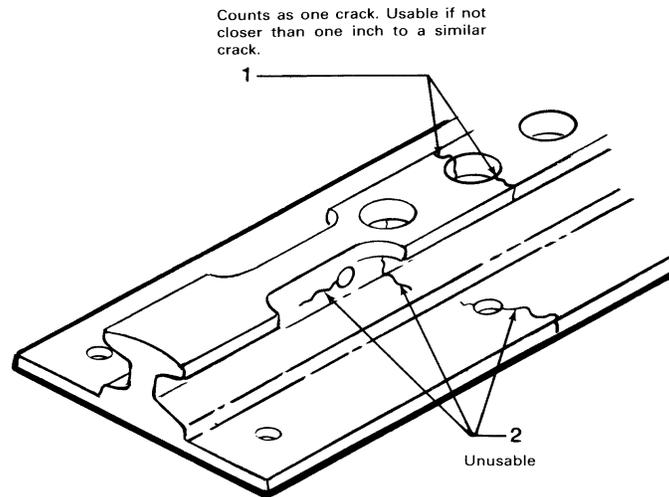
(8) Visually inspect the seat rails for cracks.

- (1) Any portion of web or lower flange is cracked (index 2).
- (2) Any crack in crown of rail is in any direction other than right angle to length of rail.
- (3) Number of cracks on any one rail exceeds four, or any two cracks (index 1) are closer than one inch.

(i) If there are seat rail cracks that exceed the crack criteria in figure 5, before further flight, replace the seat rail.
