[Docket No. FAA–2010–1101; Directorate Identifier 2009–CE–013–AD; Amendment 39–16690; AD 2011–10–09]

Airworthiness Directives; Cessna Aircraft Company Models 150, 152, 170, 172, 175, 177, 180, 182, 185, 188, 190, 195, 206, 207, 210, T303, 336, and 337 Airplanes

ACTION: Final rule.

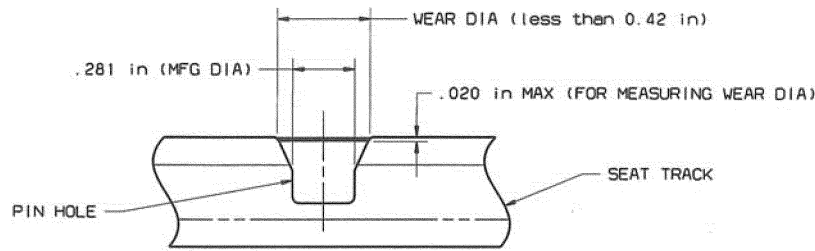
Figure 1. Diameter of seat pin locking engagement hole

(3) Inspect the diameter of each seat locking pin engagement hole in the pilot and copilot seat rails for excessive wear. Due to wear on the rail surface at the hole opening, we allow this measurement 0.020 of an inch below the surface of the rail. You must take this measurement somewhere between the surface of the rail or no more than 0.020 of an inch below the surface of the rail.

(i) If the diameter of any of the holes is 0.42 of an inch or more (see figure 1), before further flight, replace the rail.

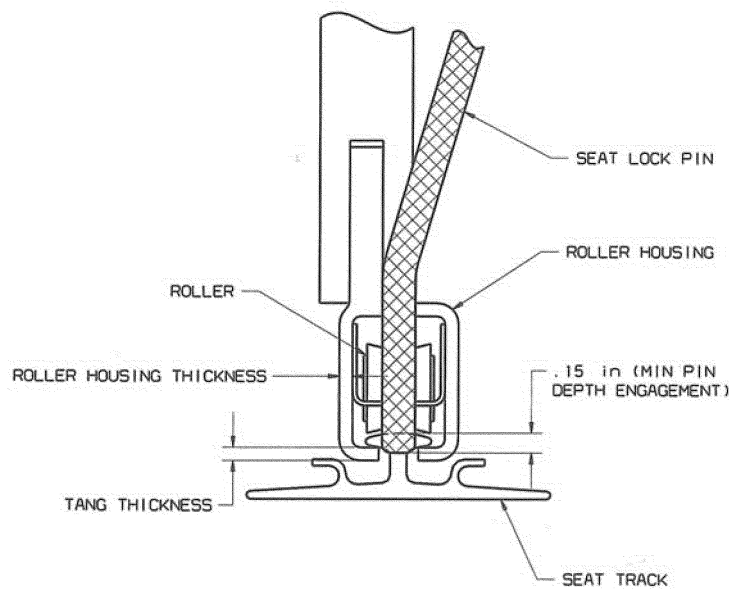
Figure 2. Seat locking pin depth engagement

(10) Lift up the forward edge of each seat to eliminate vertical play of the seat locking pin in the engagement hole, and from this position, inspect the depth of engagement of each seat locking pin (see figure 2). If the rail is worn, this depth is measured from the worn surface, not the manufactured surface.

(i) If engagement of any of the seat locking pins measures less than 0.15 of an inch, before further flight, replace or repair any seat components necessary to achieve a seat pin engagement of a minimum of 0.15 of an inch.

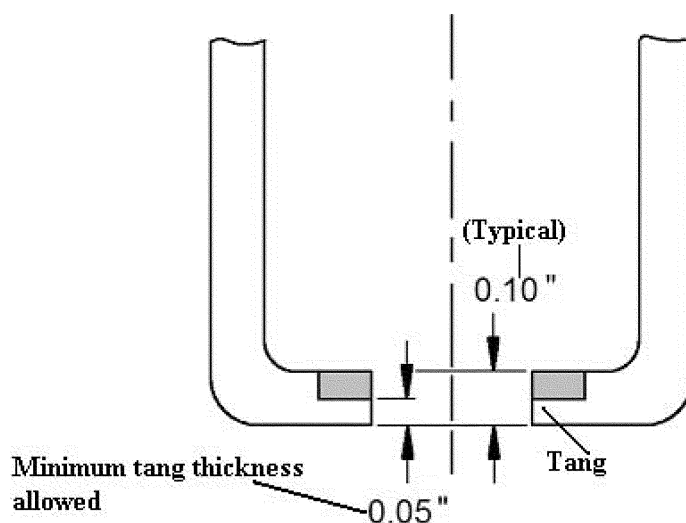
Figure 3. Closeup of seat roller housing and tang thickness

(5) Inspect the thickness of the tang (see figure 2 and figure 3). Due to wear of the tang chafing against the seat rail, measure the tang

(i) If the tang thickness measures less than 0.05 of an inch, before further flight replace the roller housing.

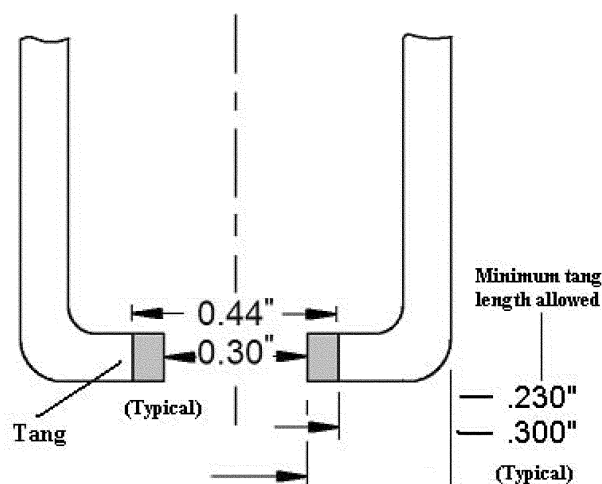
Figure 4. Closeup of seat roller housing and tang gap width

We have changed the callouts in figure 4 to measure the tang length from outside of the roller housing instead of from inside of the roller housing. We have also changed the description of the tang measurement in figure 4 to more accurately describe the measurement.

(6) Due to wear or deformation of the tangs, inspect the tang length from the inner edge of the tang to the outer edge (the bend area) of the roller housing (see figure 4).

(i) The minimum measurement allowed for the remaining tang length is 0.230 inches remaining on either of the tangs, from the inner edge of the tang to the outer edge (the bend area) of the roller housing. If the measurement is less than 0.230 inches on either of the tangs, before further flight, replace the roller housing.
