[Docket No. FAA-2011-0468; Directorate Identifier 2011-CE-013-AD; Amendment 39-16697; AD 2011-10-16]

**Airworthiness Directives; PIAGGIO AERO INDUSTRIES S.p.A Model P-180 Airplanes**

### **Airworthiness Directives; Airbus Model A300 and A310 Series Airplanes, and Model A300 B4-600, B4-600R, and F4-600R Series Airplanes, and Model C4-605R Variant F Airplanes (Collectively Called A300-600 Series Airplanes)**

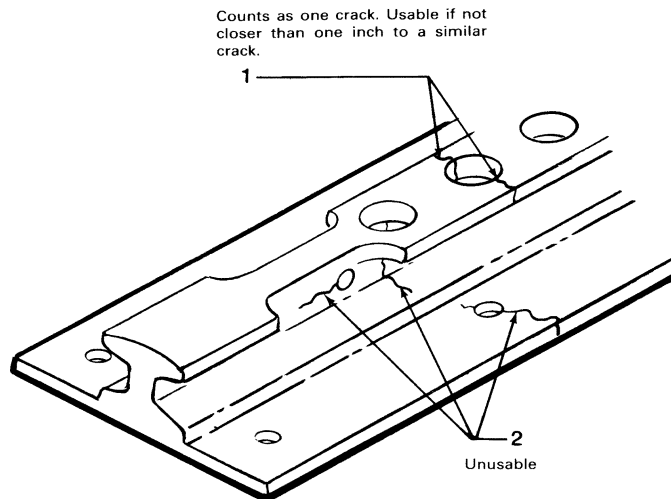
Figure 5. Seat rail

- (1) Any portion of web or lower flange is cracked (index 2).
- (2) Any crack in crown of rail is in any direction other than right angle to length of rail.
- (3) Number of cracks on any one rail exceeds four, or any two cracks (index 1) are closer than one inch.

Use of seat rail cargo tie-downs is not permissible on seat rails with cracks.

REPLACE SEAT RAIL WHEN:
