[Docket No. FAA–2007–28661; Directorate Identifier 2007–NM–013–AD; Amendment 39–16785; AD 2011–18–03]

Airworthiness Directives; The Boeing Company Model 737–600, –700, –700C, –800, and –900 Series Airplanes

ACTION: Final rule.

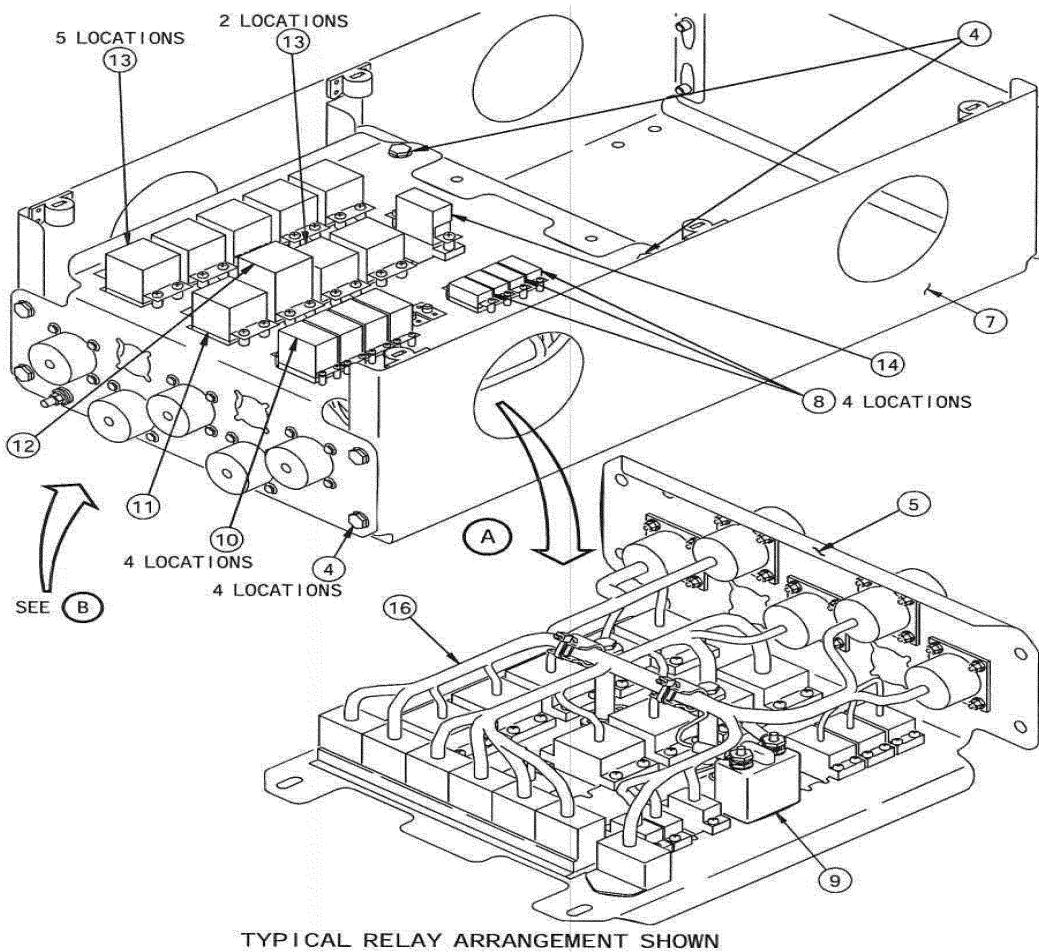
Part 1 and Part 2 of the Accomplishment Instructions of Boeing Alert Service Bulletin 737-28A1206, Revision 2, dated May 21, 2009, except that Figure 1 of this AD must be used in lieu of Sheet 2 of Figure 11 of Boeing Alert Service Bulletin 737-28A1206, Revision 2, dated May 21, 2009. If a placard has been previously installed on the airplane in accordance with paragraph (h) of this AD, the placard may be removed from the flight deck of only that airplane after the automatic shutoff system has been installed. Installing automatic shutoff systems on all airplanes in an operator's fleet, in accordance with this
