**DEPARTMENT OF TRANSPORTATION****Federal Aviation Administration****14 CFR Part 39**

[Docket No. FAA-2011-0994; Directorate Identifier 2010-NM-143-AD]

**Airworthiness Directives; Bombardier, Inc. Model CL-600-2C10 (Regional Jet Series 700, 701, & 702), CL-600-2D15 (Regional Jet Series 705), and CL-600-2D24 (Regional Jet Series 900) Airplanes****AGENCY:** Federal Aviation Administration (FAA), DOT.**ACTION:** Notice of proposed rulemaking (NPRM).

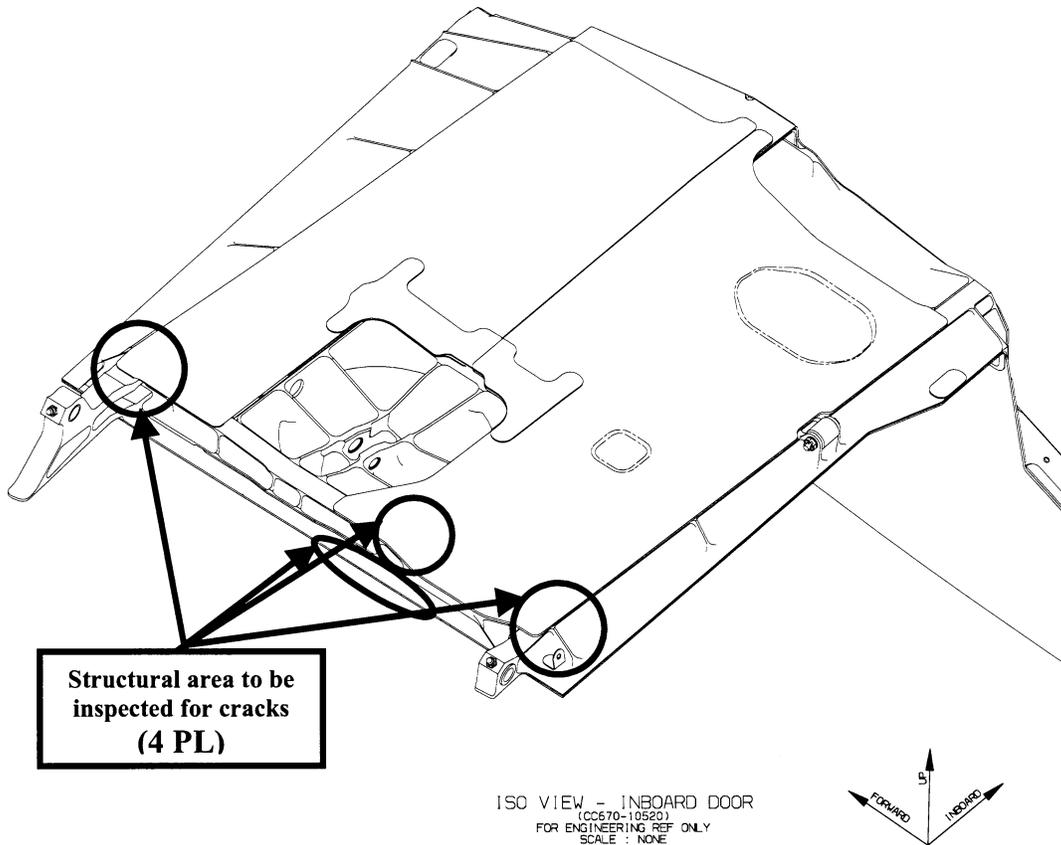
**Figure 1**  
LH side shown  
RH side opposite

(h) For Model CL-600-2C10 (Regional Jet series 700 & 701) series airplanes, S/Ns 10003 through 10230 inclusive; and Model CL-600-2D24 (Regional Jet series 900) series airplanes, S/Ns 15002 through 15053 inclusive, 15055 and 15056: At the applicable time specified in paragraph (g) of this AD, perform detailed inspections of the lower panel, part number (P/N) CC670-10520, of the left- and right-hand MLG doors for the conditions and in the areas specified in paragraphs (h)(1), (h)(2), (h)(3), and (h)(4) of this AD; and Figures 1, 2, and 3 of this AD.

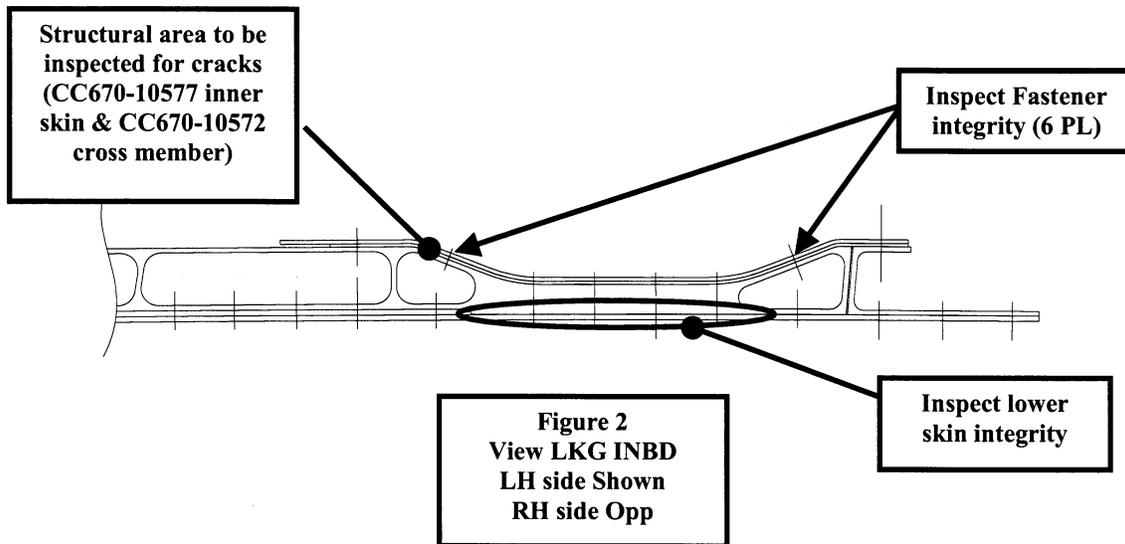
(1) Inspect the cross member, P/N CC670-10572, of the MLG door lower panel for cracking or deformation, in accordance with Figure 2 of this AD.

(2) Inspect the inner skin, P/N CC670-10577, of the MLG door lower panel at the cross member (P/N CC670-10572) for cracking or deformation, or pulled or missing fasteners, in accordance with Figure 2 of this AD.

(3) Inspect the outer skin, P/N CC670-10574, of the MLG door lower panel at the cross member (P/N CC670-10572) for cracking or deformation, or pulled or missing fasteners, in accordance with Figure 2 of this AD.

(j) If any cracking or deformation, or pulled or missing fastener, as applicable, is found during any inspection done in accordance with paragraph (h) or (i) of this AD: Before further flight, accomplish paragraph (j)(1), (j)(2), or (j)(3) of this AD.  
 (1) Repair the damage in accordance with a method approved by either the Manager, New York Aircraft Certification Office (ACO),

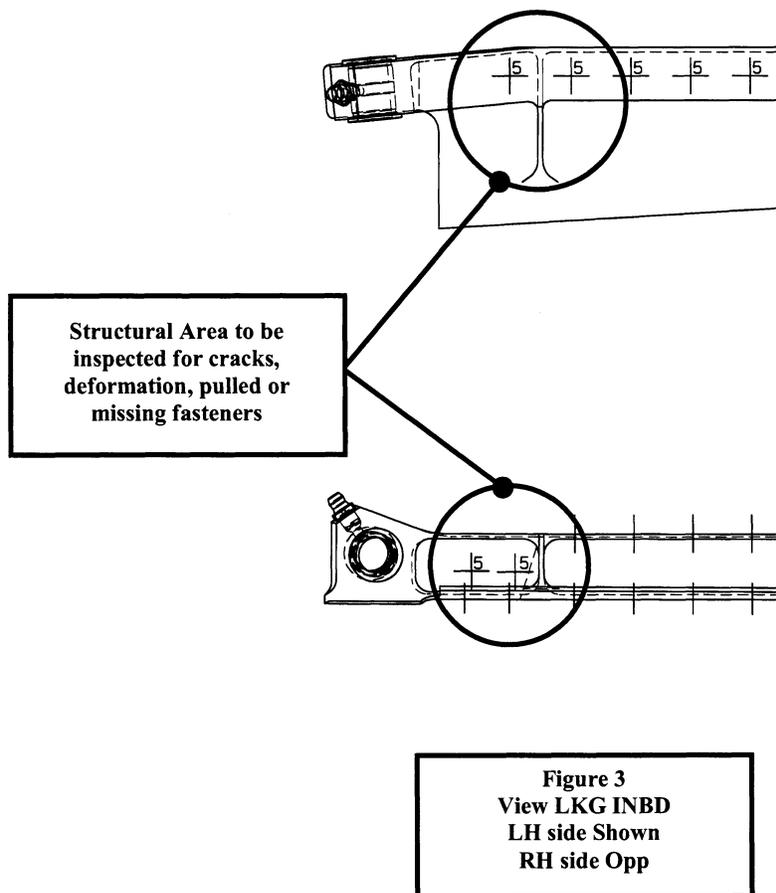
(4) Inspect the forward member, P/N CC670-10570, and aft member, P/N CC670-10571, of the MLG door lower panel for cracking or deformation, or pulled or missing fasteners, in accordance with Figure 3 of this AD. Figures 1 through 3 of this AD follow.
