#### Airworthiness Directives; Sikorsky Aircraft Corporation (Sikorsky) Model S-92A Helicopters

**ACTION:** Notice of proposed rulemaking (NPRM).

**Sikorsky Aircraft Corporation:** Docket No. FAA-2011-1115; Directorate Identifier 2010-SW-011-AD.

*Applicability:* Model S-92A helicopters, certificated in any category.

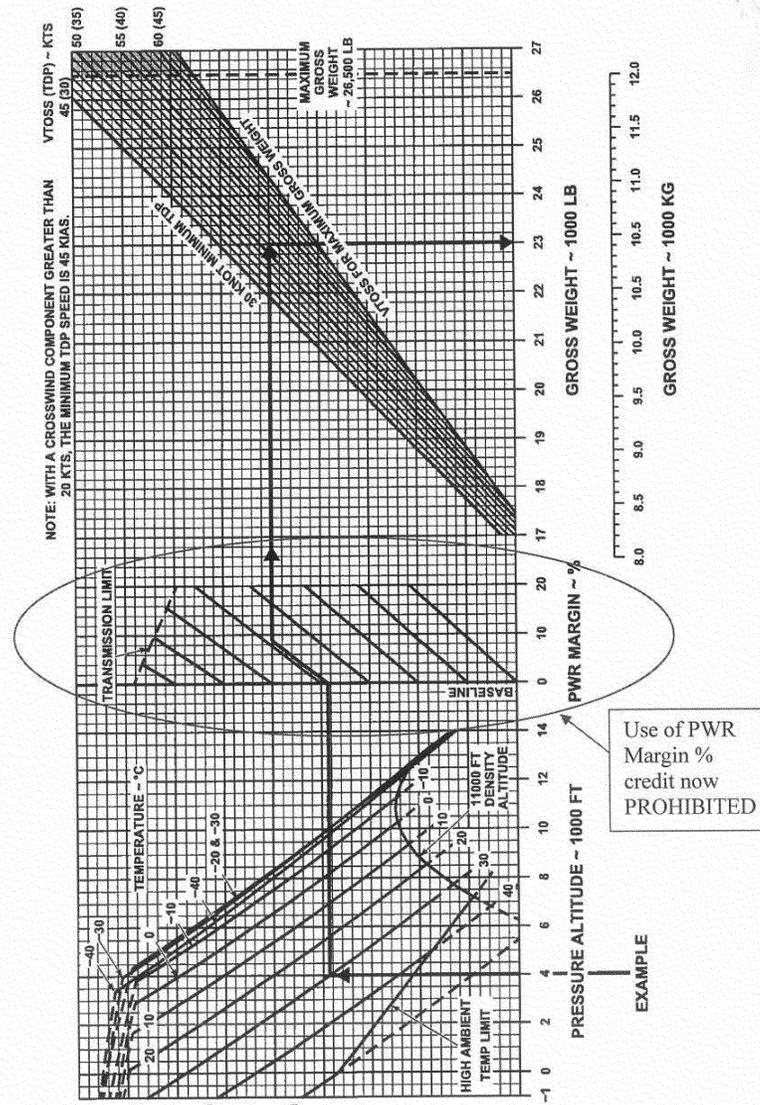
Figure 1. Cat 'A' Takeoff and Landing Gross Weight

(b) If the RFM already contains the revisions appropriate for your helicopter as listed in the following Table 1, all dated April 9, 2008, with the correct performance charts, without the performance credit as depicted in the circled area of Figure 1 of this AD, the operating limitation required by paragraph (a) of this AD does not need to be inserted into the RFM.

**Note 1:** Previous RFM revisions allowed for the use of above-specification engine power margin as depicted in the circled area of Figure 1 of this AD.

(a) By making pen and ink changes, insert into the Operating Limitations section, Part 1, Section 1, *Weight Limits*, of RFM SA S92A-RFM-002, -003, -004, -005, and -006 the following limitation “Performance credit for above specification engine power margin is prohibited.”
