[Docket No. FAA–2011–0939; Directorate Identifier 2010–SW–067–AD; Amendment 39 16798; AD 2011–18–16]

Airworthiness Directives; Eurocopter France (Eurocopter) Model AS332C, AS332L, AS332L1, and AS332L2 Helicopters

2011-18-16 Eurocopter France:

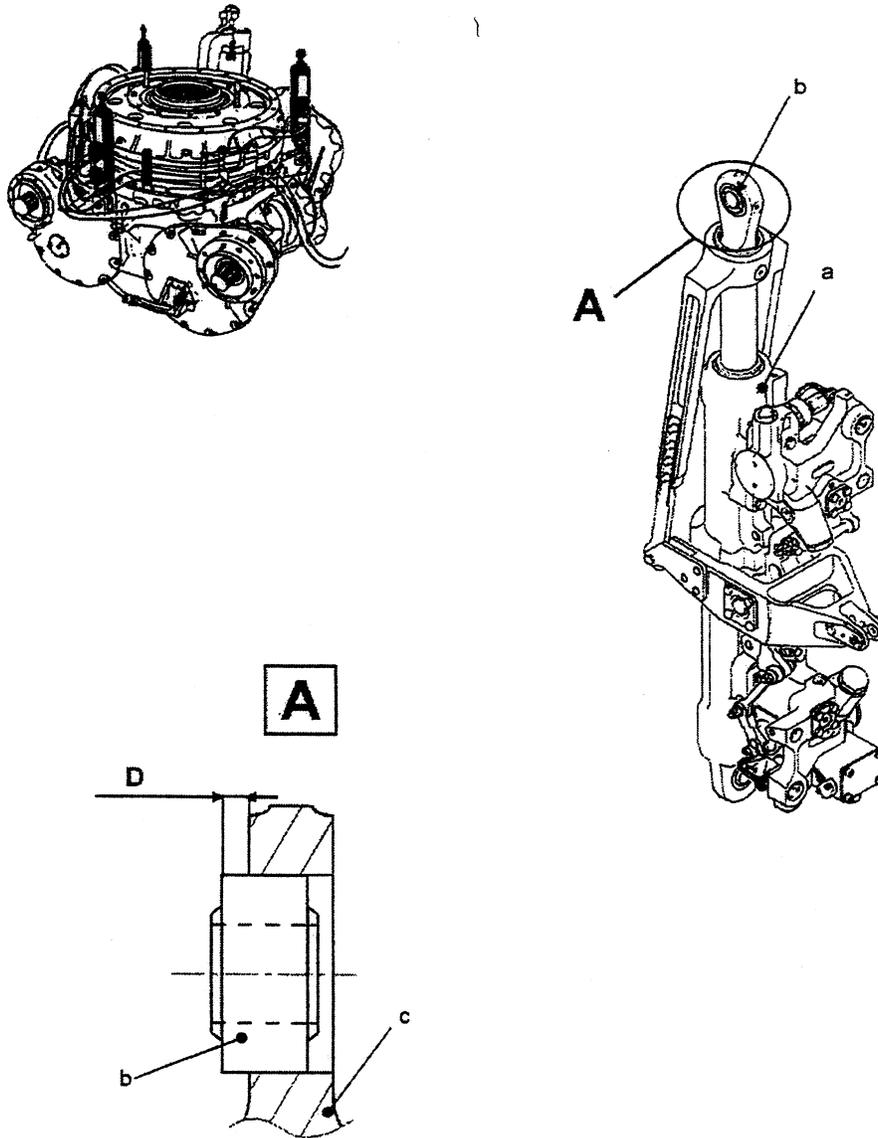
Investigation has shown that the swaging load applied to the ball joints was 1.3 metric tons instead of the specified 13 metric tons. The actions specified in this AD are intended to prevent failure of the upper end fitting ball joints of the main rotor servocontrols, failure of the upper end fittings, and loss of control of the helicopter.

(a) Within 15 hours time-in-service (TIS), unless accomplished previously, using a feeler gage, measure the lateral play between the outer ring of the ball joint and each of the two faces of the upper end fitting as depicted in Figure 1 of this AD.

(b) If the lateral play is greater than or equal to 1 millimeter (MM) (0.04 inch) and the servocontrol has accumulated 825 or more hours TIS, before further flight, replace it with an airworthy servocontrol.

servocontrol has accumulated less than 825 hours TIS, on or before the servocontrol accumulates 825 hours TIS, replace it with an airworthy servocontrol.

(d) If the lateral play is less than 1 mm (0.04 inch), at intervals not to exceed 300 hours TIS, repeat the inspection required by

paragraph (a) of this AD. At each 300 hour TIS interval inspection, if the lateral play is greater than or equal to 1 mm (0.04 inch), within 525 hours TIS, replace the servocontrol with an airworthy servocontrol.
