[Docket No. FAA-2011-1035; Directorate Identifier 2011-SW-038-AD; Amendment 39-16817; AD 2011-15-51]

Airworthiness Directives; Bell Helicopter Textron Canada (Bell) Model 407 and 427 Helicopters

2011–15–51 Bell Helicopter Textron, Inc. (Bell): Amendment 39–16817; Docket No. FAA–2011–1035; Directorate Identifier 2011–SW–038–AD.

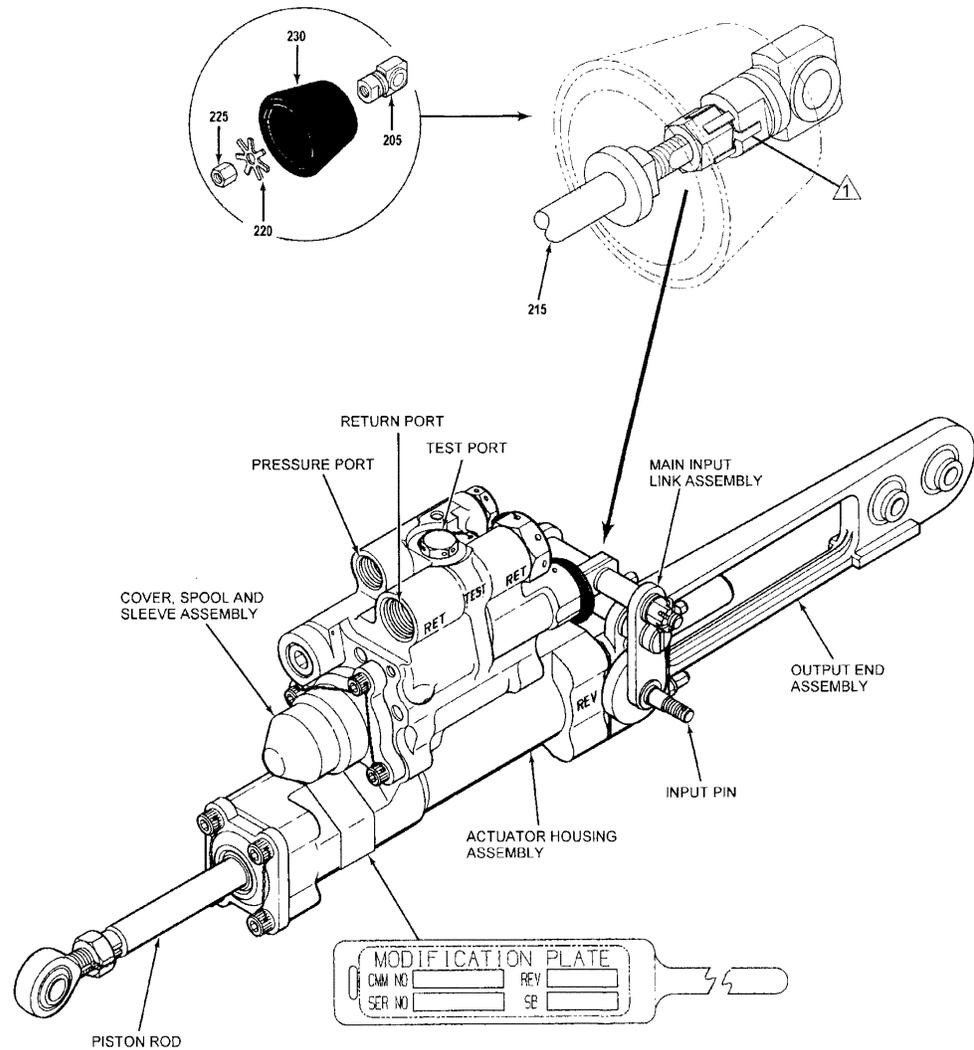
Clevis Assembly
 Figure 1

NOTE:
 ▲ ACCEPTABLE CONDITION
 A MINIMUM OF ONE TAB SHALL BE IN LINE AND BENT FLUSH WITH THE NUT FLAT SURFACE AND A MINIMUM OF ONE TAB SHALL BE IN LINE AND BENT FLUSH WITH THE CLEVIS ASSEMBLY FLAT SURFACE

(2) Applying only hand pressure, determine whether the nut, shaft, or clevis assembly, depicted as “225,” “215,” and “205,” respectively, in Figure 1 of this AD, turns independently. If the shaft turns independently of the nut or the clevis assembly, before further flight, replace the servo with an airworthy servo.

(3) If the shaft does not turn independently, inspect to determine whether at least one tab of the lock washer is bent

flush against a flat surface of the nut and at least one tab of the lock washer is bent flush against a flat surface of the clevis assembly.

(i) If at least one lock washer tab is not aligned and bent flush with a nut flat surface and at least one lock washer tab is not aligned and bent flush with a flat surface of the clevis assembly, before further flight, replace the servo with an airworthy servo.

(ii) If any tab of the lock washer is not bent flush against either a flat surface of the nut

or clevis assembly, bend the tab flush against a flat surface.

(4) After accomplishing paragraph (a)(1) through (a)(3) of this AD, reidentify the servo by metal-impression stamping or by vibro-etching “67-01” onto the modification plate.
