**[Docket No. FAA-2011-1158; Directorate Identifier 2010-SW-018-AD; Amendment 39-16847; AD 2011-22-05]**

#### **Airworthiness Directives; Eurocopter France Model AS350B, B1, B2, B3, BA, C, D, and D1; and AS355E, F, F1, F2, N, and NP Helicopters**

#### 2011-22-05 EUROCOPTER FRANCE

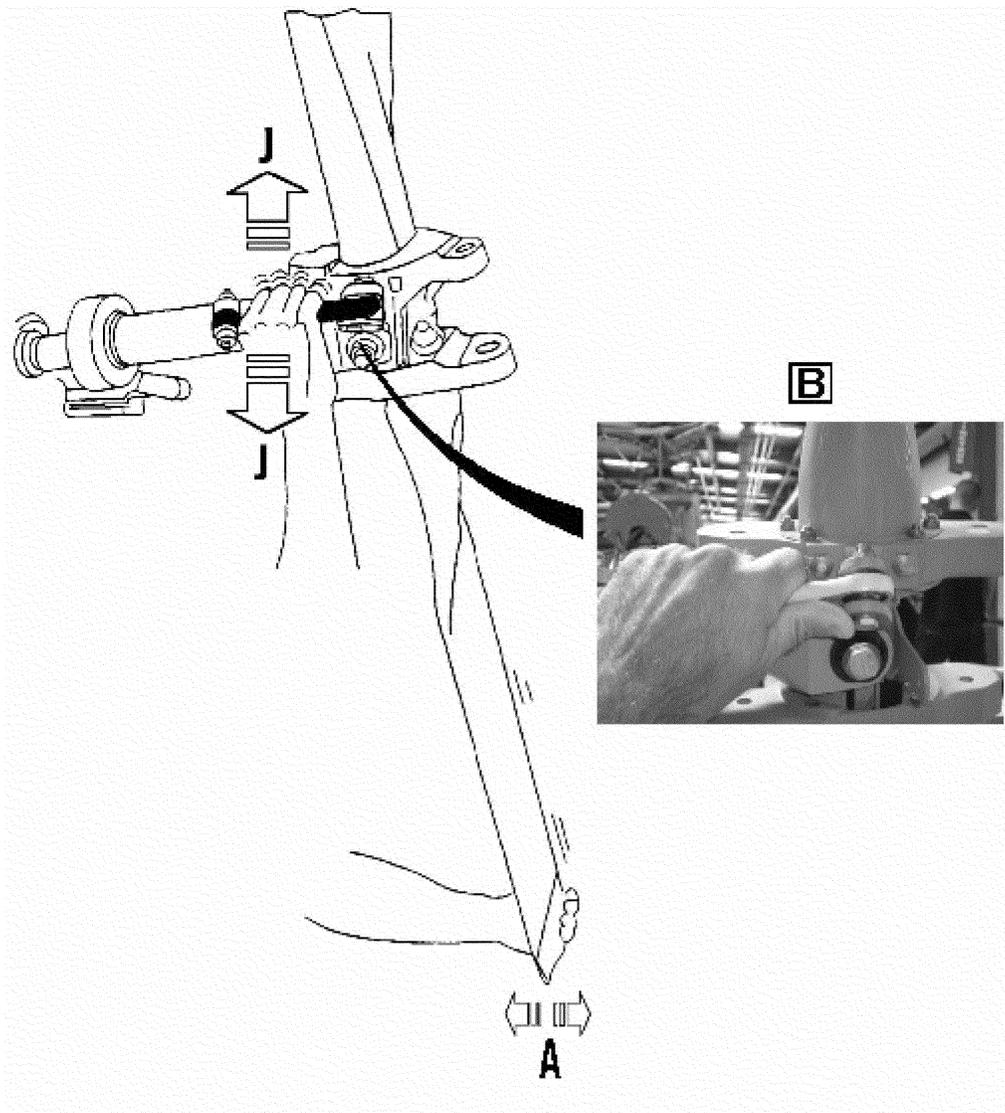
Figure 1: Manual Check for Play of the Tail Rotor Pitch Control Rod

- (a) Before the first flight of each day, place the T/R pedals in the neutral position. If the helicopter is fitted with a T/R load compensator, discharge the accumulator as described in the rotorcraft flight manual. Check the control rod bearing (bearing) for play on the helicopter, by observation and feel, by slightly moving the T/R blade in the flapping axis while monitoring the bearing for movement. See the following Figure 1 of this AD. The actions required by this paragraph may be performed by the owner/operator (pilot) holding at least a private pilot certificate, and must be entered into the helicopter maintenance records showing compliance with this AD in accordance with 14 CFR 43.9(a)(1)-(4) and 14 CFR 91.417(a)(2)(v). The record must be maintained as required by 14 CFR 91.173, 121.380, or 135.439.

(b) If the Teflon cloth is coming out of its normal position within the bearing, totally or partially, or if there is discoloration or scoring on the bearing, before further flight,

replace the control rod with an airworthy control rod.

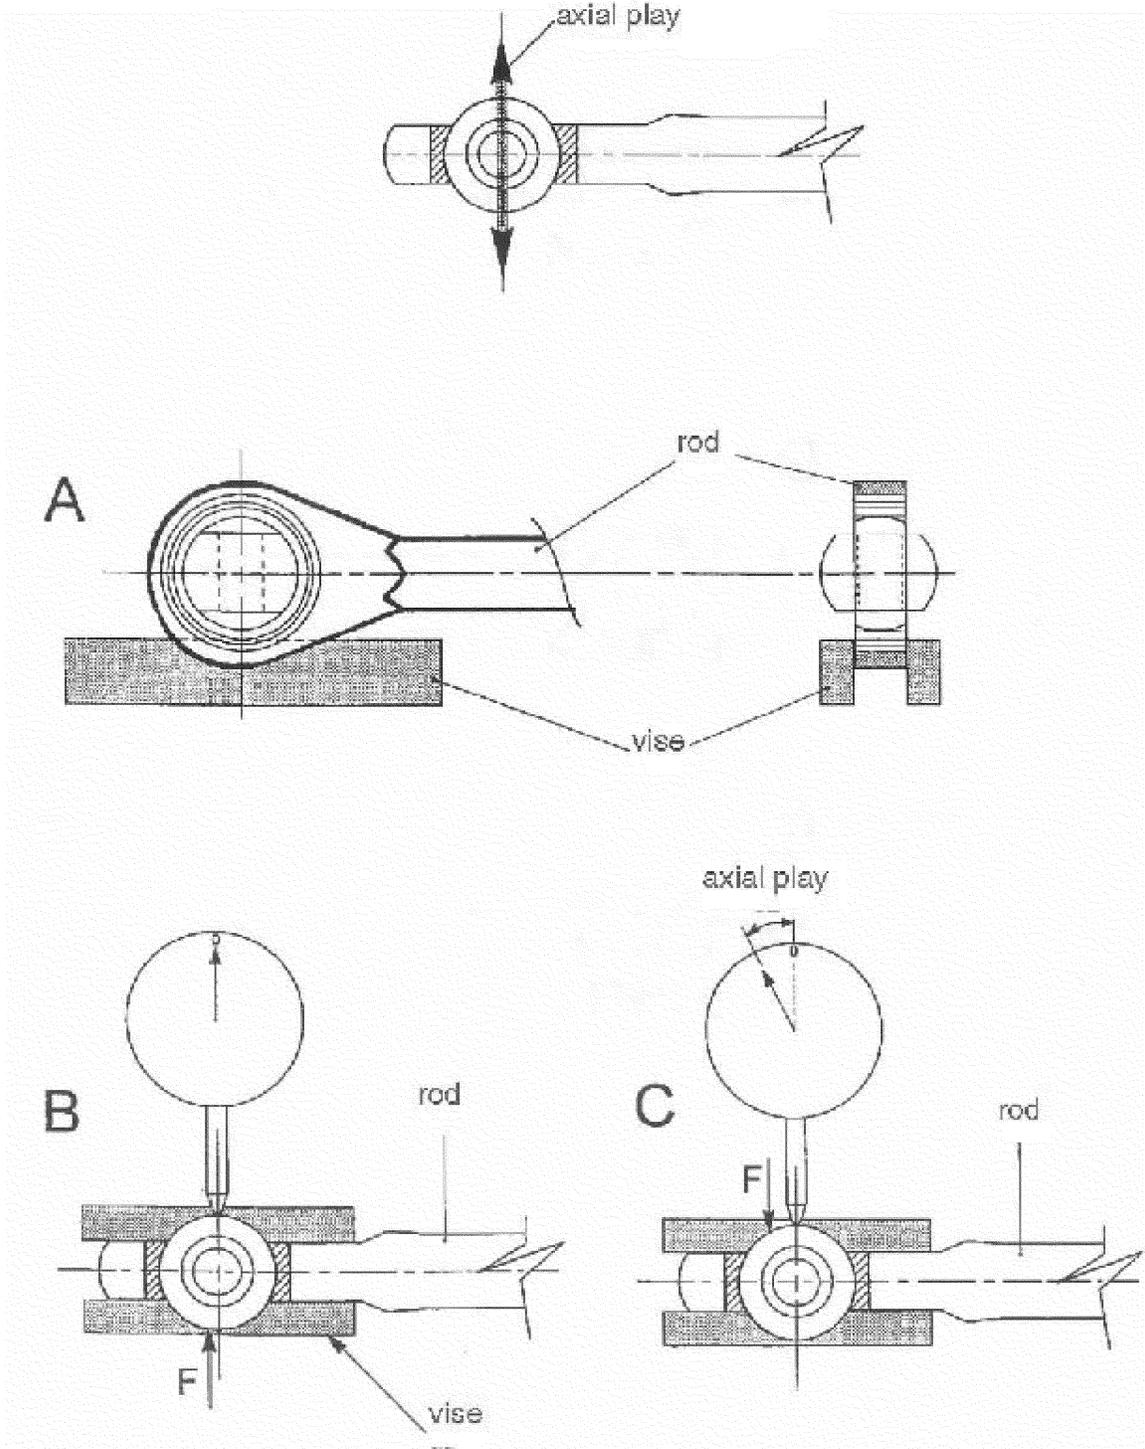
Figure 2: Measurement of the Axial Play (A) of the Bearing

the helicopter, and using a dial indicator, measure the bearing wear according to the following and as shown in Figures 2 and 3 of this AD:

(2) Mount the control rod in a vise as shown in Figure 2 of this AD.

(3) Using a dial indicator, take axial play readings by moving the spherical bearing in the direction F (up and down) as shown in Figure 2 of this AD.

(8) If the radial play exceeds 0.008 inch or axial play exceeds 0.016 inch, replace the control rod with an airworthy control rod before further flight.

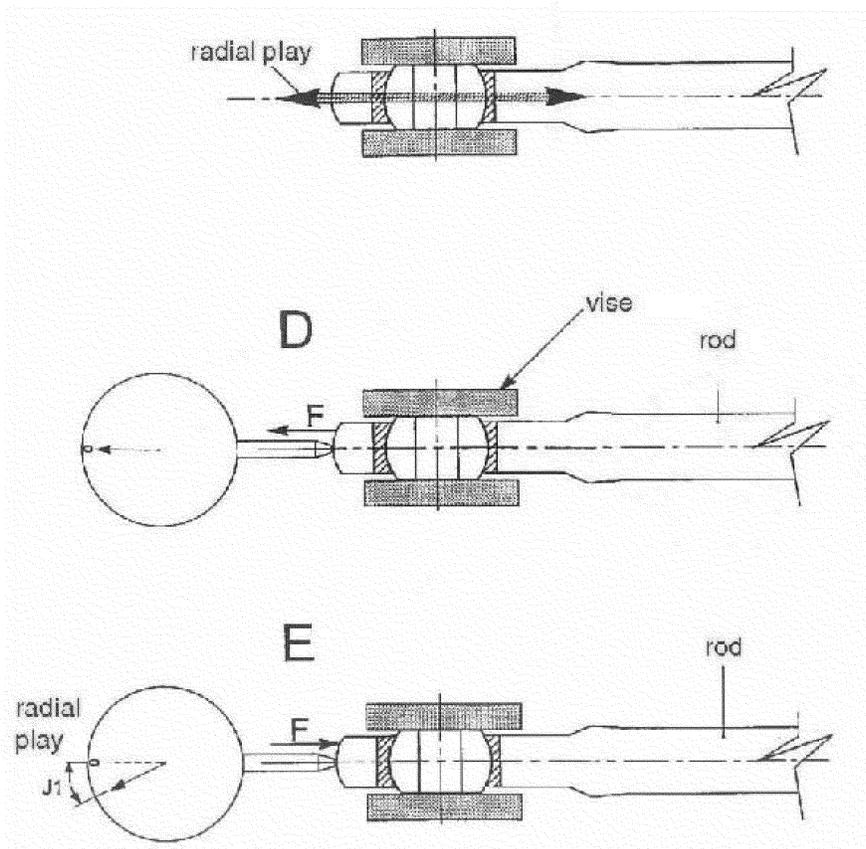
Figure 3: Measurement of the Radial Play (R) of the Bearing

(5) Mount the control rod and bearing in a vise as shown in Figure 3 of this AD.

(6) Using a dial indicator, take radial play measurements by moving the control rod in the direction F as shown in Figure 3 of this AD.
