DEPARTMENT OF TRANSPORTATION**Federal Aviation Administration****14 CFR Part 39**

[Docket No. FAA–2011–0994; Directorate Identifier 2010–NM–143–AD; Amendment 39–16949; AD 2012–03–08]

Airworthiness Directives; Bombardier, Inc. Airplanes

2012–03–08 Bombardier Inc.: Amendment 39–16949; Docket No. FAA–2011–0994; Directorate Identifier 2010–NM–143–AD.

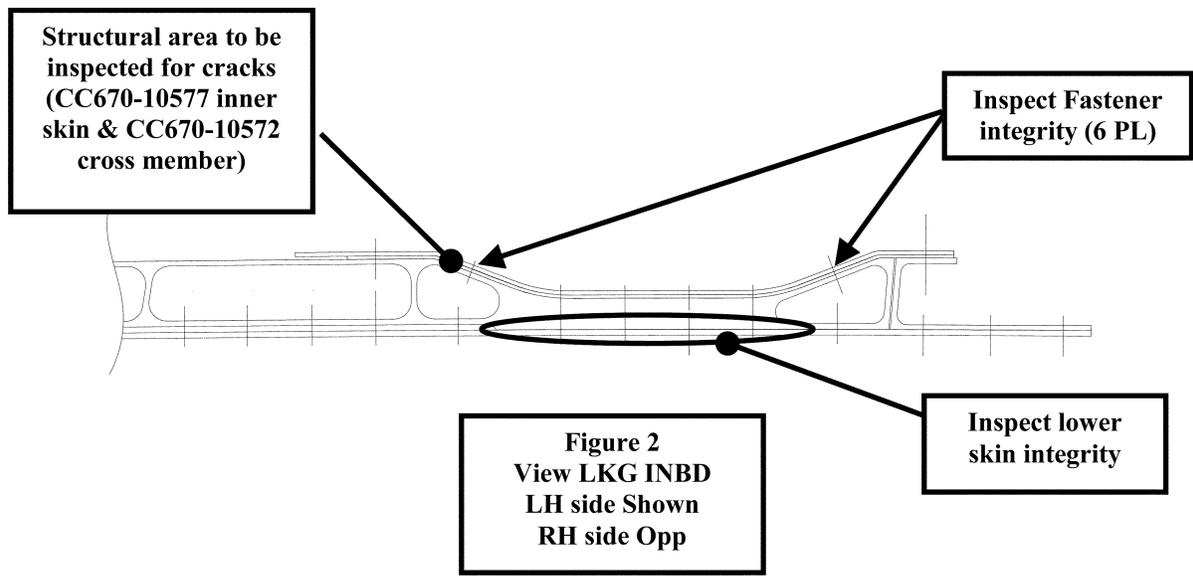
(1) Inspect the cross member, P/N CC670–10572, of the MLG door lower panel for cracking or deformation, in accordance with Figure 2 of this AD.

(2) Inspect the inner skin, P/N CC670–10577, of the MLG door lower panel at the cross member (P/N CC670–10572) for cracking or deformation, or pulled or missing fasteners, in accordance with Figure 2 of this AD.

(3) Inspect the outer skin, P/N CC670–10574, of the MLG door lower panel at the cross member (P/N CC670–10572) for cracking or deformation, or pulled or missing fasteners, in accordance with Figure 2 of this AD.

If any cracking or deformation, or pulled or missing fastener, as applicable, is found during any inspection done in accordance with paragraph (h) or (i) of this AD: Before further flight, accomplish paragraph (j)(1), (j)(2), or (j)(3) of this AD.

(1) Repair the damage in accordance with a method approved by either the Manager, New York Aircraft Certification Office (ACO), FAA; or Transport Canada Civil Aviation (TCCA) (or its delegated agent); and accomplish repetitive inspections in accordance with a method and at a repetitive interval approved by same.

(2) Replace the lower panel assembly, P/N CC670-10520, of the affected MLG door with

(3) Remove the lower panel assembly, P/N CC670-10520, of the affected MLG door, and accomplish paragraph (j)(3)(i) or (j)(3)(ii) of this AD, as applicable.

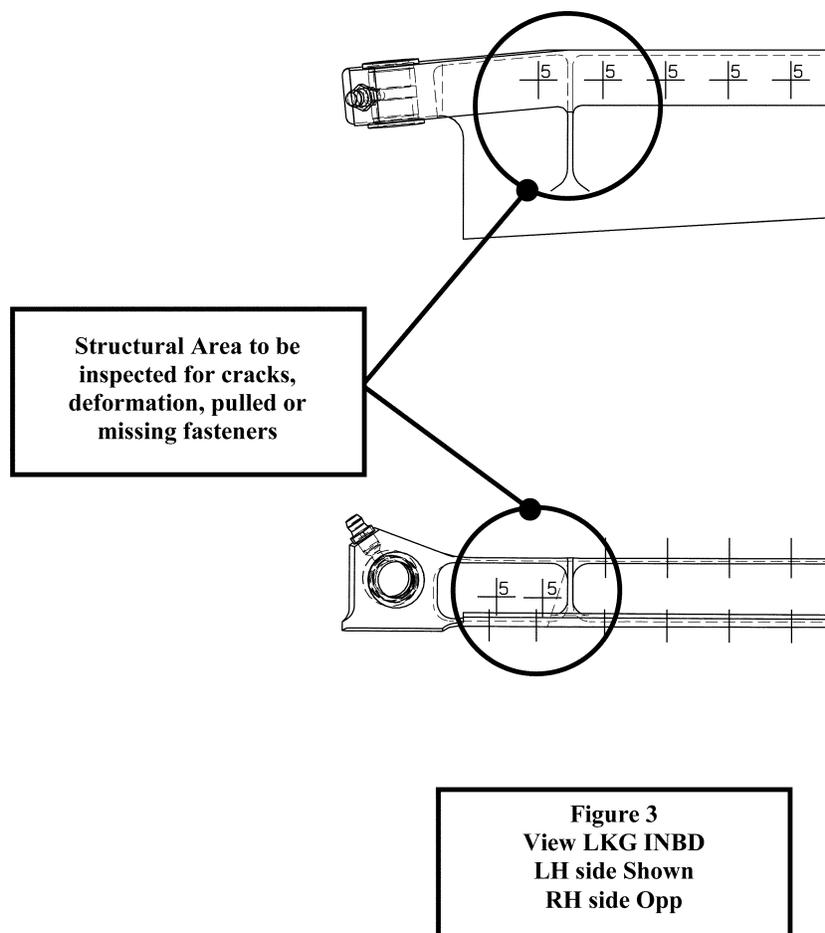
Figure 3
View LKG INBD
LH side Shown
RH side Opp

(4) Inspect the forward member, P/N CC670–10570, and aft member, P/N CC670–10571, of the MLG door lower panel for cracking or deformation, or pulled or missing fasteners, in accordance with Figure 3 of this AD. Figures 1 through 3 of this AD follow.
