[Docket No. FAA-2011-1115; Directorate Identifier 2010-SW-011-AD; Amendment 39-17017; AD 2012-08-01]

#### Airworthiness Directives; Sikorsky Aircraft Corporation Helicopters

**2012-08-01 Sikorsky Aircraft Corporation:**

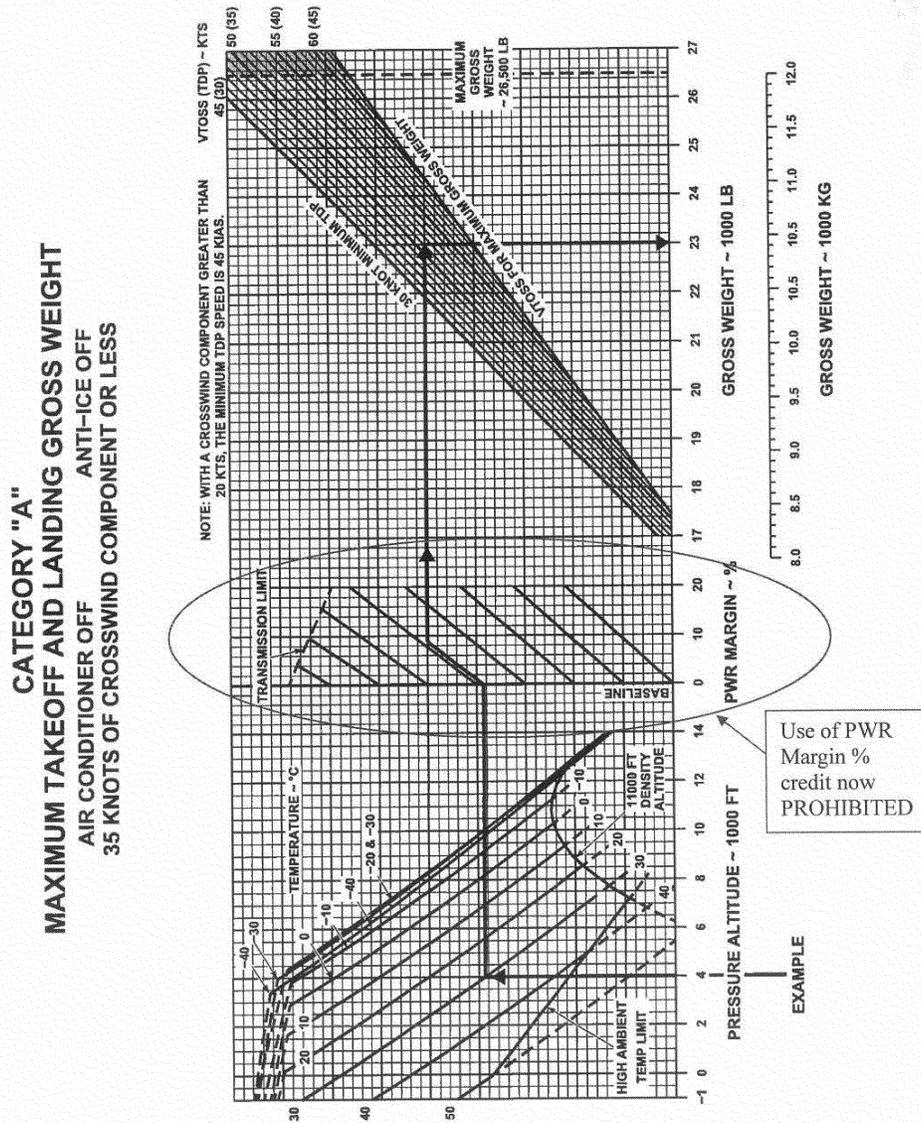
Figure 1. Cat 'A' Takeoff and Landing Gross Weight

(2) If the RFM already contains the revisions appropriate for your helicopter as listed in the following Table 1, all dated April 9, 2008, with the correct performance charts, without the performance credit as depicted in the circled area of Figure 1 of this AD, the operating limitation required by paragraph (1) of this AD does not need to be inserted into the RFM.

**Note to paragraph (e)(2) of this AD:**  
Previous RFM revisions allowed for the use of above-specification engine power margin as depicted in the circled area of Figure 1 of this AD.

(1) By making pen and ink changes, insert into the Operating Limitations section, Part 1, Section 1, Weight Limits, of Rotorcraft Flight Manuals (RFMs) SA S92A-RFM-002, -003, -004, -005, and -006 the following limitation “Performance credit for above specification engine power margin is prohibited.”
