[Docket No. FAA-2012-0415; Directorate Identifier 2008-SW-065-AD]

Airworthiness Directives; Bell Helicopter Textron, Incorporated Helicopters

Bell Helicopter Textron, Inc. (BHTI): Docket No. FAA–2012–0415; Directorate Identifier 2008–SW–065–AD.

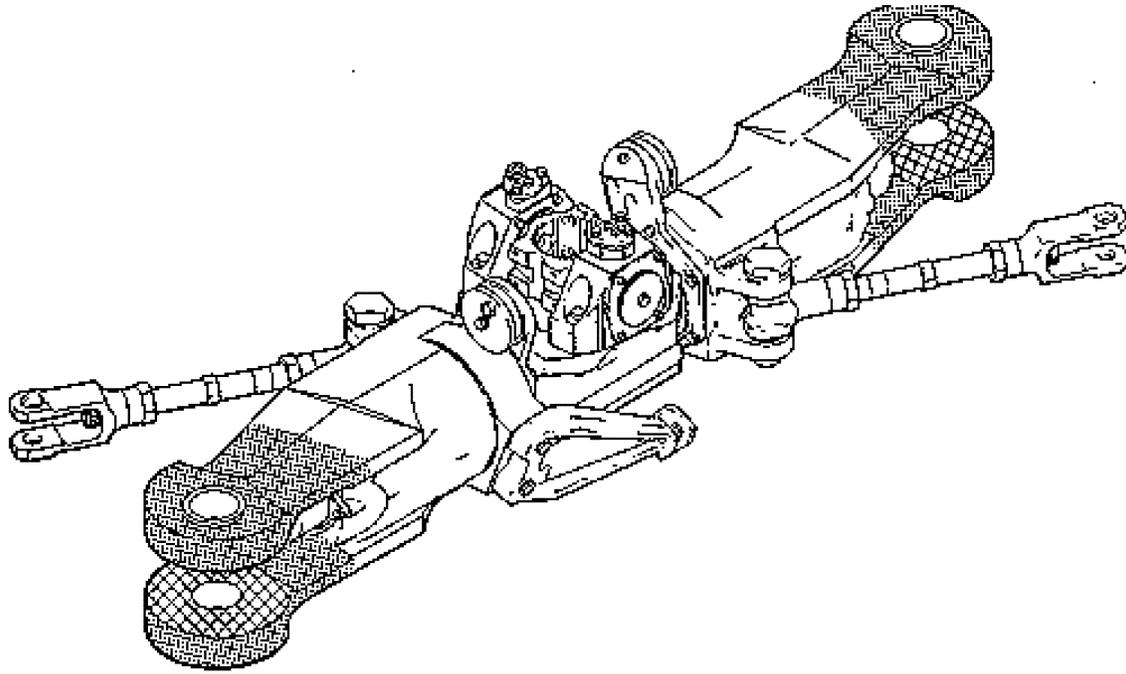
Figure 1. Inspection of Main Rotor Hub Grip Tangs

- (i) Clean the exposed surfaces of the upper and lower tangs of each grip with denatured alcohol, and wipe dry.
- (ii) Using a 10-power or higher magnifying glass, visually inspect the exposed surfaces of the upper and lower tangs of each grip for a crack. Pay particular attention to the lower surface of each lower grip tang from the main rotor blade bolt-bushing flange to the leading and trailing edge of each grip tang. See Figure 1 of this AD.

- (i) Remove each main rotor blade, and
- (ii) Inspect each grip buffer pad on the inner surfaces of each grip tang for delamination (see Figure 1 of this AD). If there is any delamination, remove the buffer pad and inspect the grip surface for corrosion or other damage.
