**DEPARTMENT OF TRANSPORTATION****Federal Aviation Administration****14 CFR Part 39**

[Docket No. FAA–2012–0630; Directorate Identifier 2011–SW–010–AD]

**Airworthiness Directives; Eurocopter France Helicopters**

**ACTION:** Notice of proposed rulemaking (NPRM).

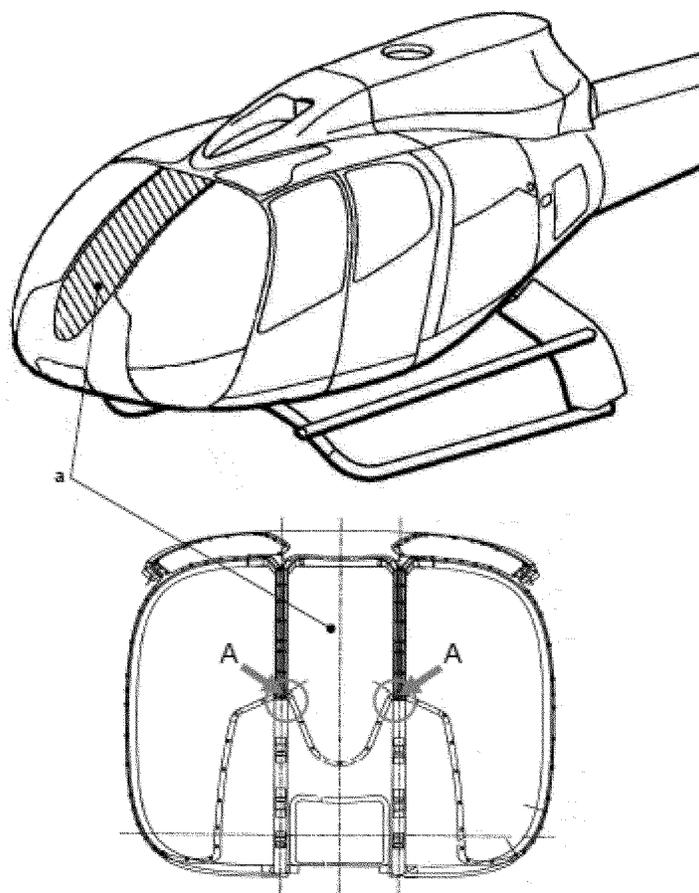
**Figure 1**

This AD defines the unsafe condition as a crack in the blending radii of the center windscreen, which could lead to failure of the center windscreen, injury to the flight crew, and subsequent loss of control of the helicopter.

(1) Until the center windscreen is replaced with center windscreen P/N 350A25-9045-20, before each flight, visually check the center windscreen for a crack in the area of the blending radii where the front-lower part of the center windscreen joins the front fuselage as depicted in Figure 1 of this AD. This visual check may be performed by the owner/operator (pilot) holding at least a private pilot certificate, and must be entered into the aircraft records showing compliance with the AD in accordance with Title 14 Code of Federal Regulations (14 CFR) 43.9 (a)(1)-(4) and 14 CFR 91.417(a)(2)(v). The record must be maintained as required by 14 CFR 91.417, 121.380, or 135.439.

(2) If there is a crack or if a pilot indicates that the center windscreen distorted during flight, before further flight, replace the center windscreen with an airworthy center windscreen, P/N 350A25-9045-20, in accordance with the Accomplishment Instructions, paragraphs 2.B.2.b. through 2.B.2.b.4. of Eurocopter Service Bulletin No. 56-003, Revision 0, dated November 16, 2010.

(3) Within 12 months, replace the center windscreen with an airworthy center windscreen, P/N 350A25-9045-20, in accordance with the instructions contained in paragraph (d)(2) of this AD.
